# Building Survey

9 Kings Avenue  
Sandwich Bay,  
Sandwich  
CT13 9PH

**Reference:** DH001 – Dan Hurley

**Date:** 19 August 2026

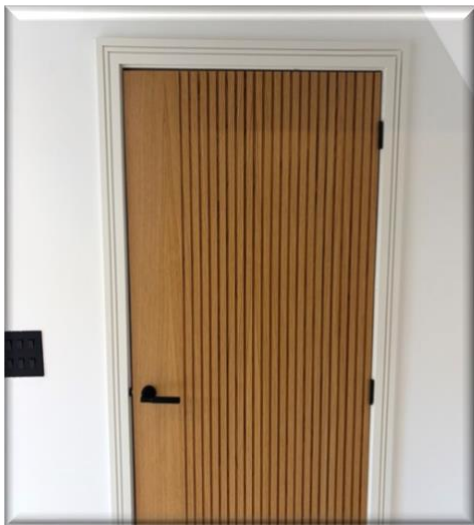
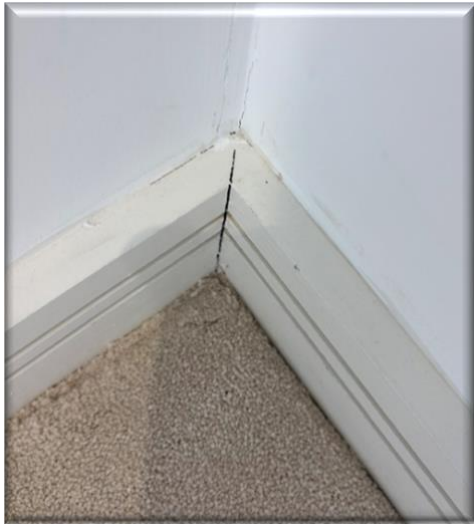
**Condition rating 2:** The staircase, built-in storage and kitchen fittings were generally modern, stable and serviceable. However, most internal doors require adjustment so that they close and latch correctly, and minor drying-shrinkage gaps at skirting-board mitres require routine making good.

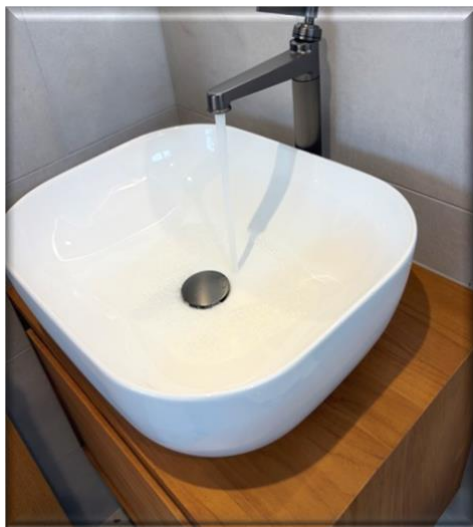
**Condition rating 1:** The ground- and first-floor sanitary fittings were modern, in good condition and operating satisfactorily, with hot water available at the tested outlets and no significant defects noted. The limescale deposits to the shower heads require routine cleaning and ongoing maintenance only.

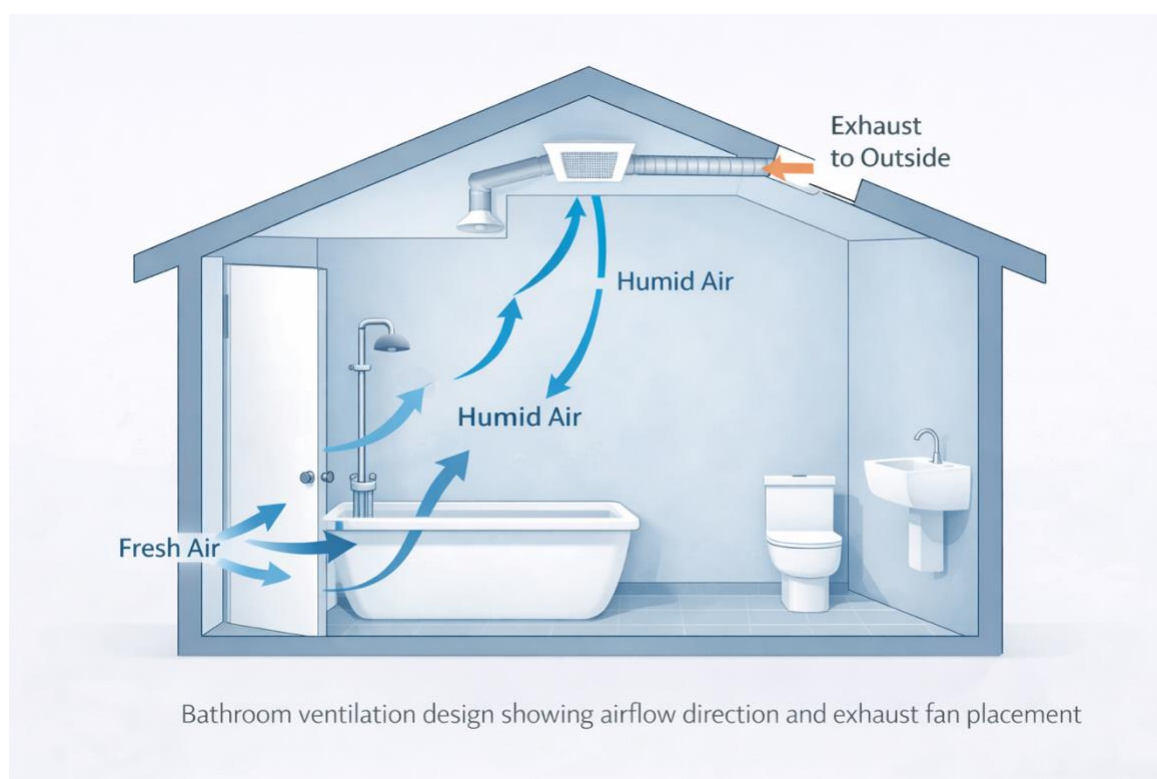
**Condition rating 1:** The sanitary-room extractors were modern, operational and externally ducted, with no significant defects noted. The hob extractor also operated but is likely to recirculate and therefore will not remove cooking moisture. All extractors must be used and maintained consistently to reduce the risk of surface and concealed condensation.

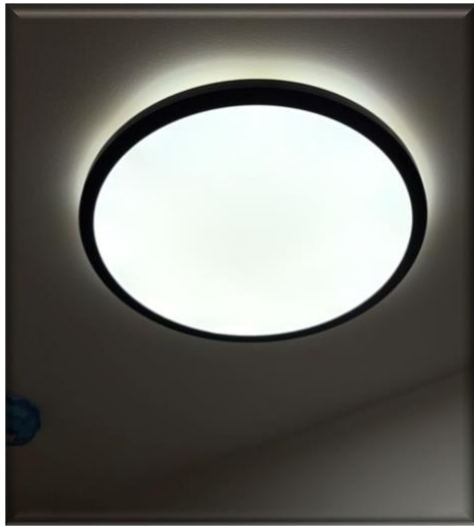
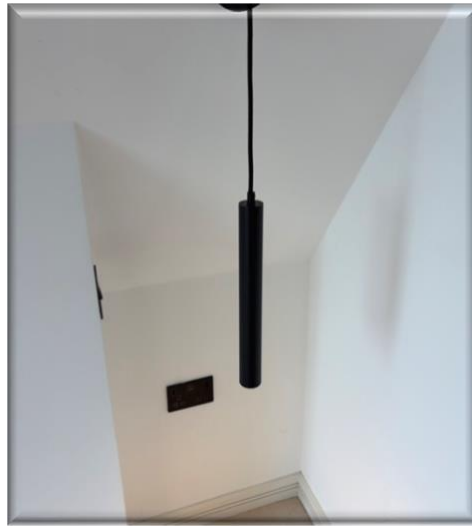
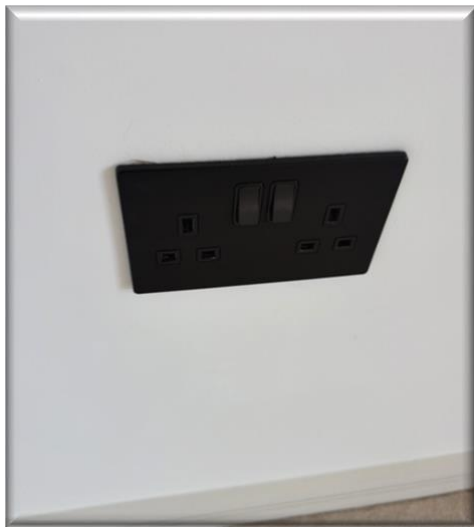
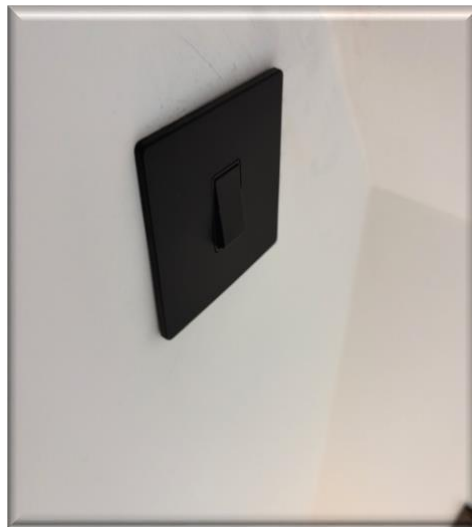
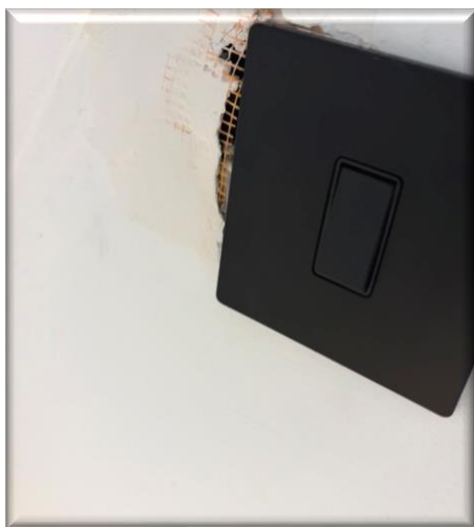
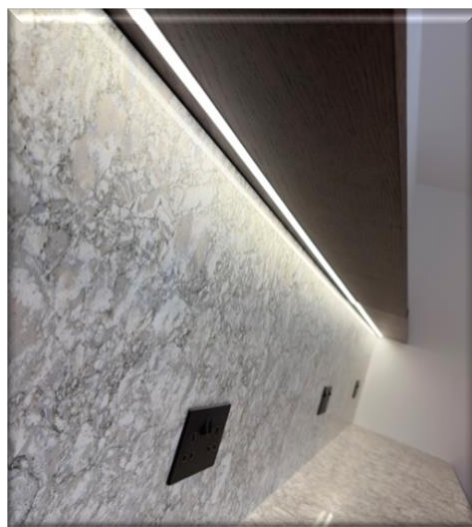
**Condition rating 2:** The electrical installation is modern, comprehensive and adaptable, with good provision of lighting, sockets, renewable generation, battery storage, EV charging and spare distribution capacity. No significant operational defect was apparent. Minor plaster and decorative repairs are required around a small number of accessories, and the complete certification, commissioning records, warranties and network approvals should be obtained.

**No recent documentation was seen to confirm that an EICR has been carried out within the last 10 years. In the absence of such evidence, the installation must be treated as potentially unsafe: serious defects can exist within concealed wiring even where the system appears to operate normally. You should therefore commission a full electrical inspection and EICR by a competent electrician prior to legal commitment to purchase, unless satisfactory, recent certification is provided.**

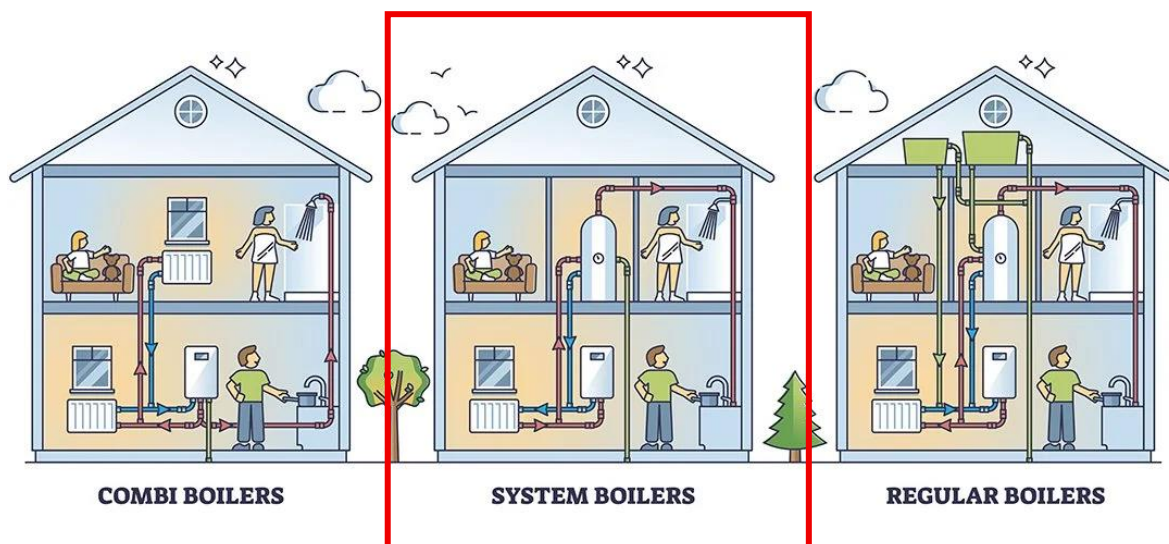
**Condition rating 2:** The unvented hot-water system appeared modern and provided good pressure and hot water at the tested outlets, with no operational defect noted. However, the required installation and Building Regulations documentation has not been identified and must be obtained or the system independently inspected and certified.

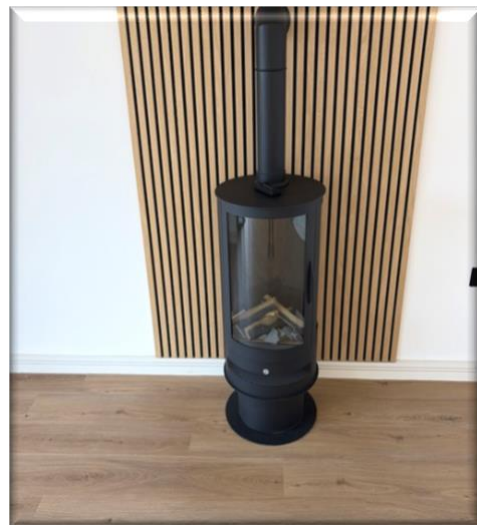
**Condition rating 1:** There are no working fireplaces, chimneys or combustion flues to maintain. The electric imitation log-burning heater appeared modern and in good visual condition, with no significant defects noted.

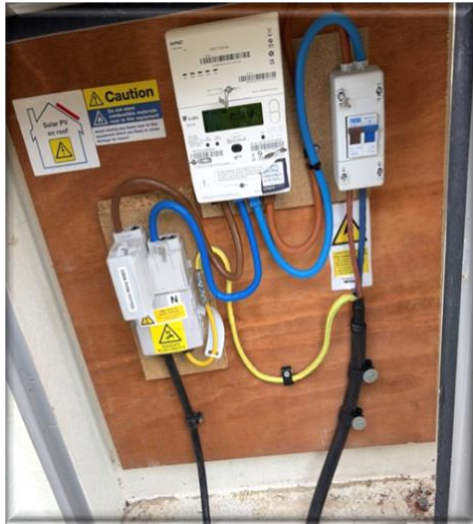
**Condition rating 2:** The electricity, gas and Openreach fibre equipment appeared modern and appropriately located, with no significant visible defects. However, the water meter and main stopcock were not identified and must be located, made accessible and tested before occupation.

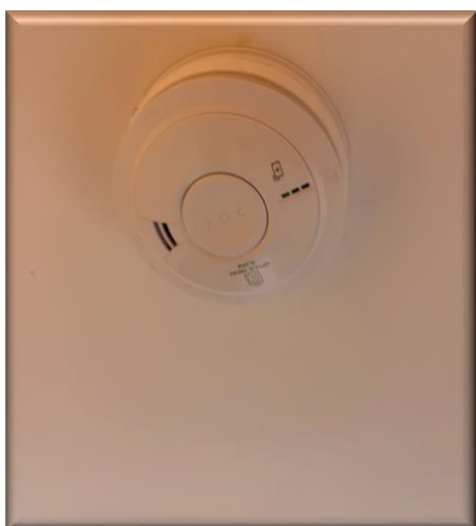
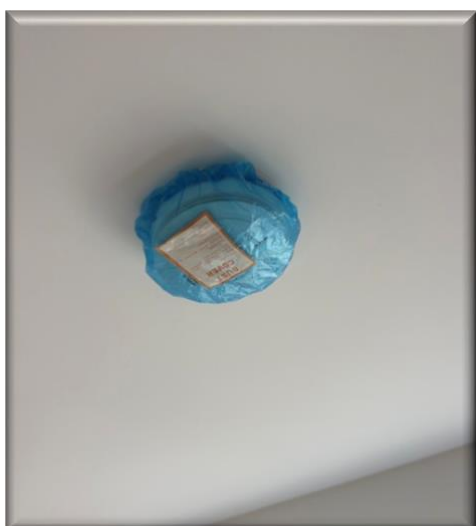
Condition rating 2: The fire-detection, burglar-alarm and CCTV systems are modern and appeared operational. However, the temporary dust covers must be removed from all detector heads and the complete interlinked alarm system retested before occupation. All codes, instructions, account access, commissioning records and warranties should be obtained from the vendor.

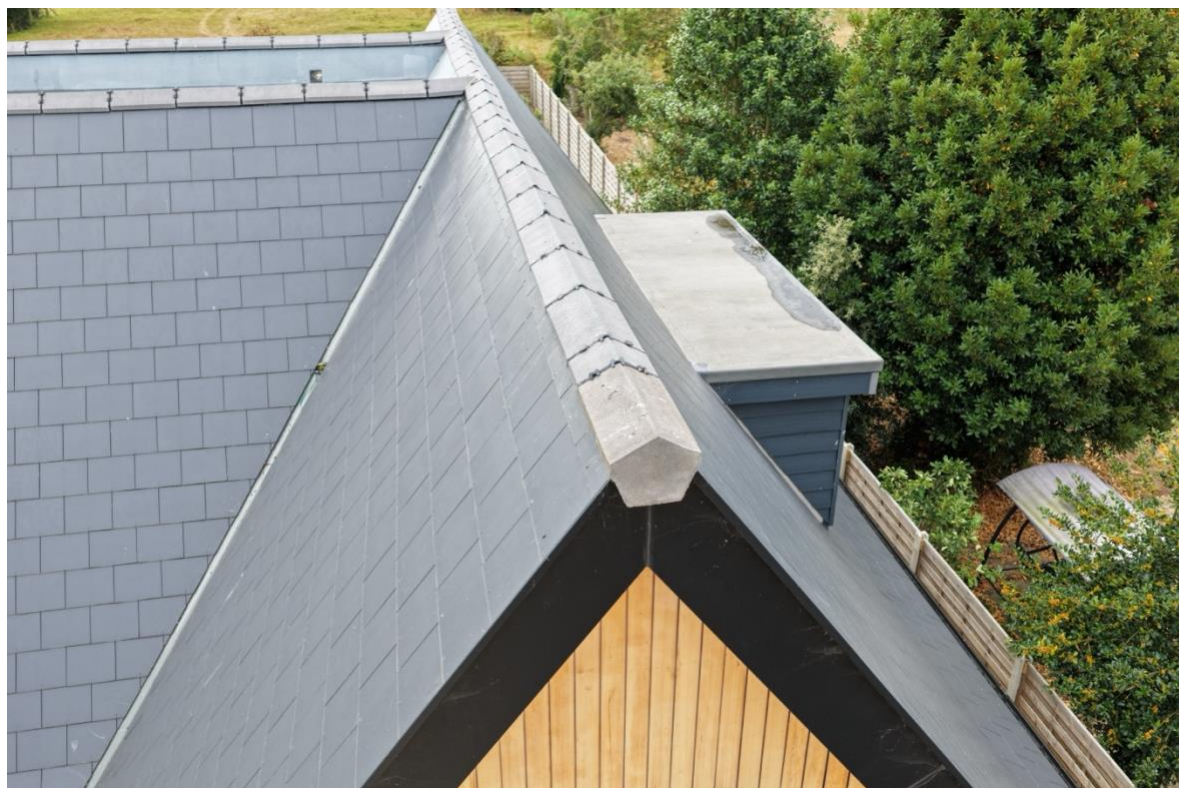
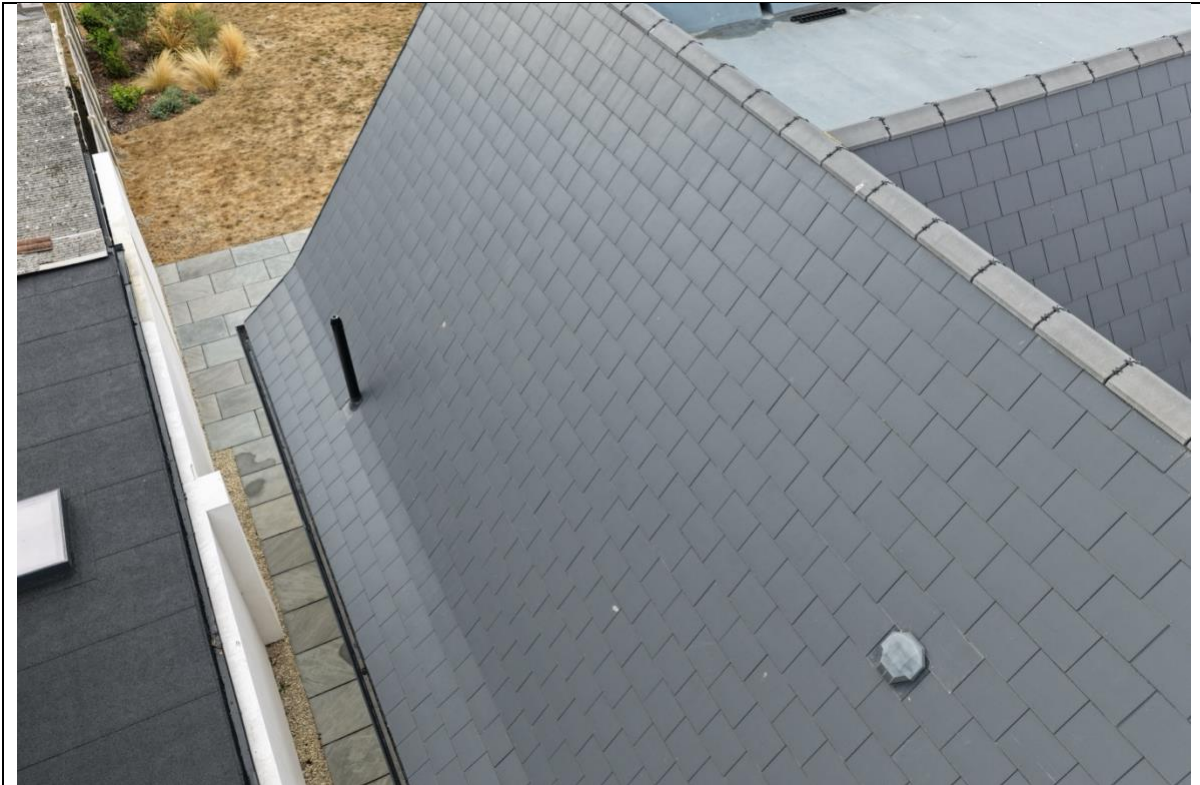
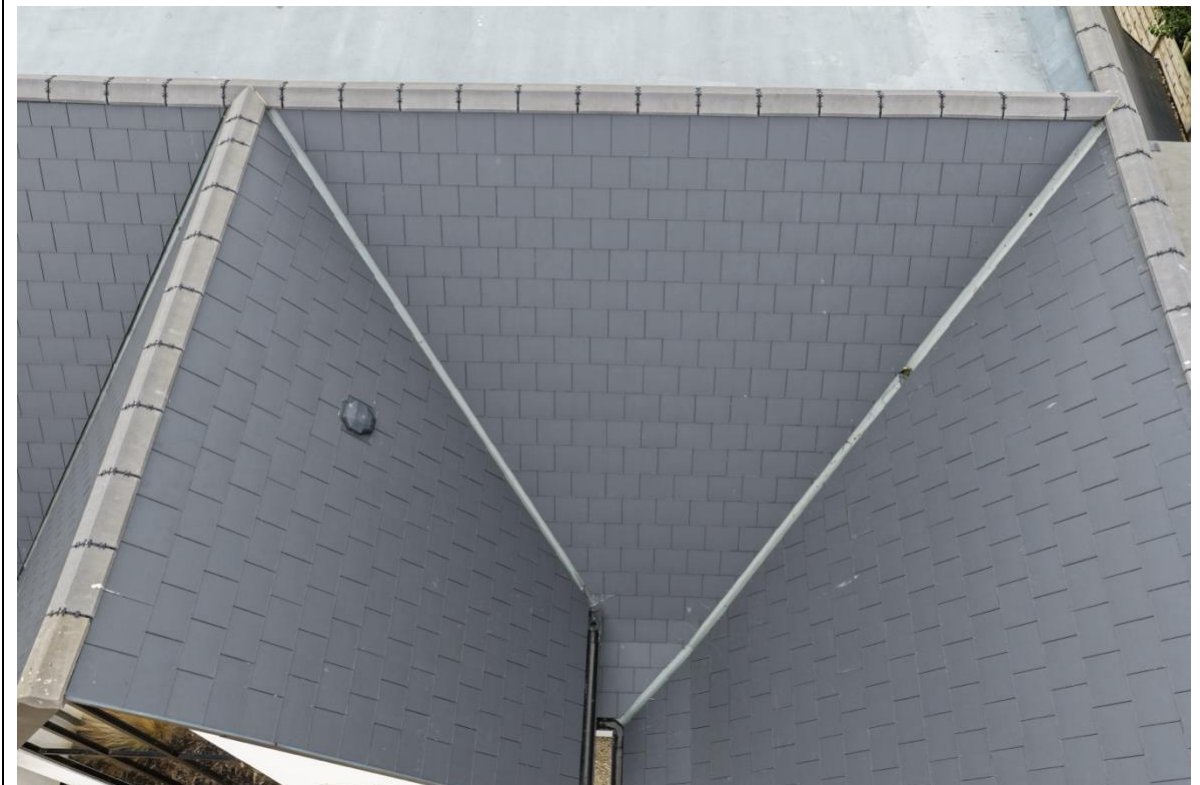
**Condition rating 2:** The new pitched and flat roof coverings were generally in good order, with no widespread displacement, distortion or evidence of current water penetration. However, debris must be removed from the valleys and gutters, the split and crazed GRP topcoat over the rear extension requires specialist investigation and repair, and the other GRP roofs should be checked for similar application defects. The untreated timber concealed behind the aluminium fascias and soffits also requires appropriate protection and careful future monitoring.

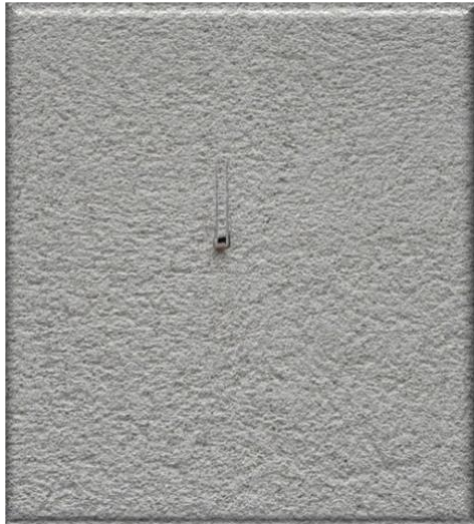
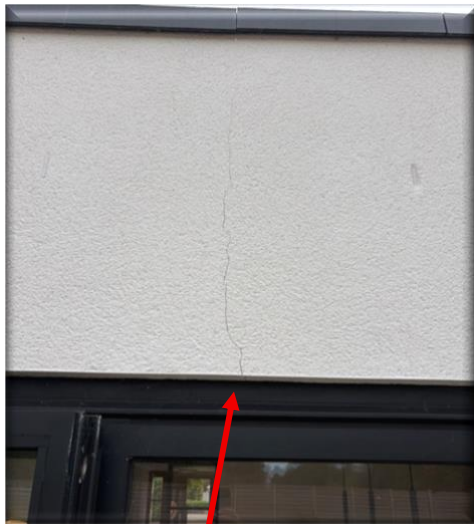
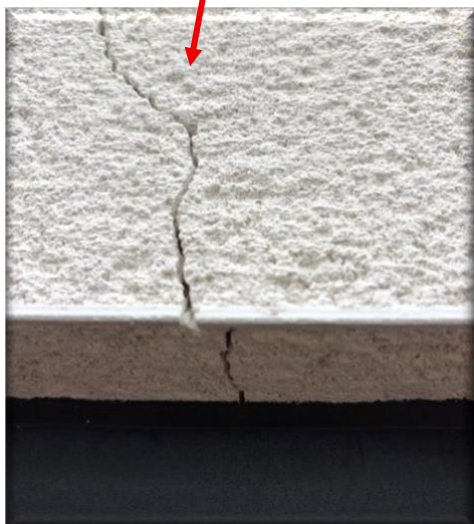
**Condition rating 2:** The external walls were generally modern, visually straight and free from evidence of significant structural instability. However, the prominent render crack to the garage side extension, cracking above the kitchen bi-fold doors, absence of movement joints, blocked cavity-tray weep vents, low render drip beads and missing section of timber cladding require investigation and remedial work. The door opening should be checked by the installer and, if satisfactory adjustment cannot be achieved or cracking recurs, by a structural engineer.

Blocked weep vents and cracked render –  
no expansion joints installed

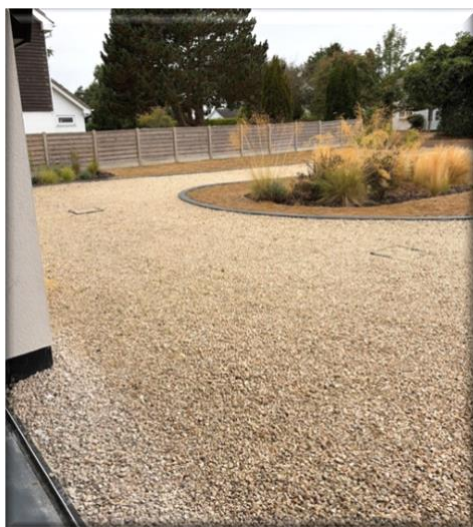
**Condition rating 1:** The gardens, paving and boundary structures were generally in good and serviceable condition. Rabbit activity at the rear boundary and concentrated rainwater staining to a rendered wall require routine monitoring and minor maintenance only.

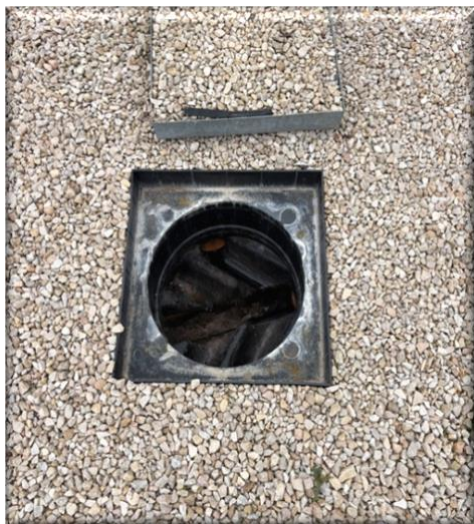
**Condition rating 2:** The accessible drainage chambers, gutters, downpipes and most rainwater outlets appeared serviceable, with no evidence of blockage or surcharge. However, the rear flat-roof outlet is not discharging effectively into its hopper and is staining the wall. The outlet requires prompt extension or alteration followed by water testing.

Following repair, the outlet should be water-tested to confirm that the full discharge enters the hopper without running back onto the render. The wall should be allowed to dry before the staining is cleaned using a method suitable for the silicone render. Any loose, softened or persistently damp render should then be repaired.

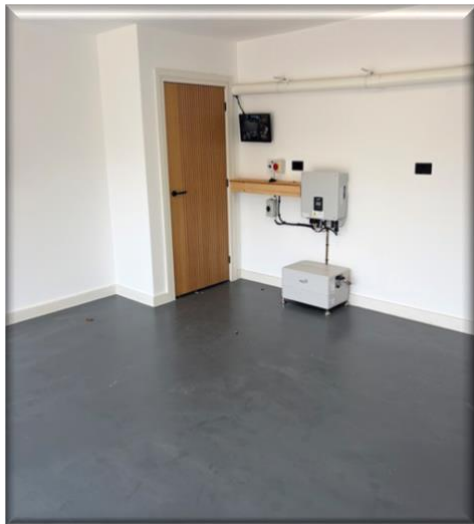
**Condition rating 3:** The garage structure and concrete floor appeared sound, but the personnel door does not provide the required fire resistance between the integral garage and the dwelling and should be replaced promptly with a certified self-closing FD30S doorset. The roller-shutter door also jammed while closing and requires specialist adjustment and safety testing.

The replacement should be installed as a tested doorset by a competent fire-door installer rather than treating the door leaf, frame and ironmongery as unrelated components. Perimeter gaps between the frame and wall must be correctly fire-stopped, and the installation should be inspected and accepted by Building Control as part of the outstanding completion process. The door should not be wedged open.

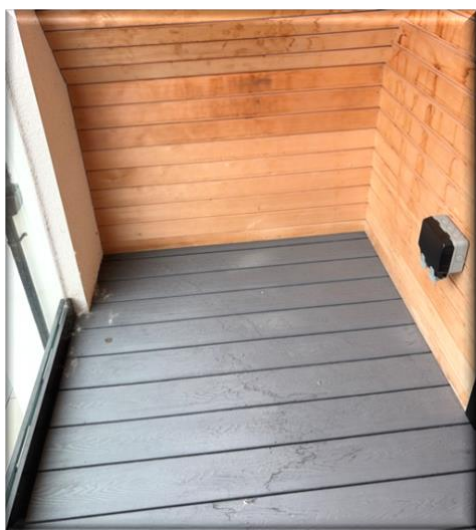
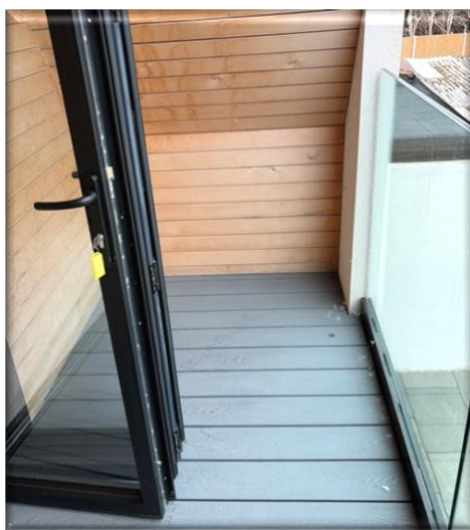
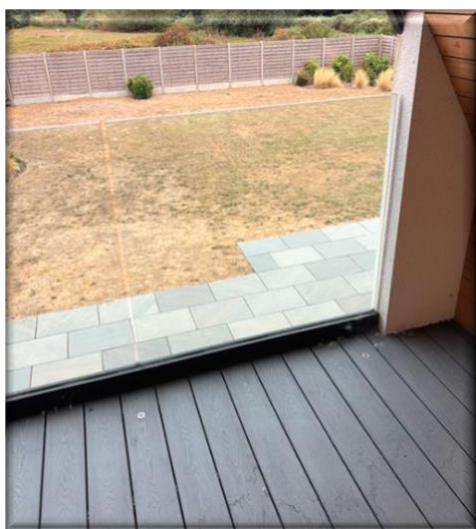
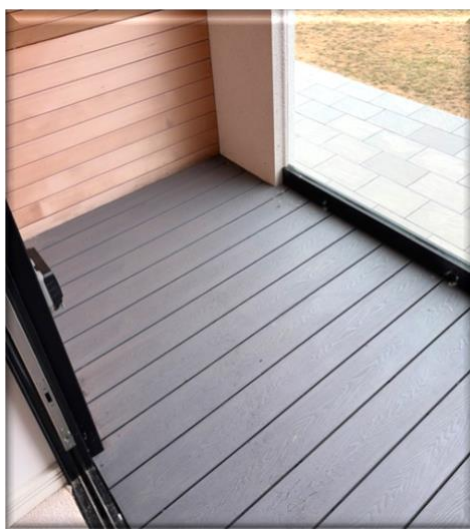
**Condition rating 1:** The balconies, composite decking and glazed balustrades appeared modern, stable and in good serviceable condition, with no significant defects noted. Routine clearing, cleaning and inspection of the drainage routes, waterproofing junctions and coastal-exposed metal components will be required.
