## Building Survey

14 Audley Rd  
Folkestone  
Kent  
CT20 3QA

**Reference:** JB001 - JENNA BANKS

**Date:** 15 July 2026

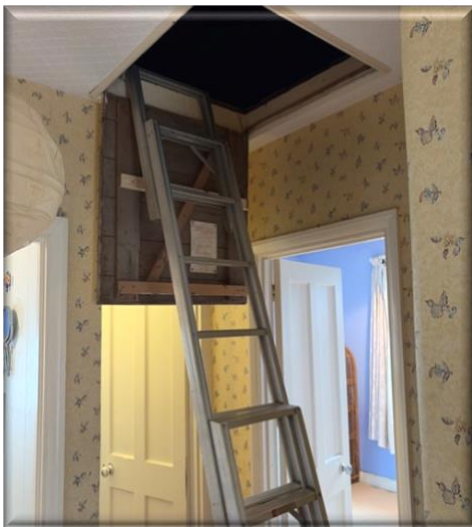
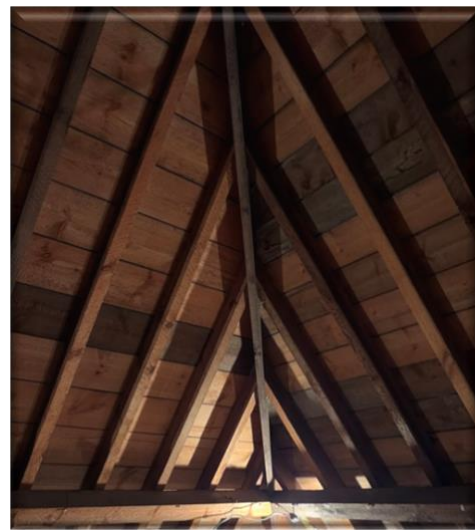
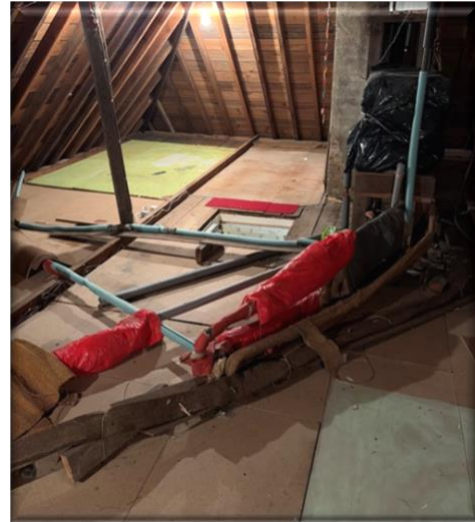
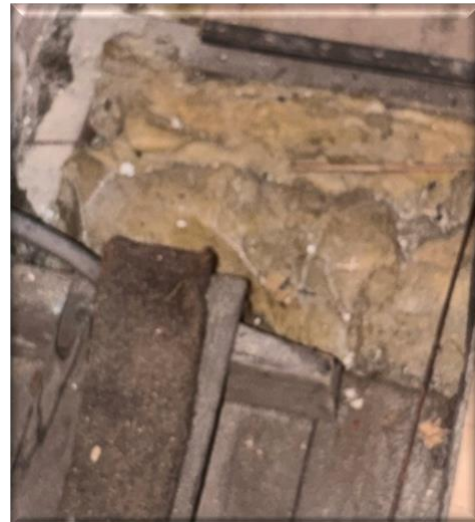
The roof structure is in good condition and no significant repair is presently required. The visible structural timbers appear sound, with no evidence of serious decay, deformation or failure. The recommendation to increase the loft insulation is an energy-efficiency improvement rather than a significant defect, and routine maintenance and periodic inspection should be sufficient.

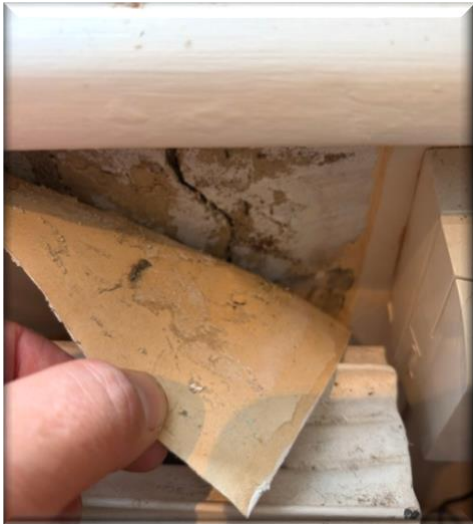
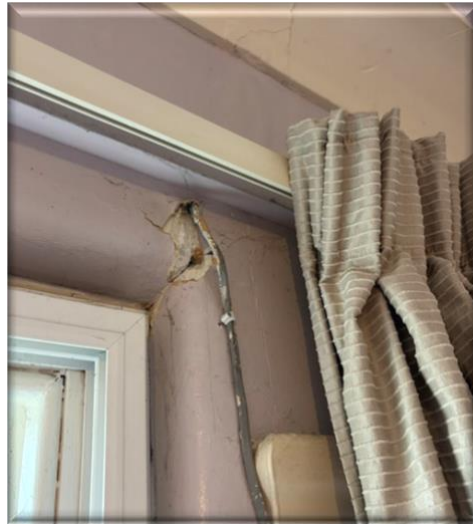
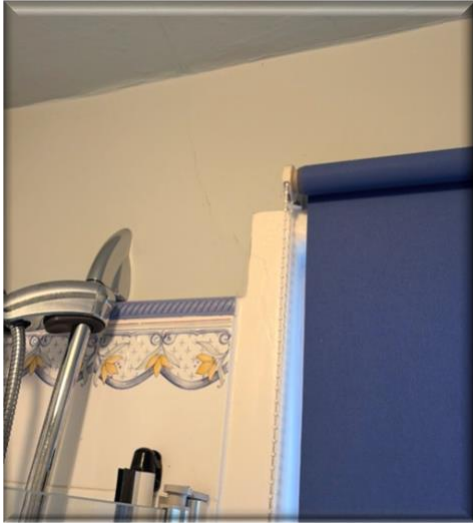
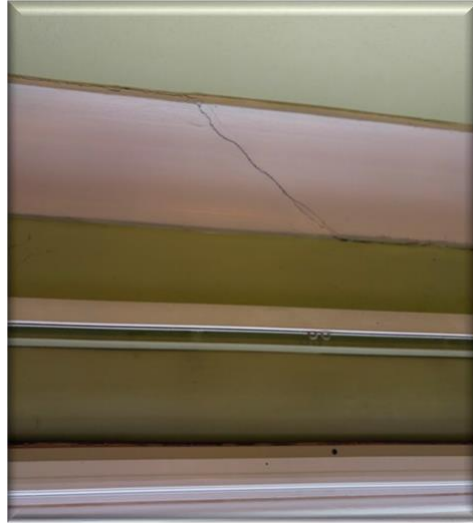
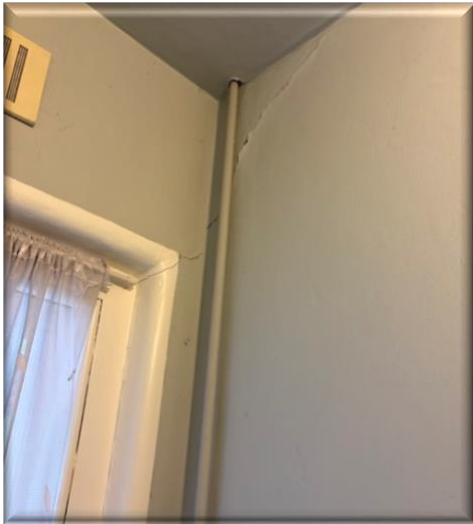
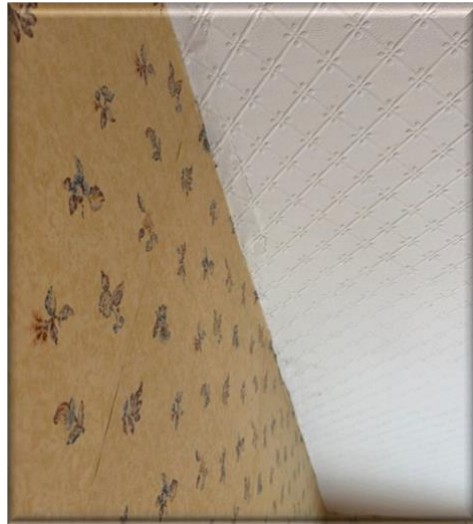
This rating has been applied because the separation and cracking within the front reception room corresponds with localised movement and defective masonry arches above the front windows, which require repair rather than decoration alone. Further investigation is also required in relation to the concealed structural support over the opening into the rear kitchen because no Building Control or structural information was available. The remaining wall and ceiling defects are generally consistent with the age and traditional construction of the property.

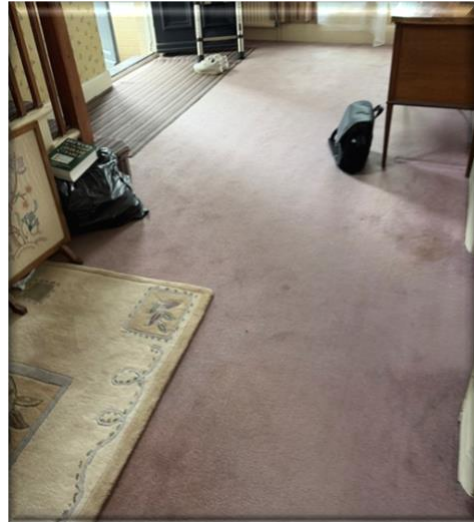
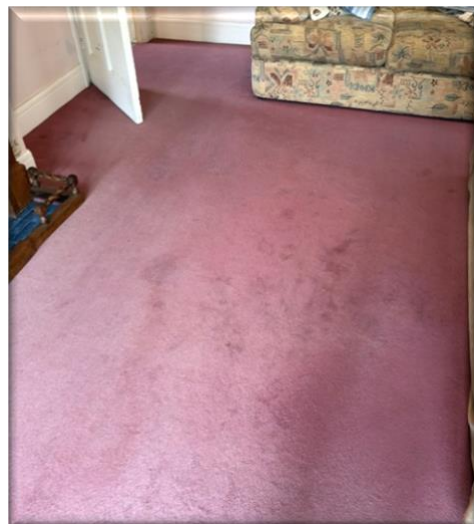
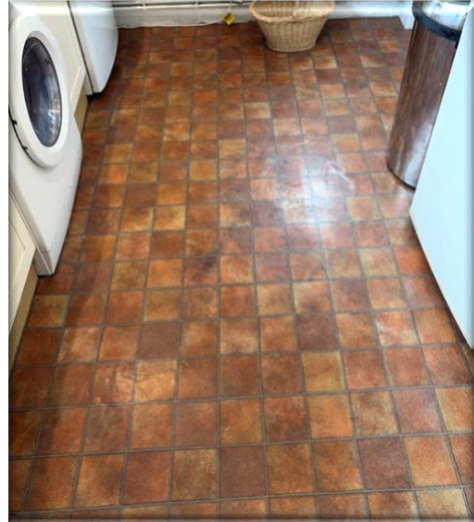
The floors were found to be performing satisfactorily with no evidence of significant structural defects. The loose floorboards adjacent to the boiler are considered a minor maintenance issue resulting from previous access for plumbing works and can be remedied as part of routine maintenance. No further investigation is considered necessary at this stage.

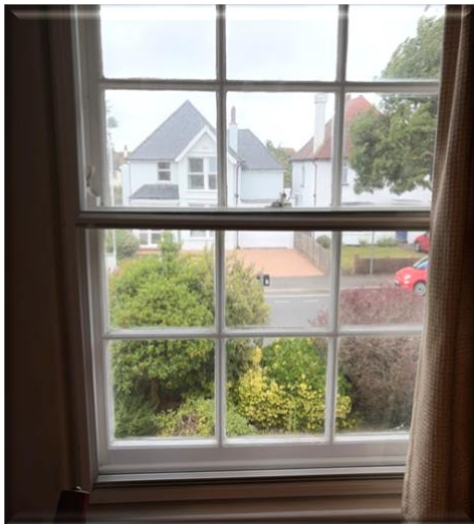
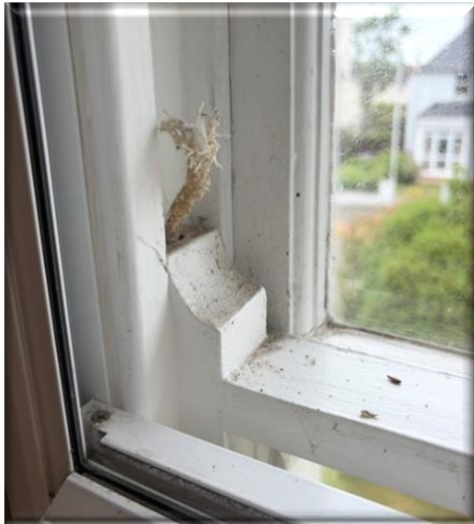
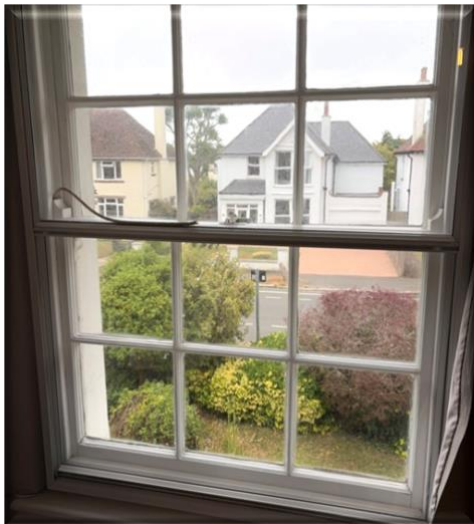
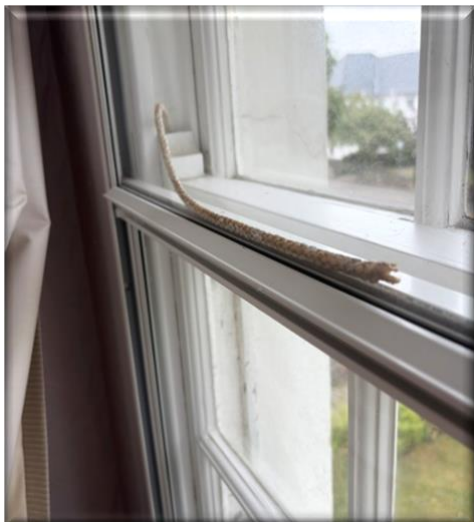
This rating has been applied because a substantial programme of repair and refurbishment is required to restore the original timber sash windows to full working order. Whilst the timber frames themselves remain largely sound, the widespread failure of sash cords, painted shut windows, missing furniture, cracked glazing and localised distortion to the front living room windows means that significant maintenance work is now necessary. In addition, the front living room windows should not be repaired until the defective brick arches and associated masonry movement have first been remedied. The modern replacement windows and doors require only minor maintenance.

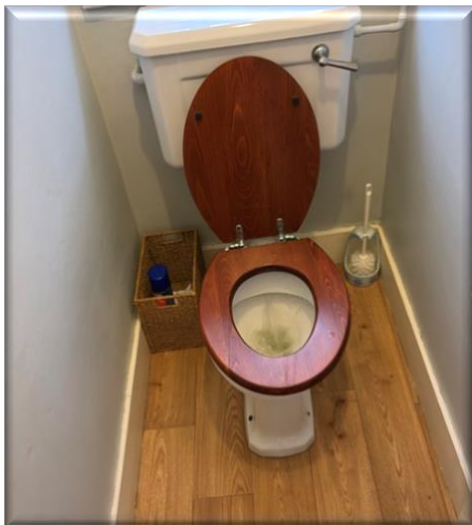
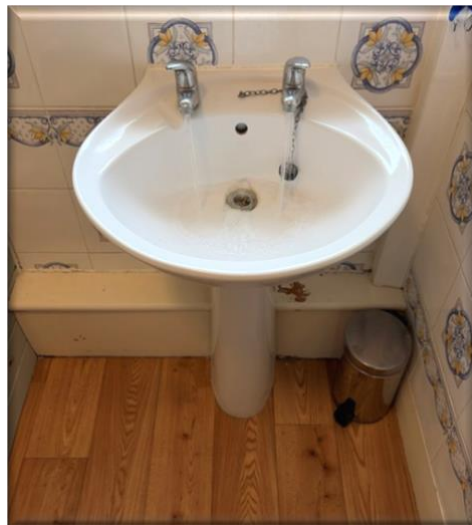
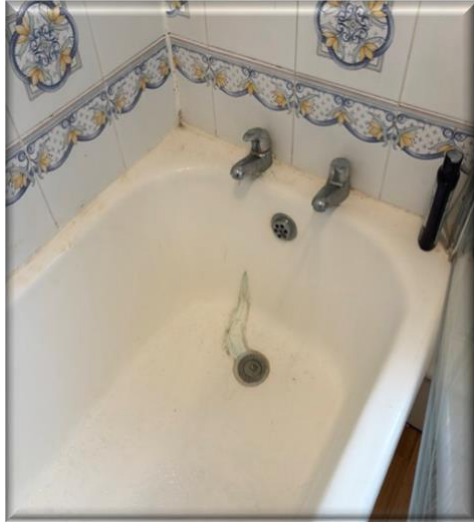
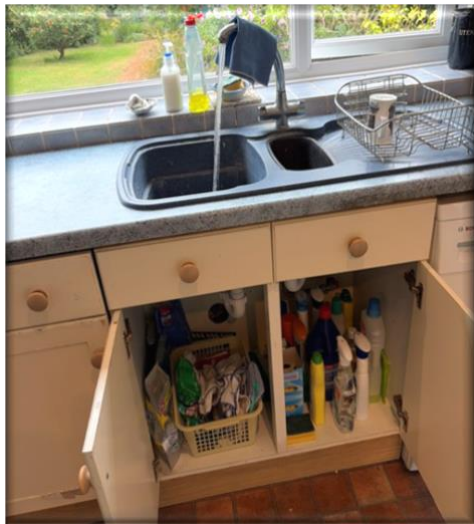
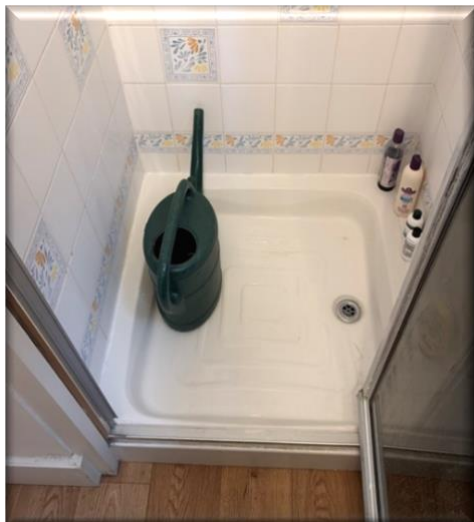
The sanitary fittings remain broadly serviceable but require repair and maintenance. The stiff bath taps should be replaced, the heavily limescaled bath should be thoroughly cleaned or renewed during refurbishment, and the cracked bedroom basin requires replacement. The remaining fittings are dated but no evidence of widespread active leakage or complete failure was identified.

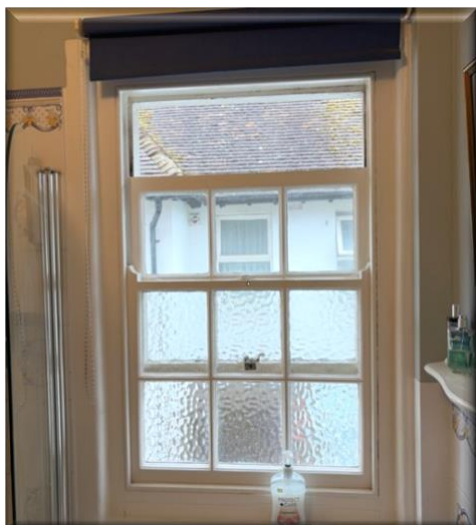
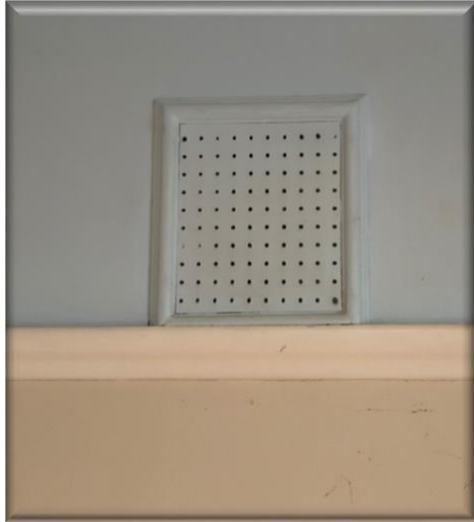
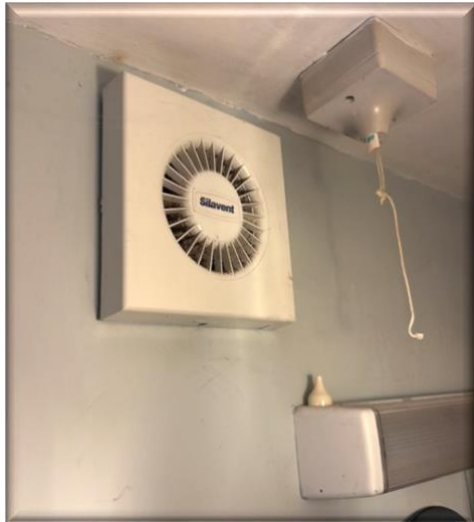
Mechanical extraction is inadequate by modern standards. The non-operational extractor fan within the ground floor shower room requires repair or replacement, and the absence of extract fans within the main bathroom and first floor WC should be addressed during future improvements to reduce the risk of condensation and improve internal air quality. The existing natural ventilation provisions should remain unobstructed.

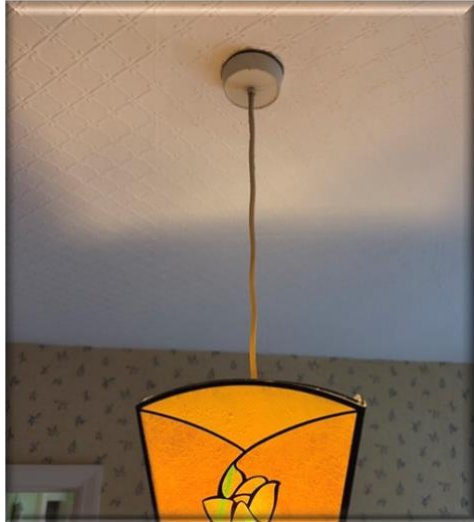
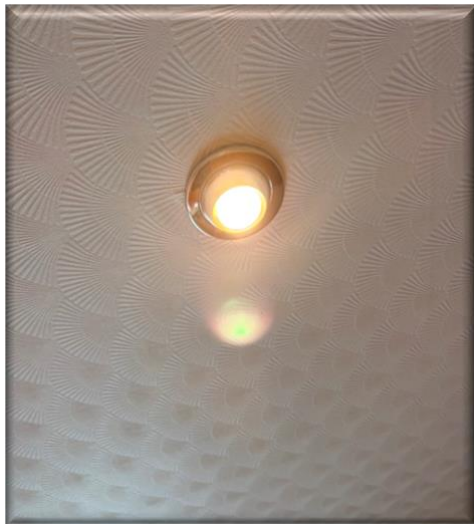
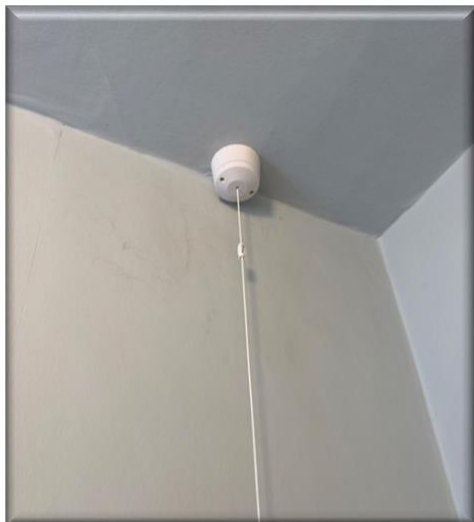
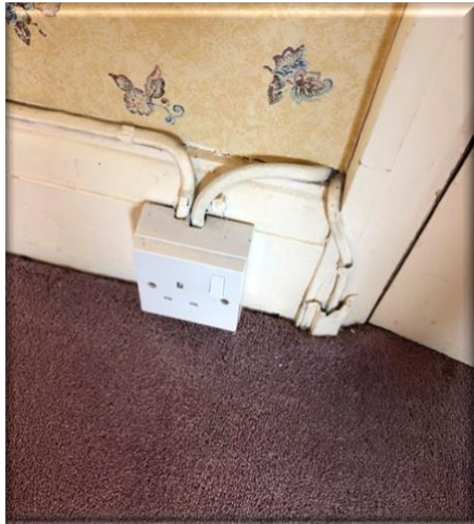
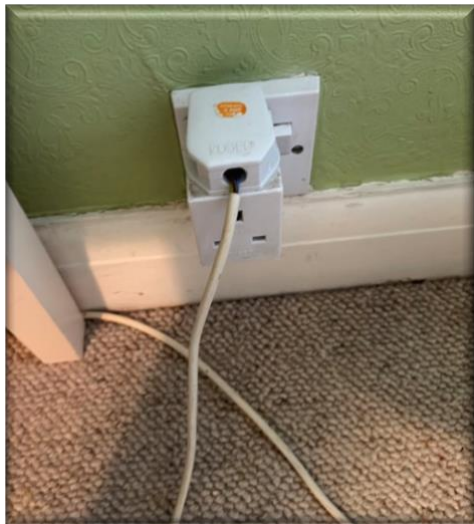
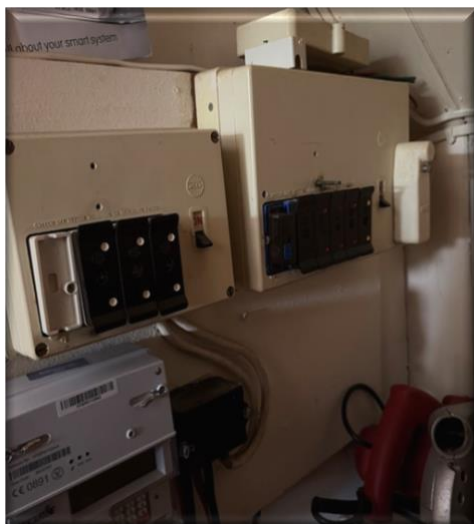
This rating has been applied because the electrical installation is of considerable age, incorporates an obsolete rewirable fuse board and is unlikely to meet modern safety standards or the demands of contemporary living. Whilst no immediate dangerous defects were visually identified, the installation requires formal testing by a qualified electrician, and significant upgrading or replacement should be anticipated depending upon the outcome of the Electrical Installation Condition Report.

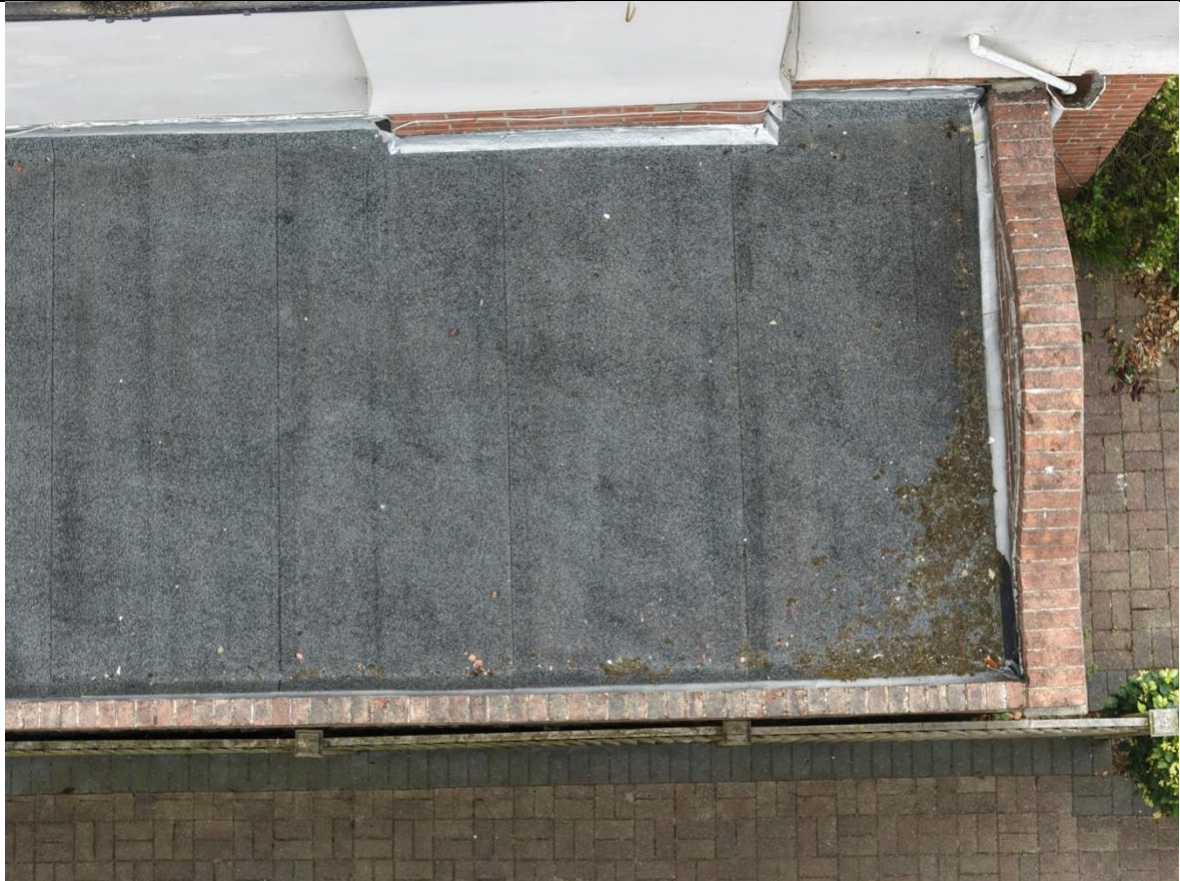
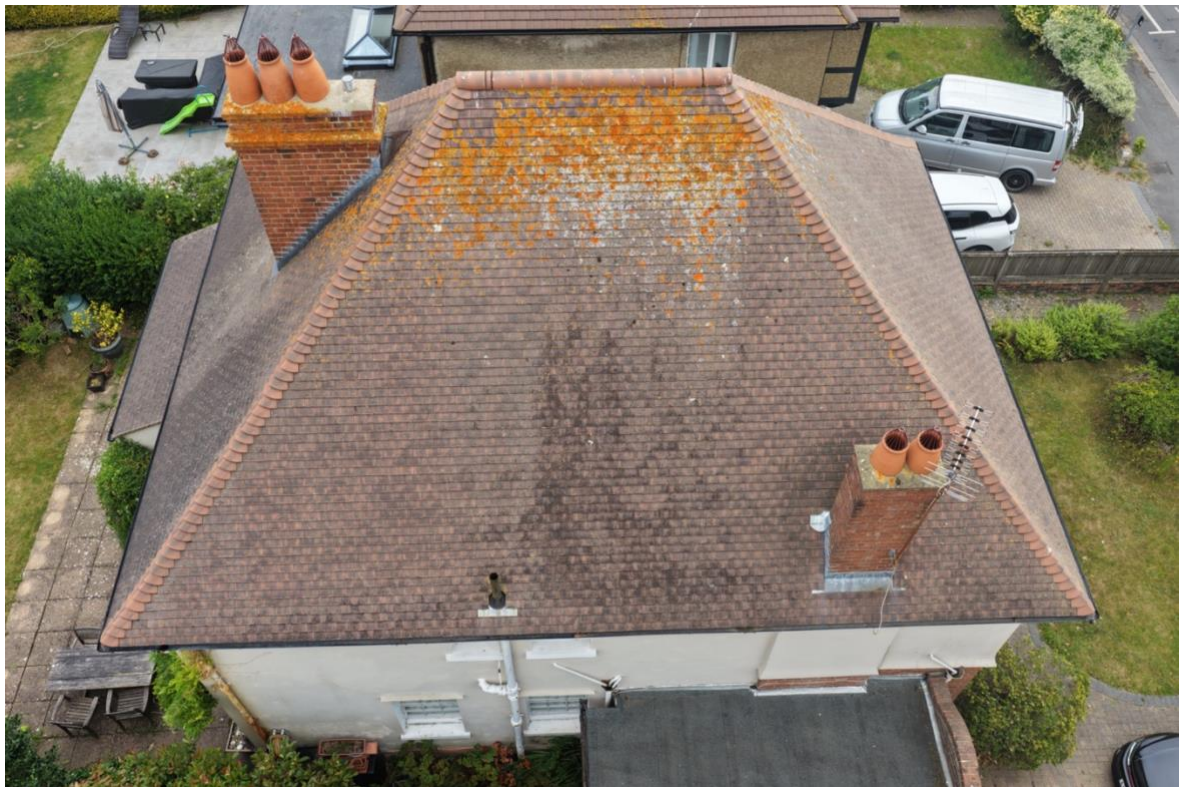
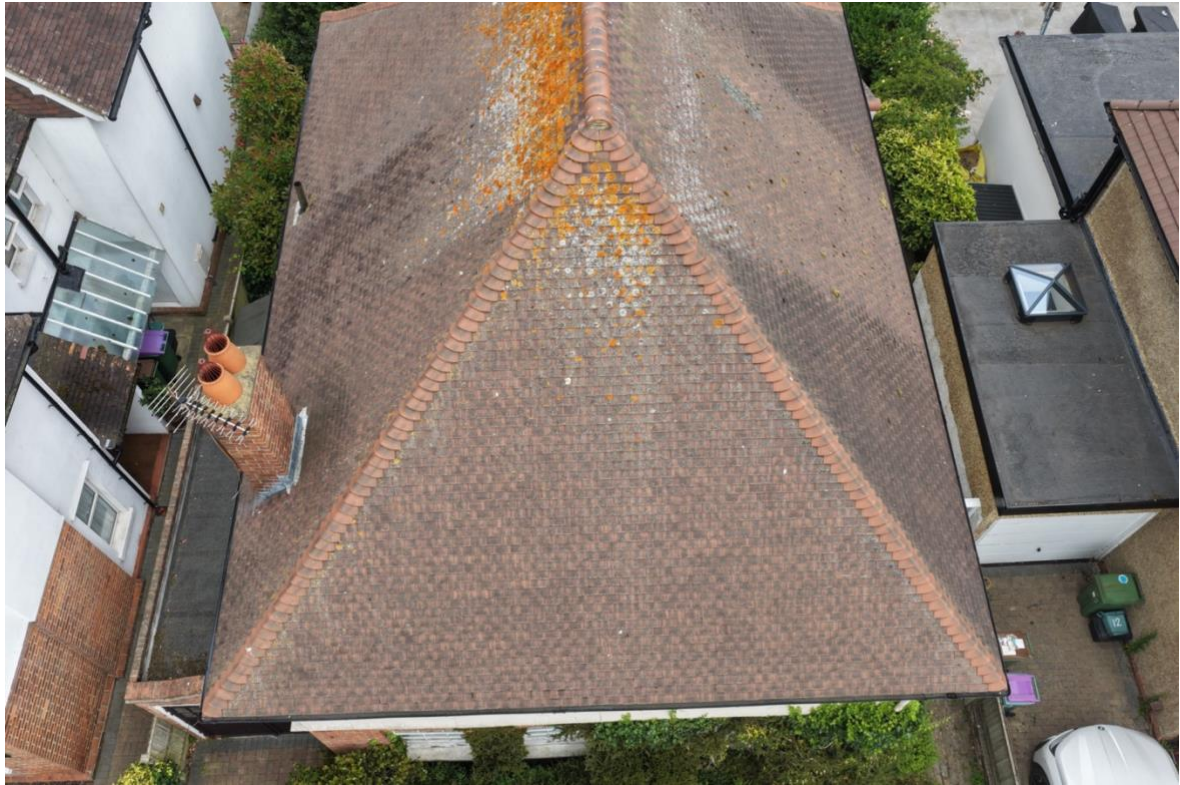
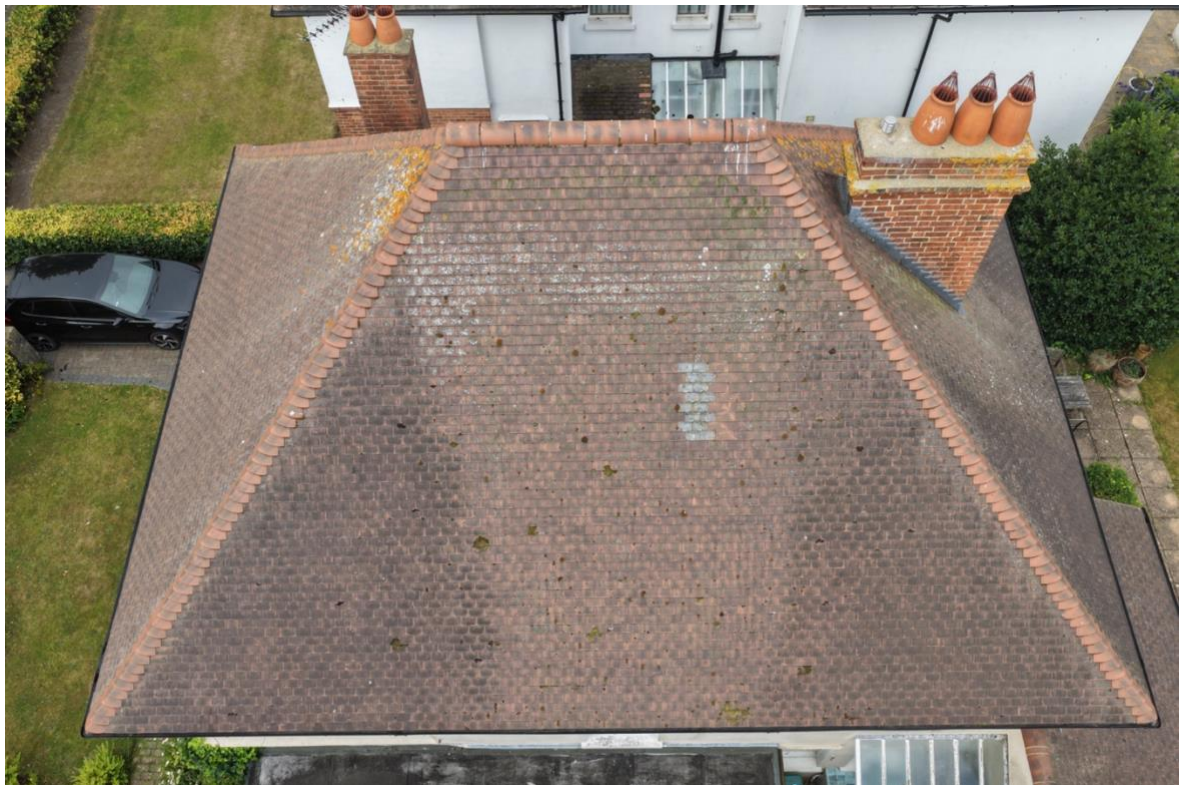
The main plain clay-tiled roof is in good condition and no significant repair is presently required, although supporting documentation for the replacement covering should be obtained. The side-extension felt roof is approaching the end of its serviceable life, while the garage roof is already allowing some water penetration and requires closer investigation and repair. Replacement of the older flat roof coverings should be anticipated as part of planned future maintenance.

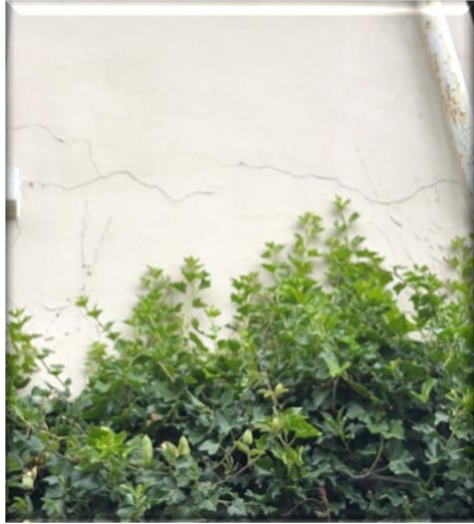
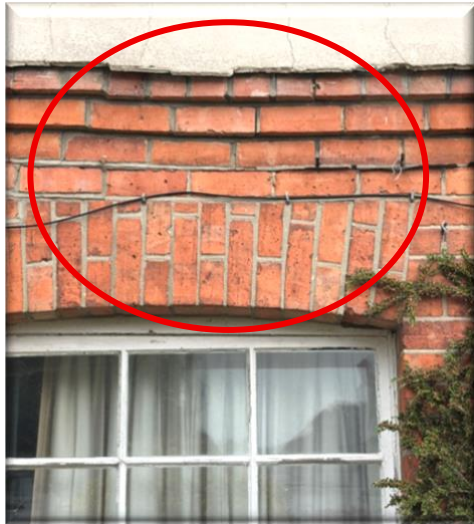
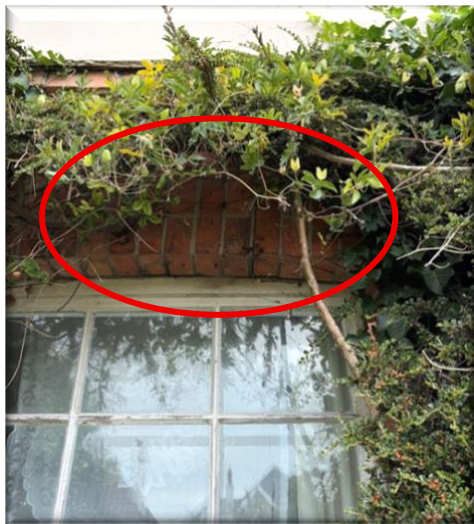
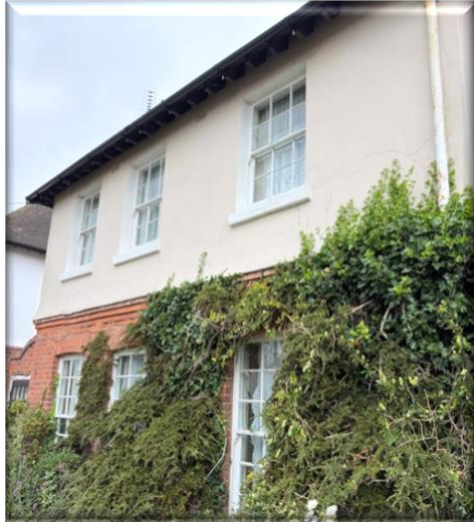
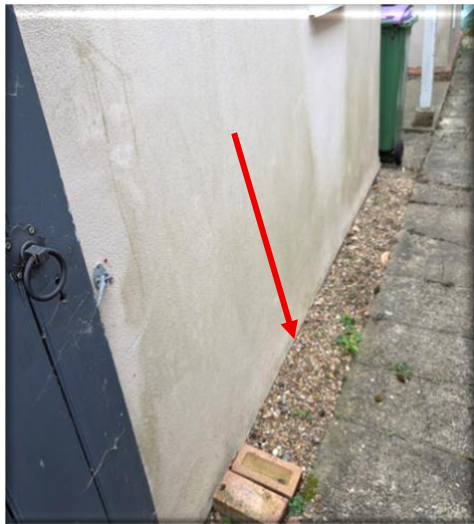
The most significant concern relates to the front elevation. Two brick arch lintels above the front windows have failed and require rebuilding. A third arch is largely concealed by vegetation and should be exposed for closer inspection as it may also require repair. Associated cracking is present within the surrounding masonry, and localised crack stitching will be required. Widespread cracking is also evident throughout the external render. Although relatively little corresponding movement is visible internally, the extent of the cracking means that further investigation is justified before undertaking repairs.

This rating has been applied because the external walls require significant repair and further investigation. Two front brick arches have failed and require rebuilding, a third arch requires closer inspection once vegetation has been removed, and crack stitching is likely to be required within the front brickwork and possibly elsewhere. The widespread horizontal cracking also warrants a specialist cavity wall tie survey before exchange of contracts. Substantial re-rendering should be anticipated after the underlying masonry defects have been stabilised.

Because horizontal cracking is present in several locations, I recommend that a specialist cavity wall tie survey is commissioned before exchange of contracts. This will establish whether corrosion of the original wall ties is contributing to the cracking. At the same time, a CCTV drainage survey should be undertaken to

- Remove climbing vegetation from the front elevation.
- Expose and inspect the third concealed brick arch.
- Rebuild the two failed brick arches.
- Undertake crack stitching to the front masonry.

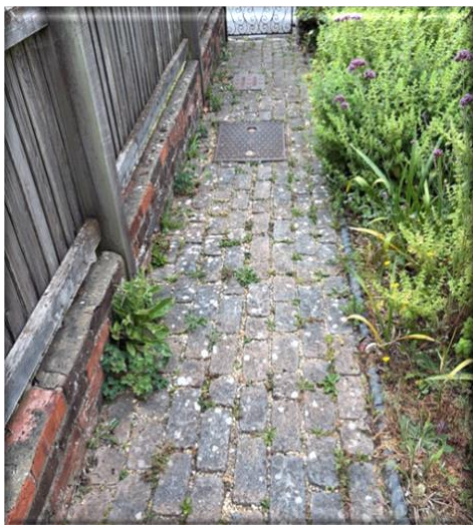
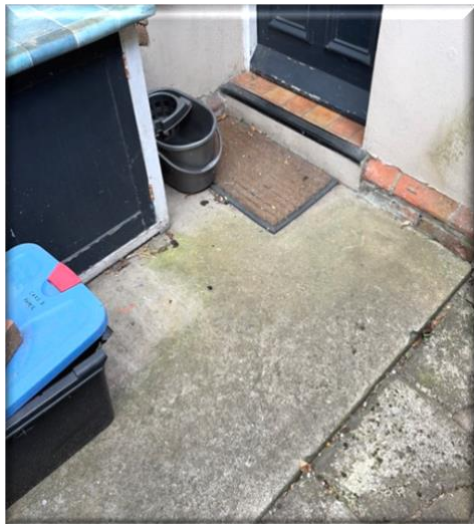
The principal grounds, driveway and front boundary wall are in generally satisfactory condition. However, the eucalyptus tree requires professional management advice, the rear fencing will need periodic repair, and the greenhouse and timber shed are in poor condition with limited remaining serviceable life. Minor paving maintenance and regular vegetation control are also required.

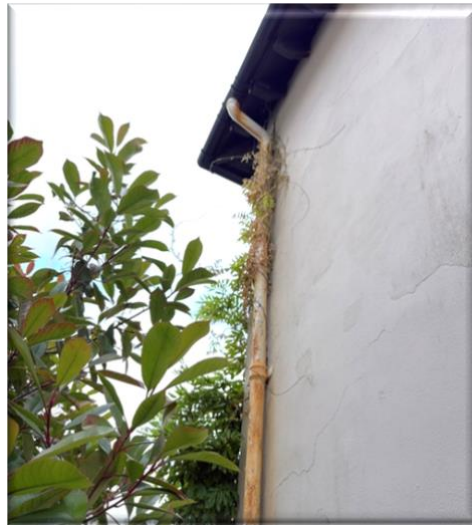
The modern plastic rainwater goods are generally in satisfactory condition. However, the retained cast iron downpipes and stacks exhibit significant corrosion and require maintenance and eventual replacement as necessary. A partial blockage was identified within one inspection chamber and should be cleared by rodding. A CCTV drainage survey is recommended before undertaking the structural masonry repairs to the front elevation to confirm that defective underground drainage is not contributing to the observed cracking.

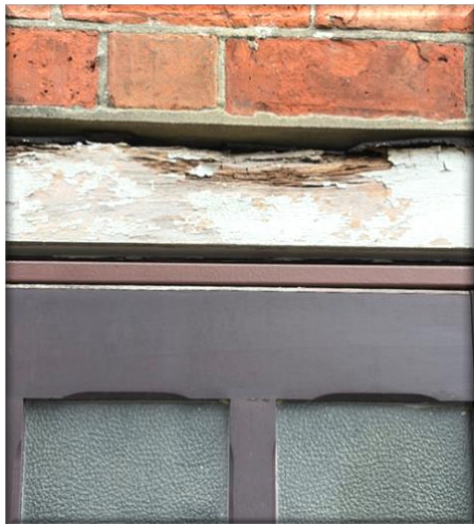
This rating has been applied because the garage is affected by active water ingress resulting in damp roof timbers and mould growth. The rotten timber garage door frame requires replacement, associated mortar joints require renewal, and some roof timbers may require replacement following repair of the leaking flat roof. Localised repointing and upgrading of the older electrical installation should also be anticipated.

- Carry out any wall tie replacement recommended by the specialist survey.
- Repair the garage flat roof and replace any defective roof timbers.
- Replace the rotten garage door frame.
