# Building Survey

9 Kings Avenue  
Sandwich Bay,  
Sandwich  
CT13 9PH

**Reference:** DH001 – Dan Hurley

**Date:** 19 August 2026

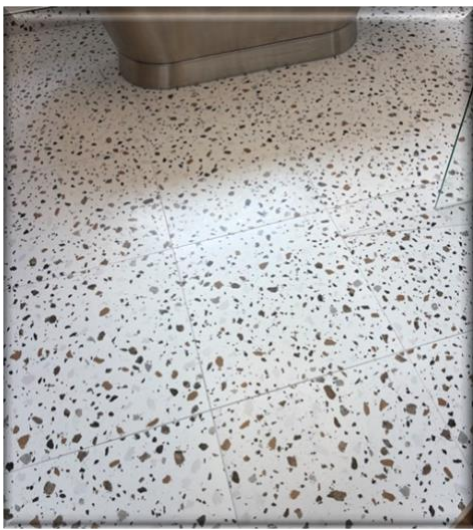
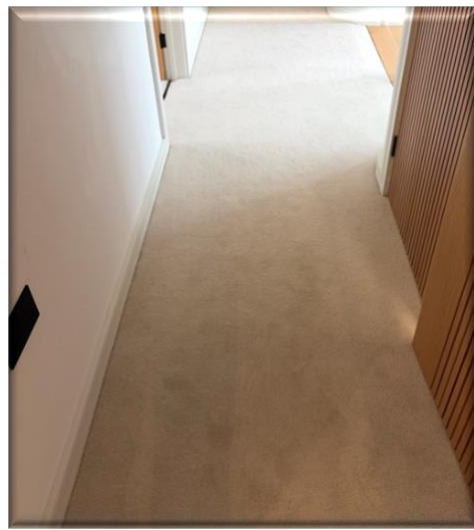
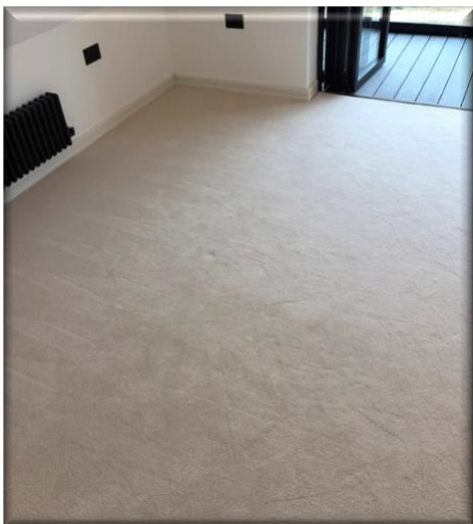
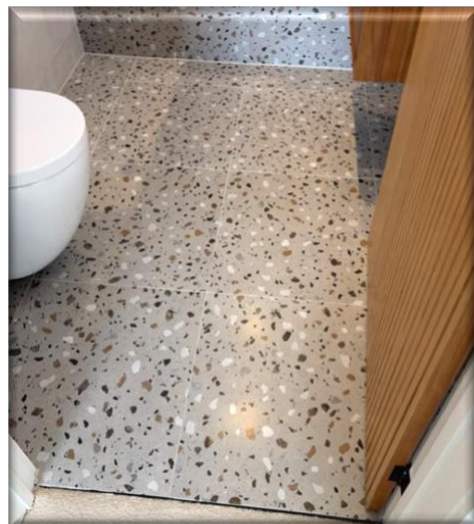
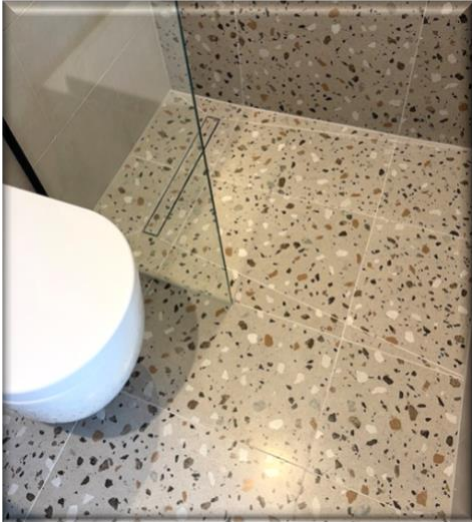
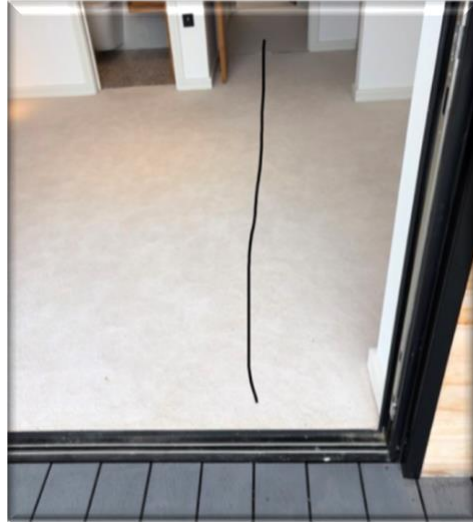
**Condition rating 2:** The floor structures appeared stable under normal use, with no significant cracking or excessive movement. However, the localised raised area in the bedroom above the garage should be monitored or investigated when the covering is next lifted, and the poorly prepared floor beneath the luxury vinyl in the study, media room and adjoining corridor requires lifting, re-levelling and renewal of the affected finish.

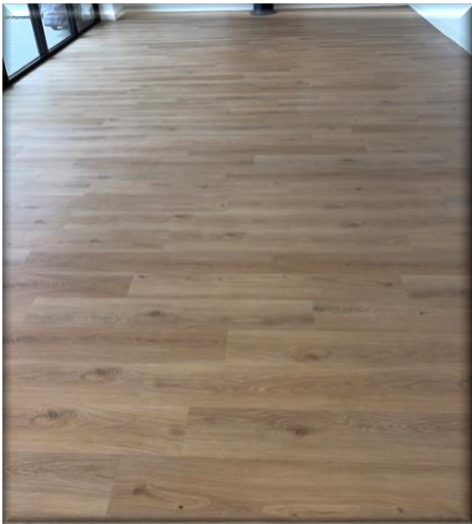
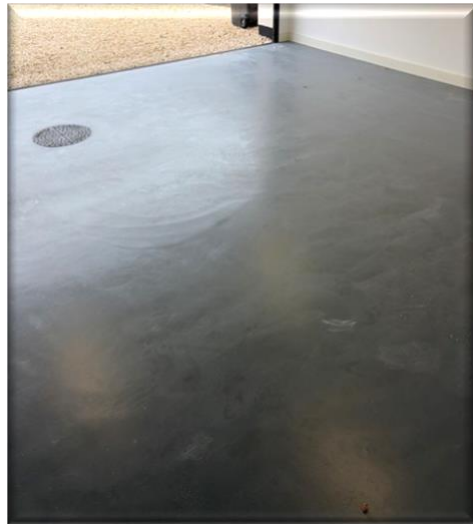
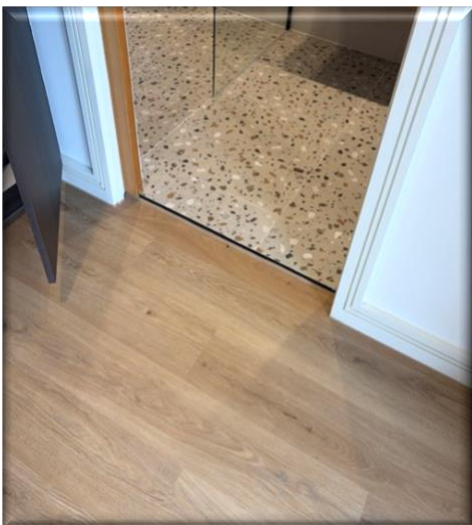
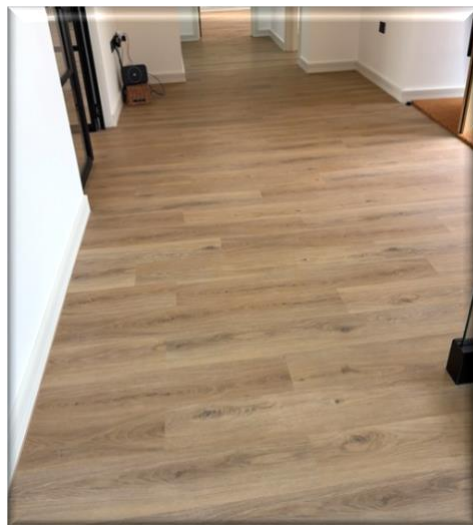
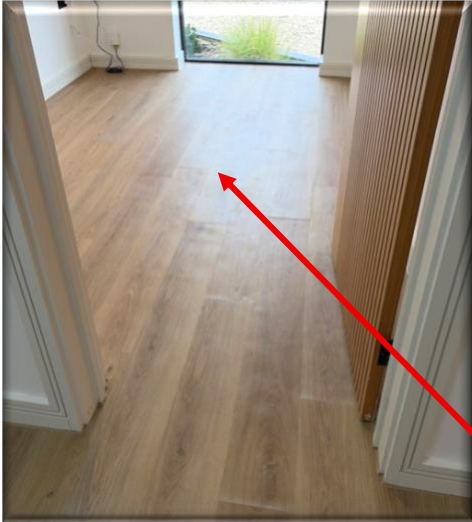
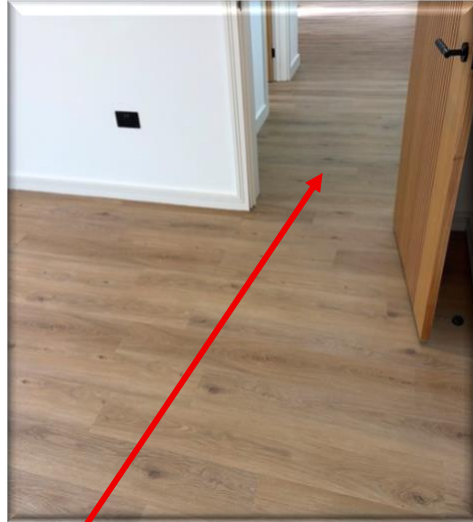
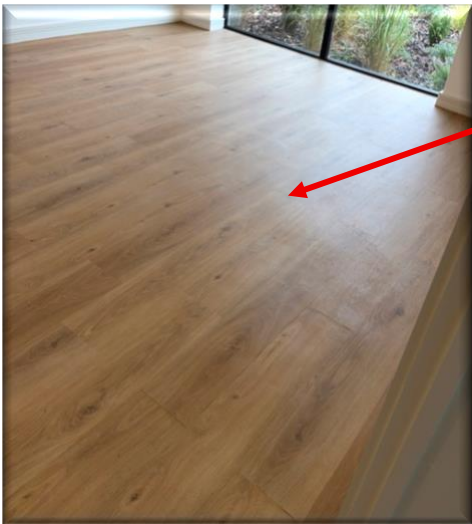
Poorly prepped screed has resulted in uneven floor coverings

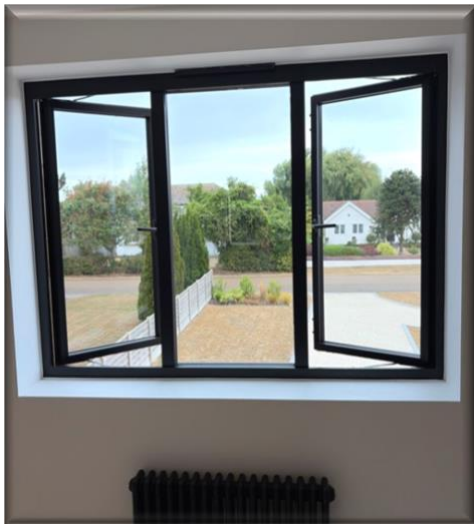
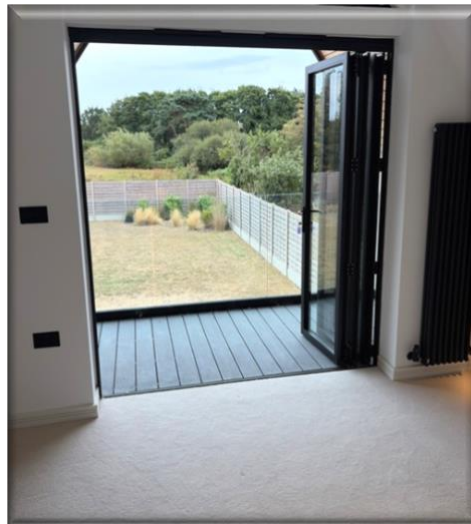
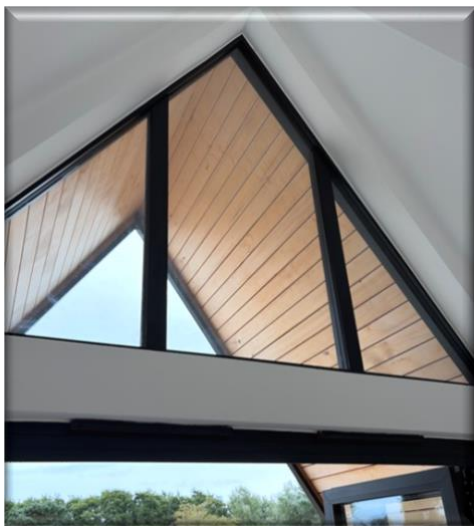
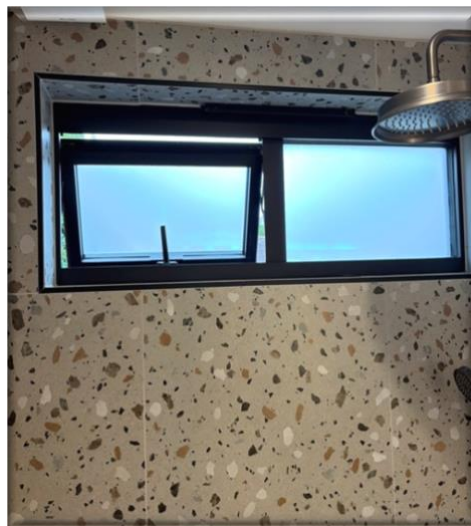
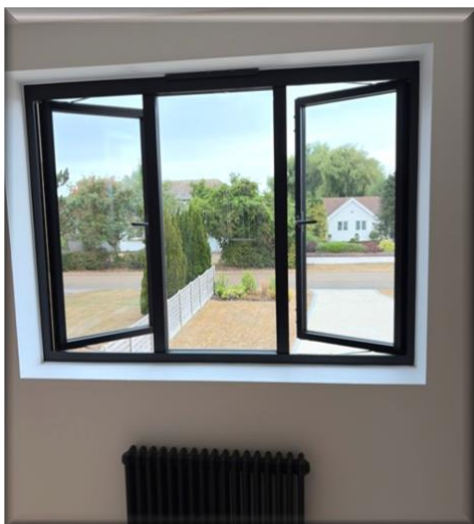
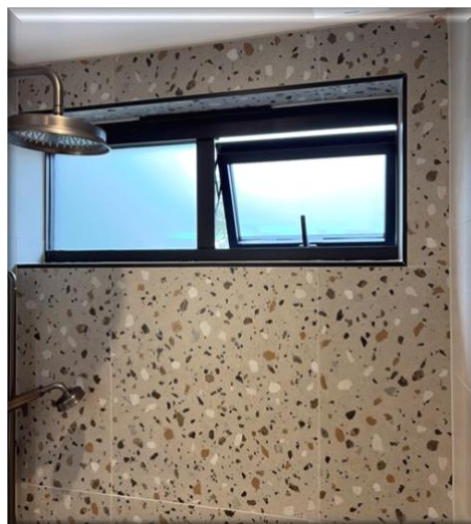
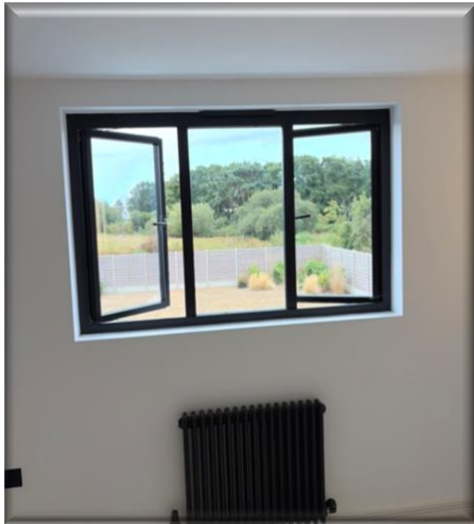
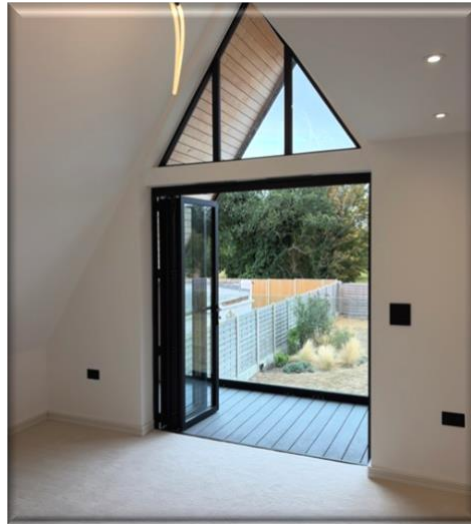
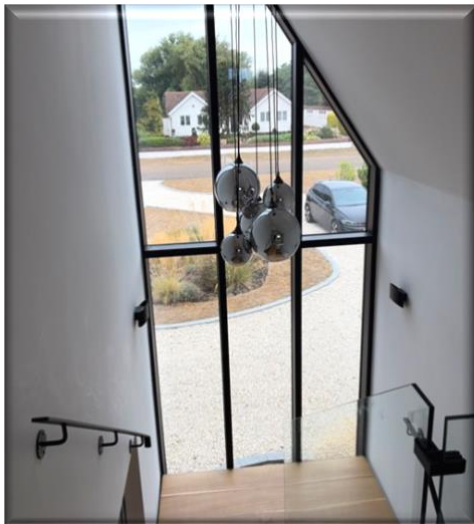
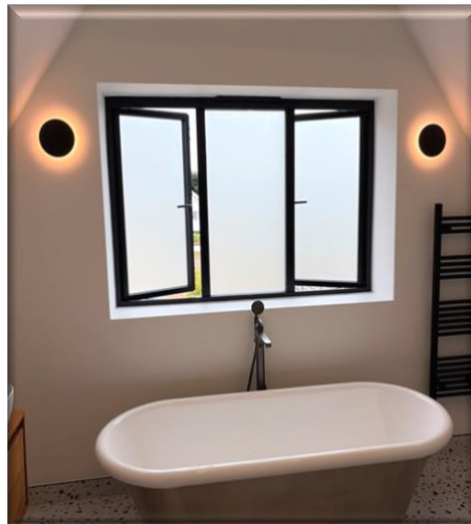
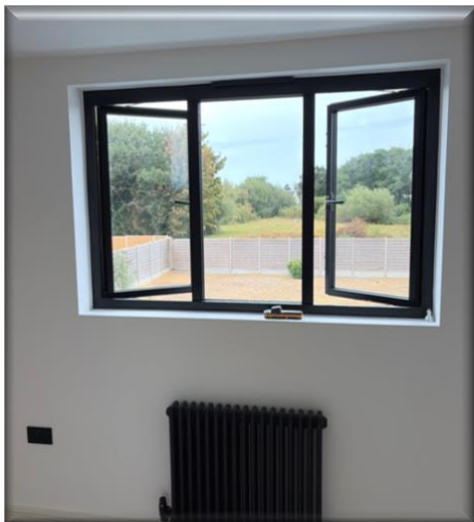
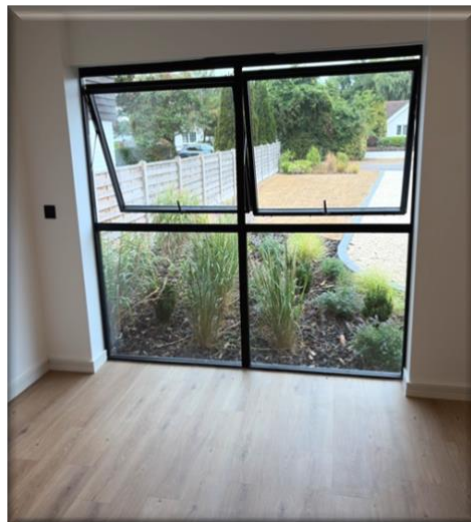
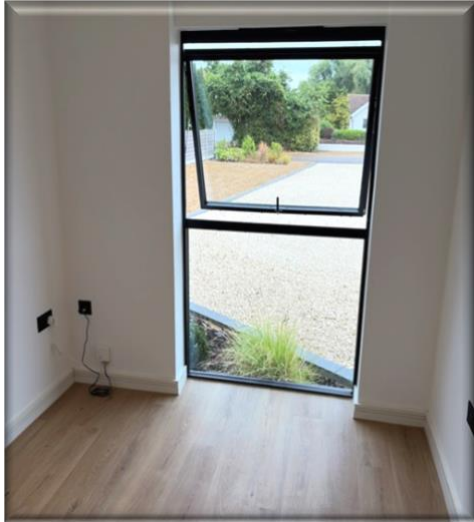
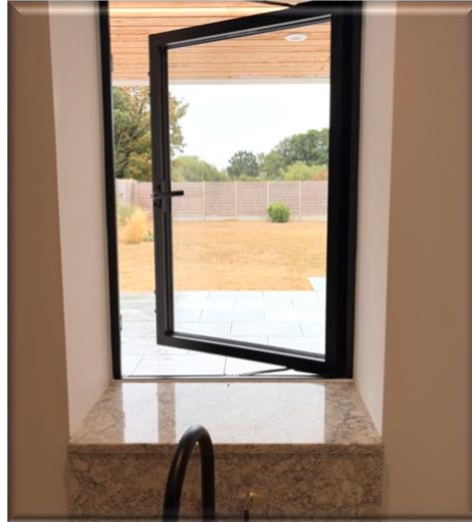
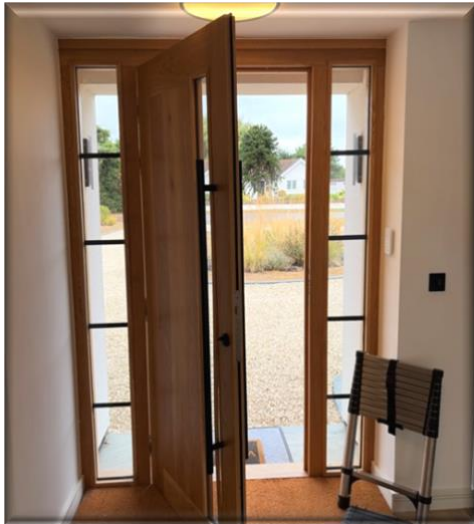
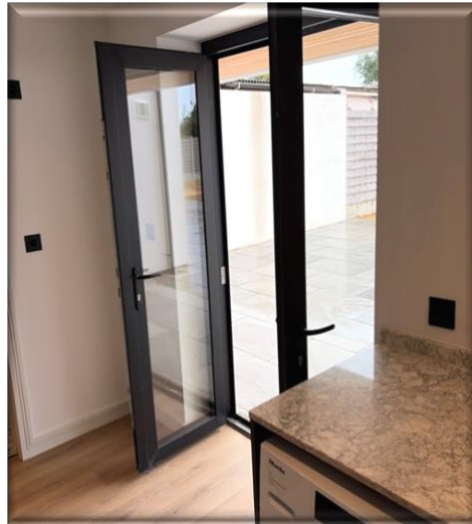
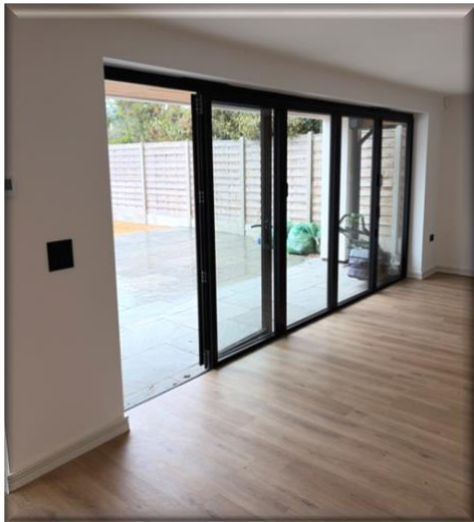
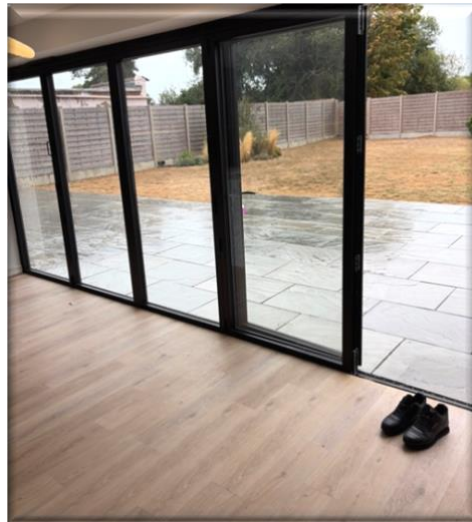
The units were generally in good visual condition and, where operated, opened and closed satisfactorily, except for the kitchen bi-folding doors. These came off their running mechanism during operation. This may result from poor initial adjustment, inadequate engagement of the rollers or guides, movement of the frame, or incorrect installation. The doors should not be forced or used unnecessarily until corrected, as a heavy glazed leaf could become unstable or damage the track, hinges or surrounding finishes. The vendor has been informed and intends to recall the installer. The complete door set should be inspected, realigned and adjusted by the original installer, including the head and threshold tracks, rollers, guides, hinges, frame fixings, locks, seals and drainage channels. Written confirmation of the repair should be obtained, and the doors should be operated through their full travel before legal completion.

Large bi-folding installations rely on the supporting opening remaining level and square. Repeated misalignment, binding or the doors leaving their track could indicate movement or inadequate support rather than a simple adjustment issue. If the fault recurs after adjustment, the frame levels and the adequacy of the structural support above and below the opening should be checked.

Conventional internal window boards have not been fitted. Instead, the plastered reveals continue across the base of the openings to form shelves or ledges finished with matt emulsion. This is mainly a durability and maintenance issue rather than a structural defect. Horizontal painted plaster surfaces readily collect dust, mark under normal use and can be difficult to wipe clean without polishing or damaging the paint. They are also more vulnerable to impact and moisture staining from condensation or plant pots. Consider fitting suitable window boards, such as sealed timber, composite or stone, or refinishing the ledges with a durable, washable coating. Any new boards should be detailed so that they do not obstruct frame drainage, trickle ventilation or opening lights.

**Condition rating 2:** The windows and external doors are new and were generally serviceable, with no widespread defects seen. However, the kitchen bi-folding doors came off their running mechanism and require prompt professional adjustment and rechecking. Certification and warranties should also be obtained, and the coastal location will require more frequent cleaning and maintenance of the frames, seals, tracks and hardware.

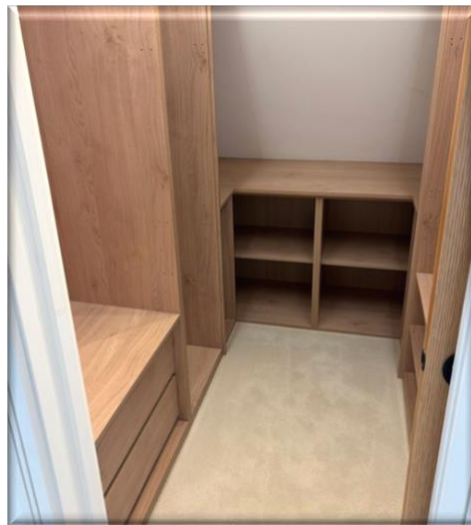
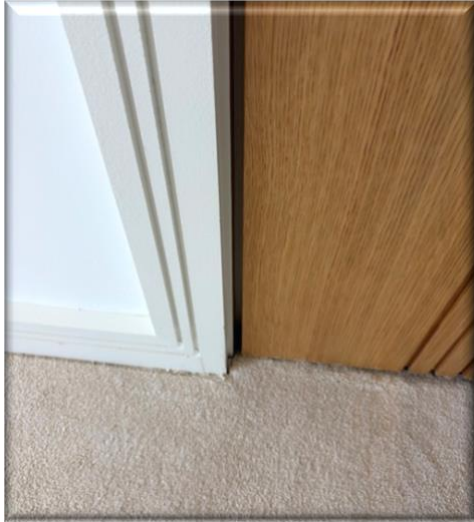
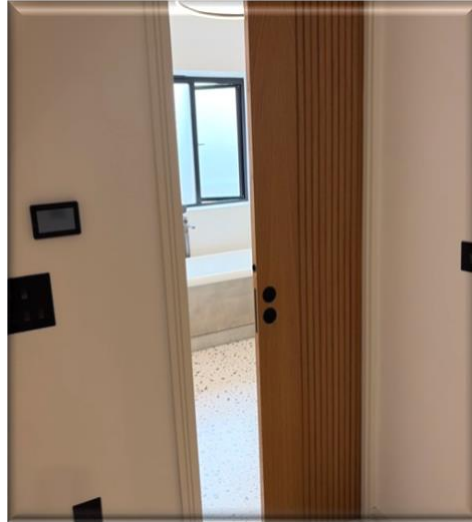
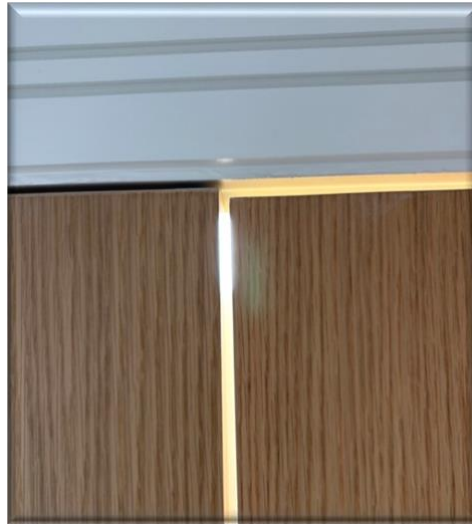
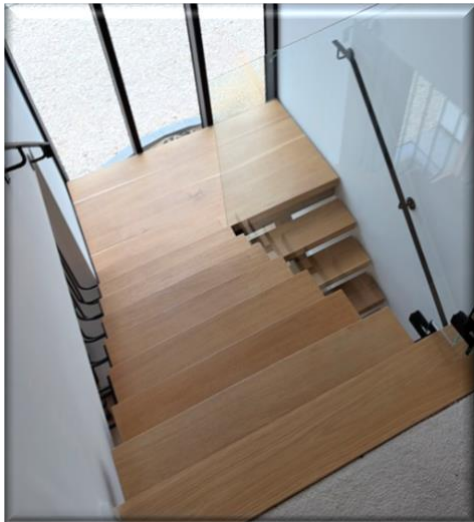
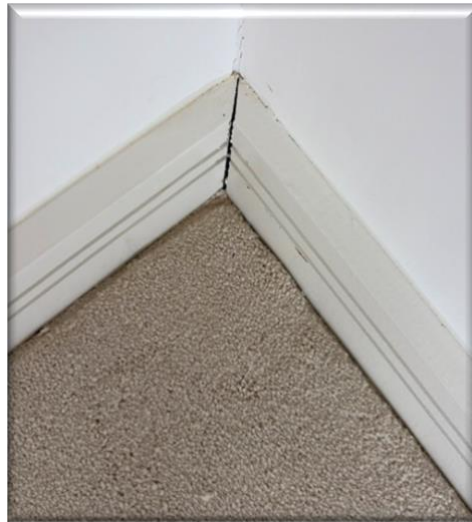
The internal doors are modern, vertically grooved timber doors set within painted frames and fitted with contemporary ironmongery. Although generally in good condition, most did not latch correctly because the latch bolts and keeps were misaligned. This is consistent with minor drying shrinkage or initial settlement of the recently completed joinery and partitions, although individual doors and frames should be checked for level before adjustment.

**Condition rating 2:** The staircase, built-in storage and kitchen fittings were generally modern, stable and serviceable. However, most internal doors require adjustment so that they close and latch correctly, and minor drying-shrinkage gaps at skirting-board mitres require routine making good.

A competent joiner should adjust the hinges, latch keeps and door stops so that each door closes evenly, engages securely and does not bind against the frame or floor covering. Gaps around the door leaves should remain reasonably uniform. Keeps should not simply be enlarged excessively, as this can leave the doors loose within their frames and weaken the fixing. Loose handles, hinges and other fittings should be tightened and adjusted at the same time.

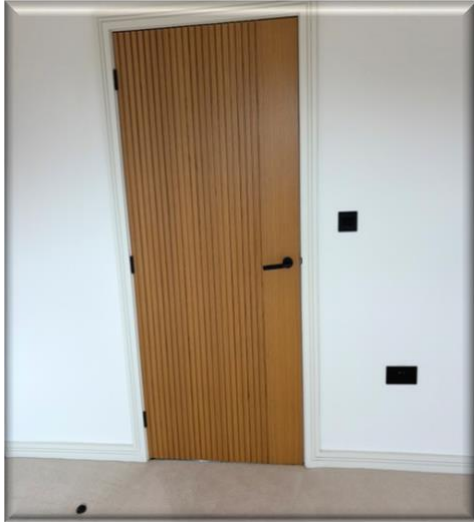
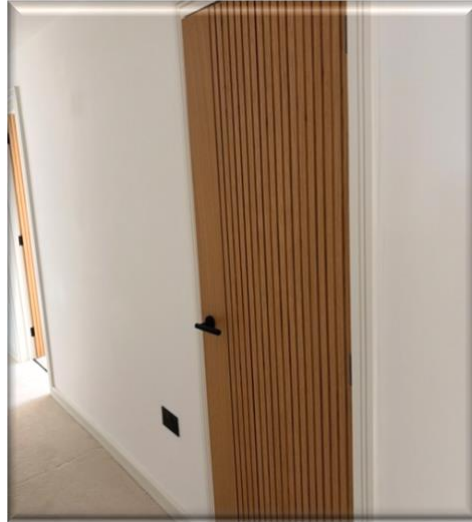
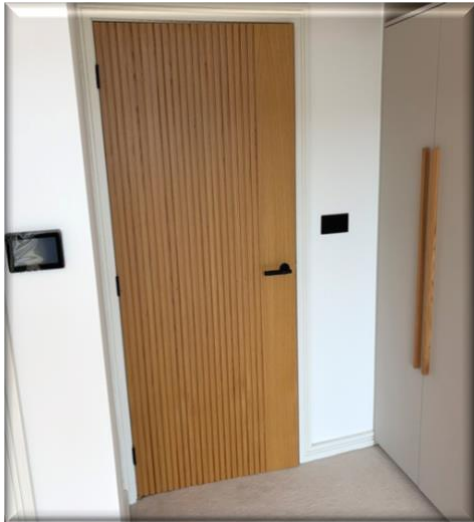
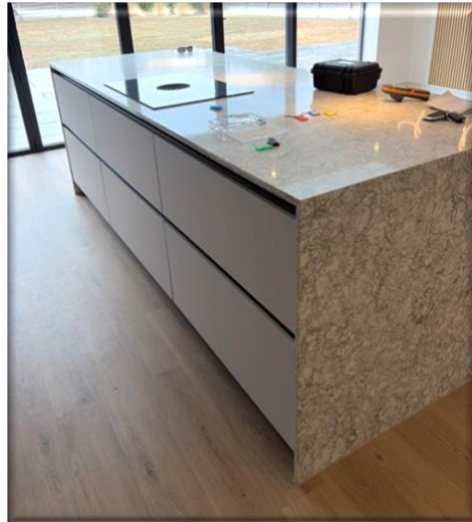
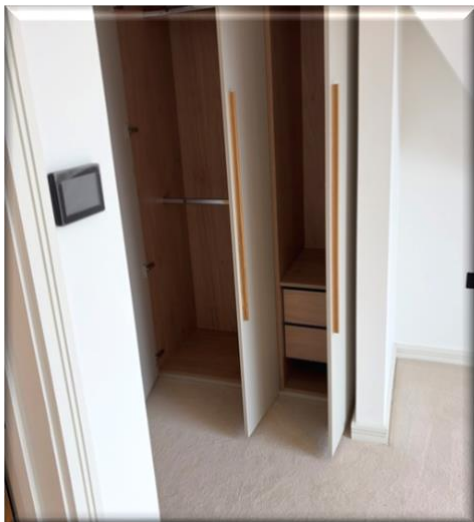
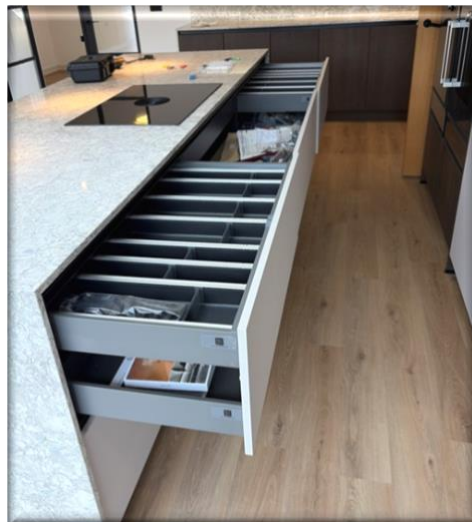
Fine joints have opened at several mitred skirting-board corners. These are typical drying-shrinkage defects in newly installed timber or manufactured joinery and are cosmetic rather than structural. The affected joints should be cleaned out, securely refixed where loose, filled with an appropriate flexible or paintable filler, prepared and redecorated. Wider or repeatedly opening joints may require the mitres to be recut or small sections of skirting to be replaced. Repairs are best undertaken after the indoor temperature and moisture conditions have stabilised.

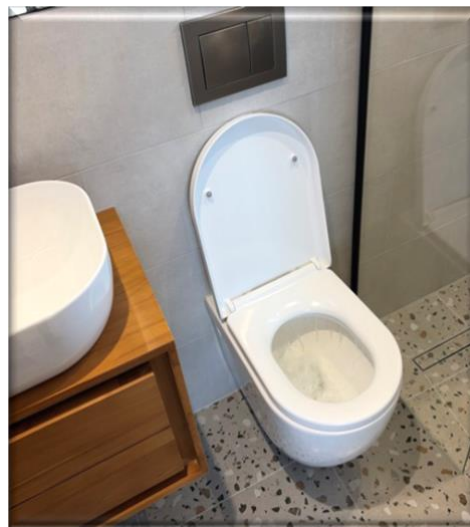
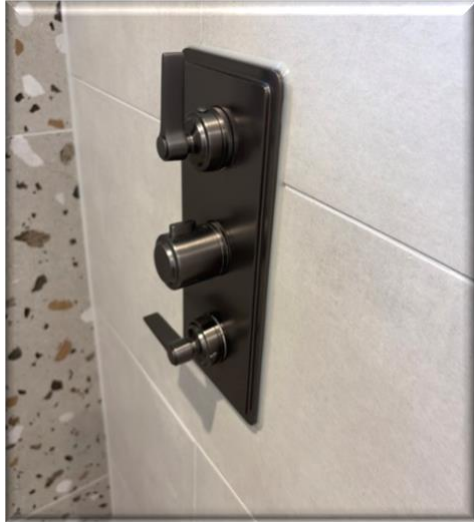
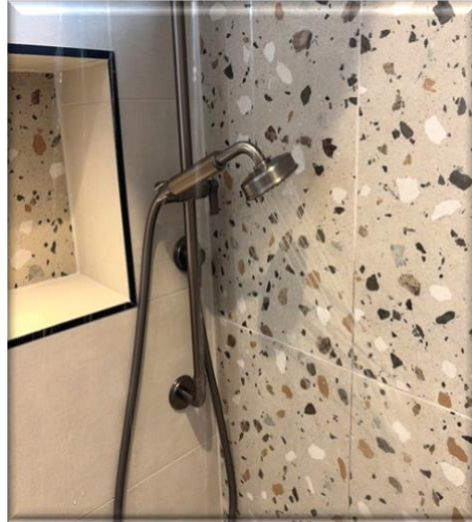
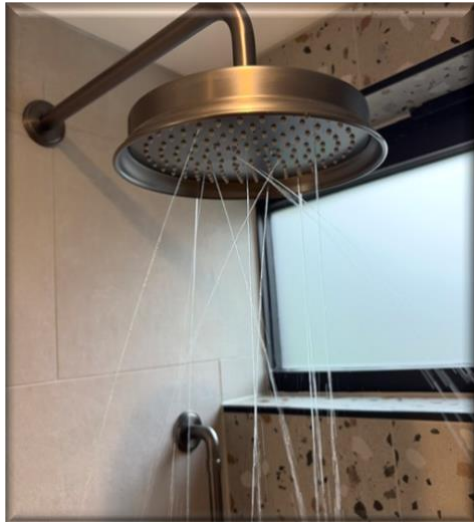
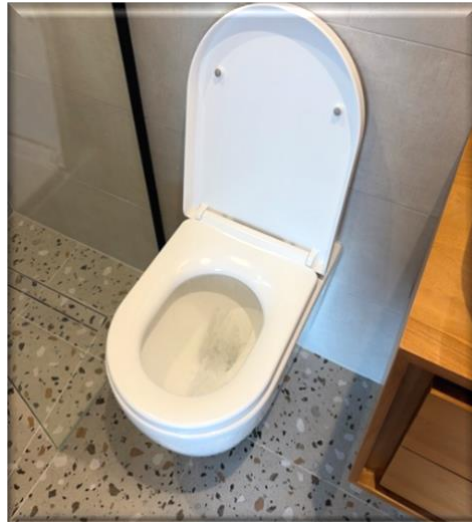
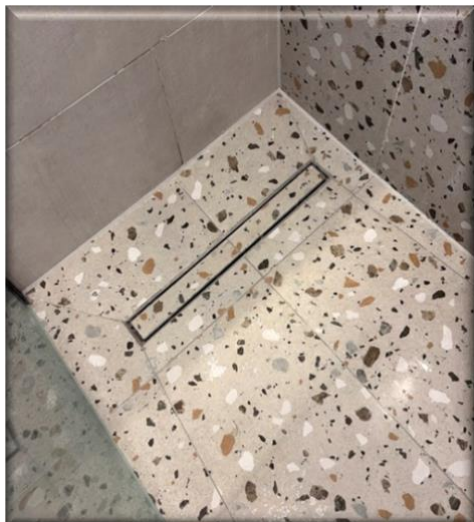
The fittings throughout were generally secure and serviceable, with no significant chips, cracks, leakage or drainage defects noted. Hot water was obtained from all hot outlets tested. Water flow appeared satisfactory, and the shower head cleaned during the inspection produced good pressure.

**Condition rating 1:** The ground- and first-floor sanitary fittings were modern, in good condition and operating satisfactorily, with hot water available at the tested outlets and no significant defects noted. The limescale deposits to the shower heads require routine cleaning and ongoing maintenance only.

damage seals and thermostatic components. The heads and removable nozzles should be descaled using products suitable for their finish, with the manufacturer's cleaning instructions followed. Routine descaling will be required, particularly if the local water supply is hard. Abrasive or acidic products should not be used on plated, black or specialist metal finishes unless specifically approved.

Silicone seals around baths, showers, basins and other wet junctions should be kept continuous and replaced when they begin to separate, harden or develop mould. Shower channels, traps and waste outlets should be cleaned regularly to maintain discharge rates. Any service panels for concealed cisterns, bath wastes, valves and shower controls should remain readily accessible.

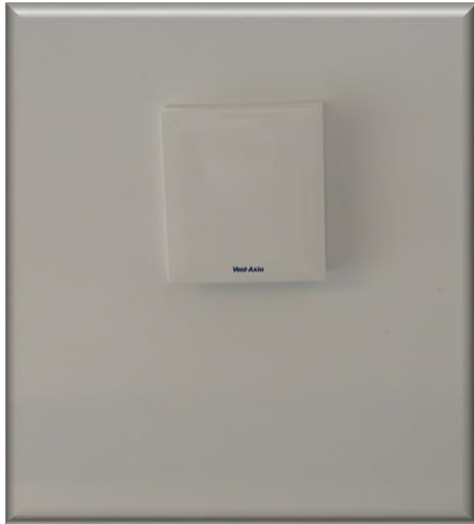
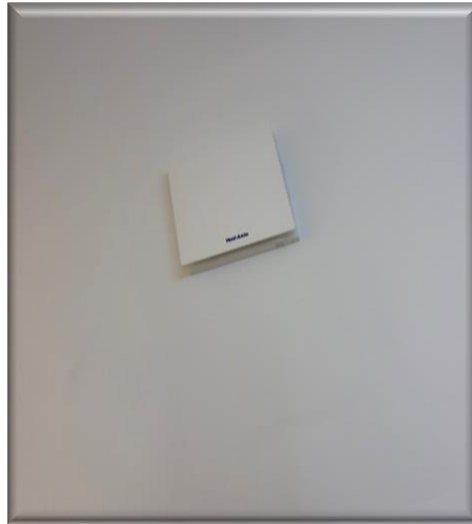
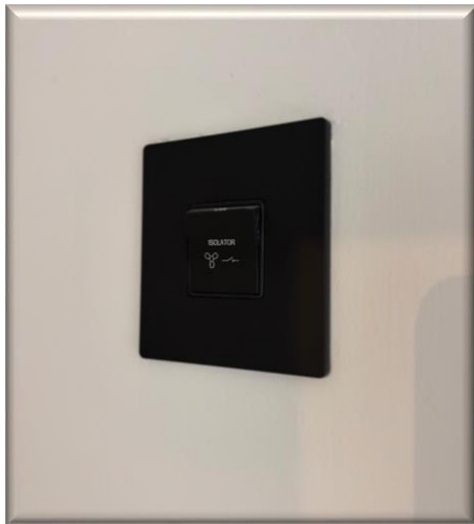
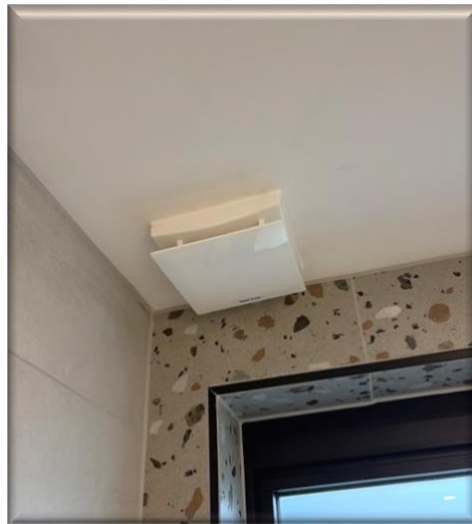
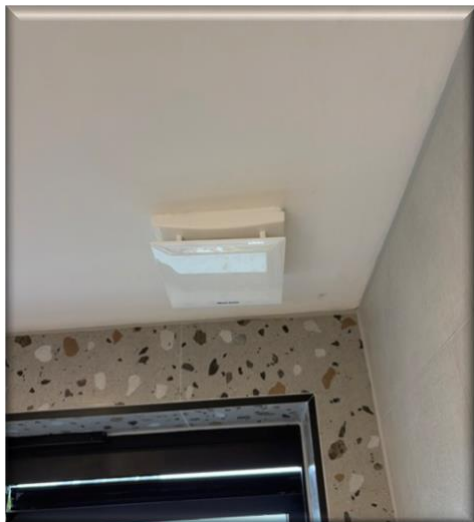
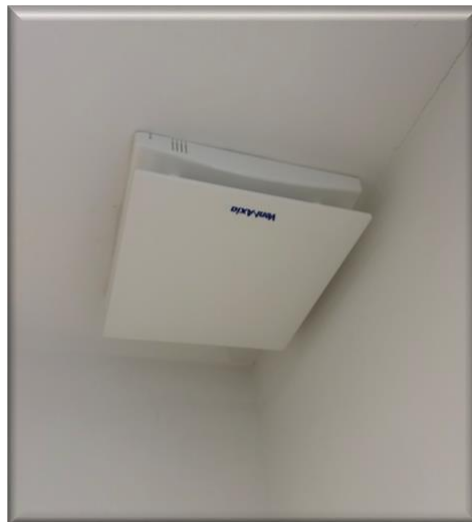
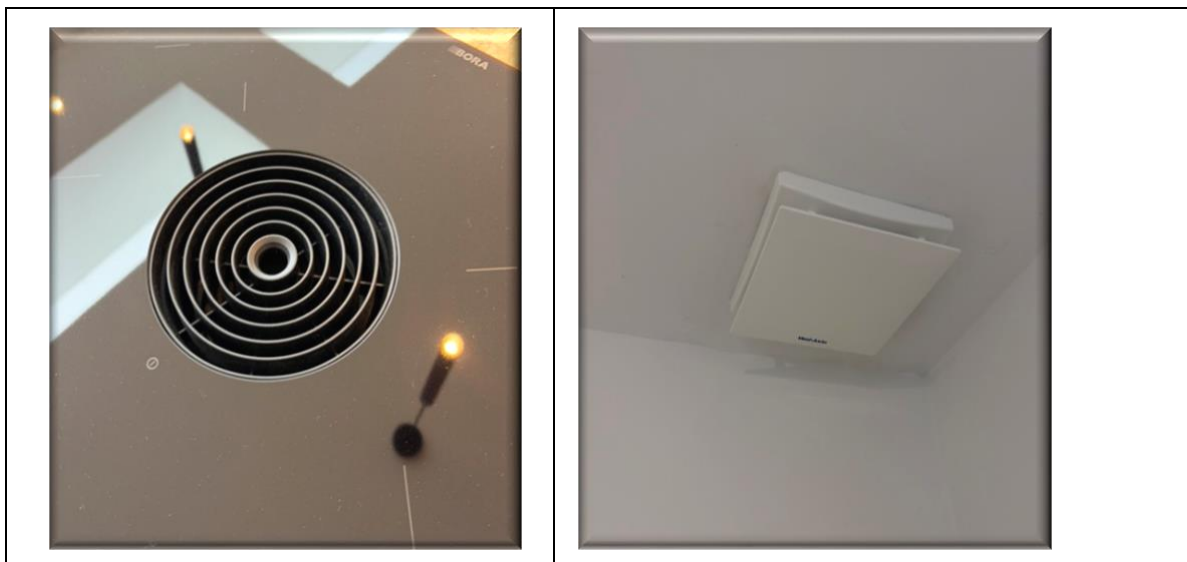
**Condition rating 1:** The sanitary-room extractors were modern, operational and externally ducted, with no significant defects noted. The hob extractor also operated but is likely to recirculate and therefore will not remove cooking moisture. All extractors must be used and maintained consistently to reduce the risk of surface and concealed condensation.

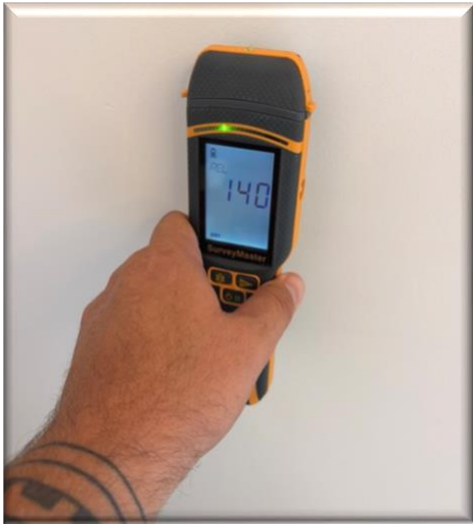
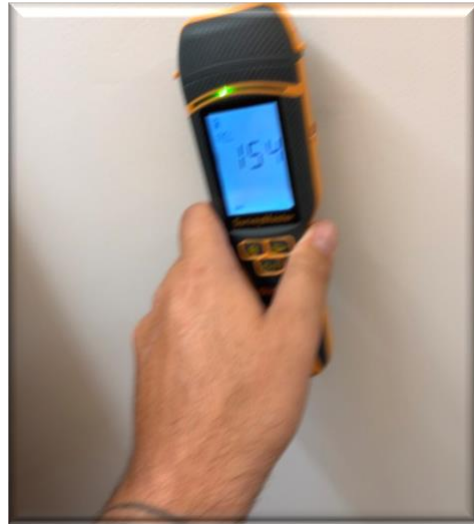
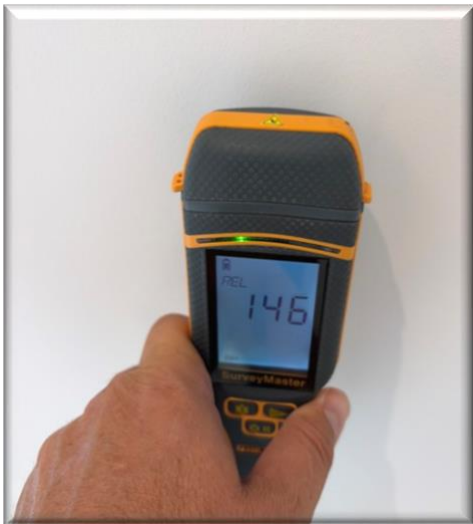
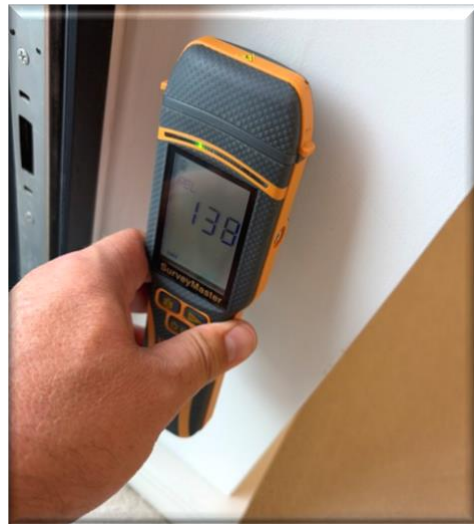
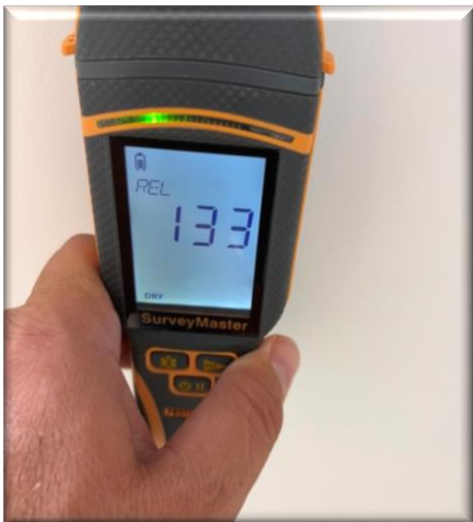
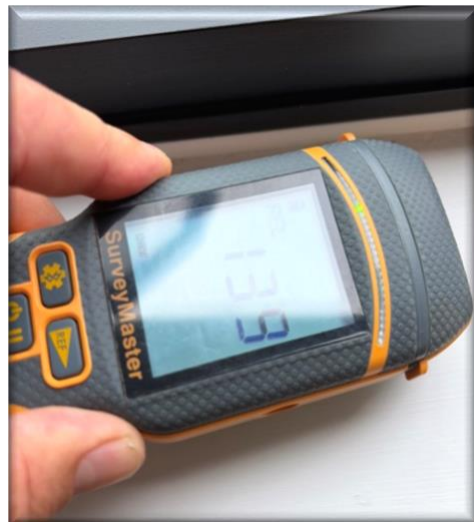
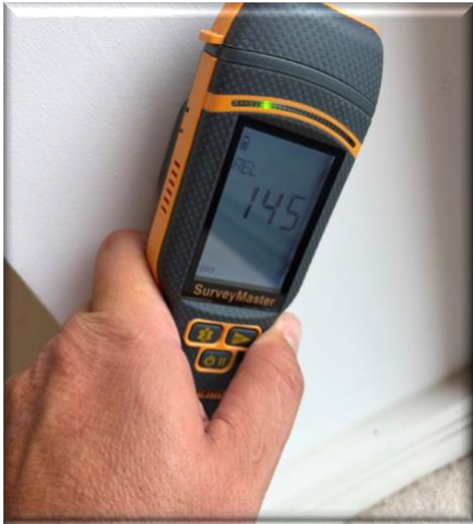
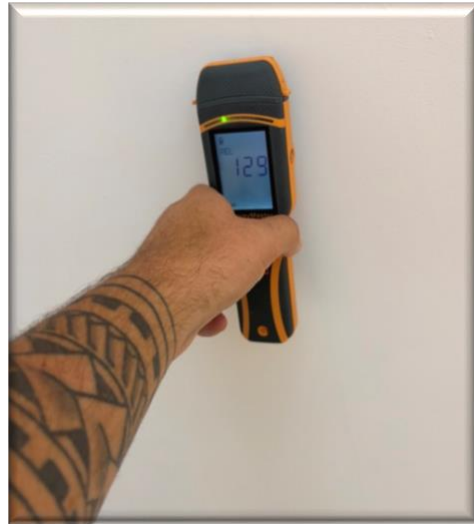
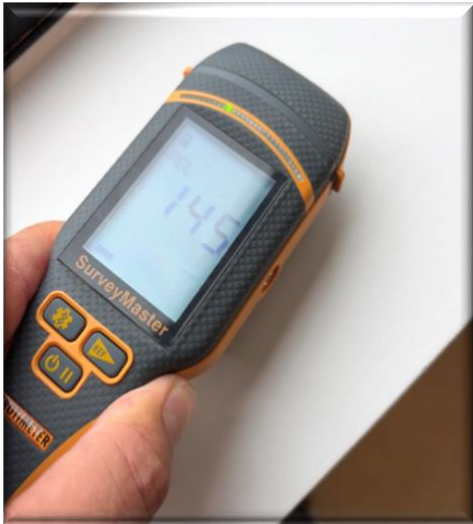
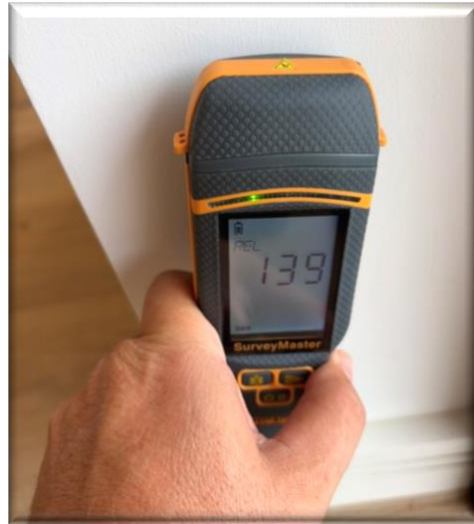
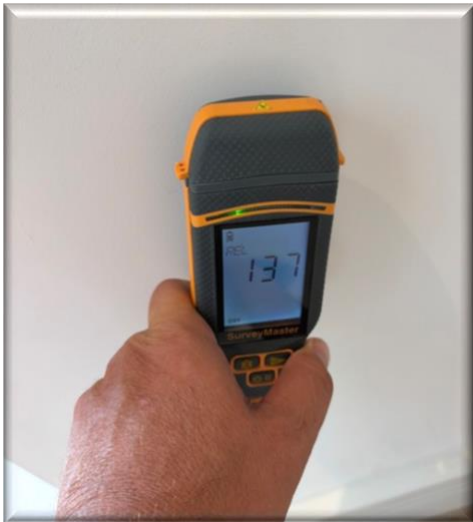
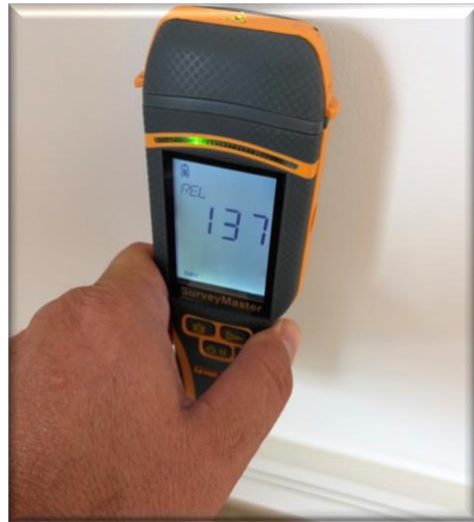
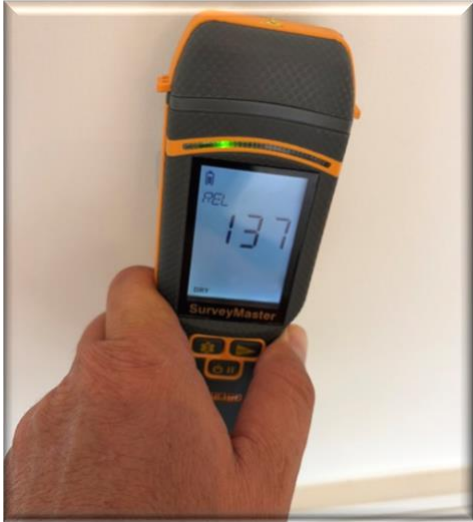
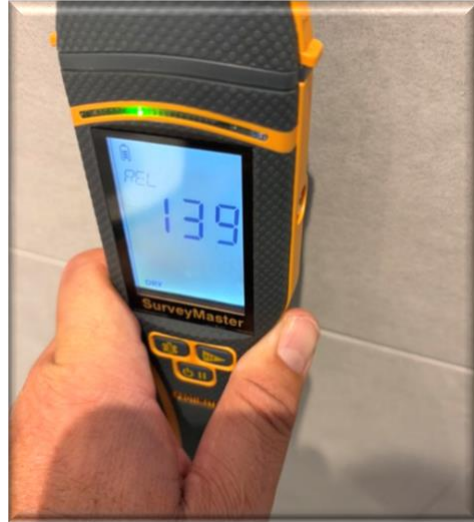
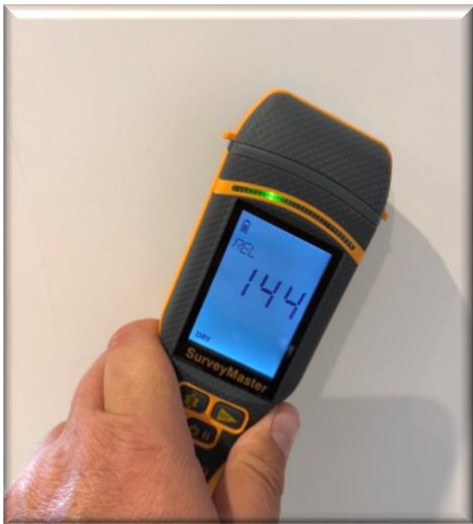
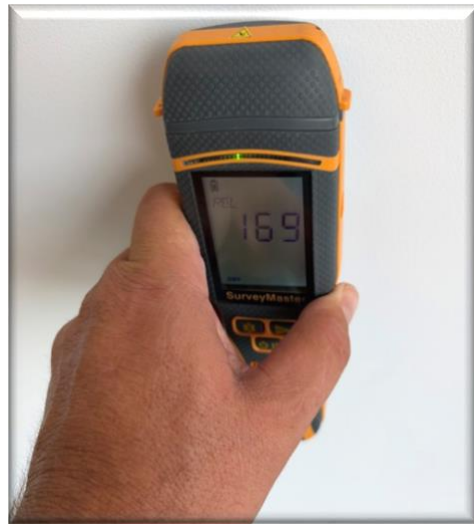
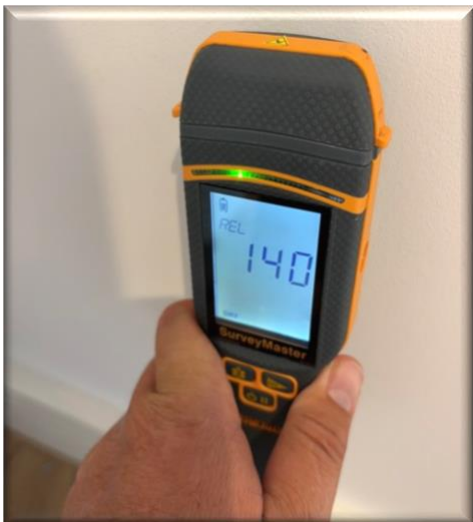
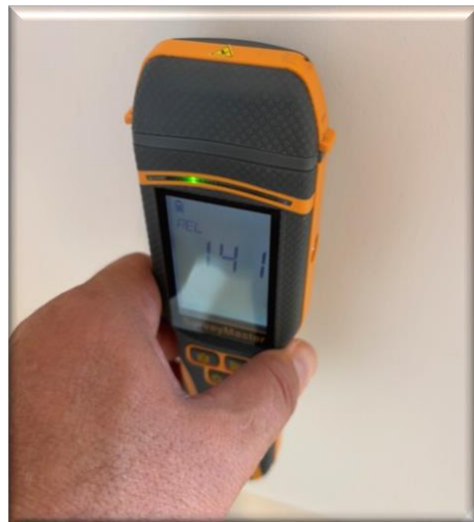
No visible evidence of significant rising dampness, penetrating dampness or surface condensation was found. The internal wall finishes were generally dry, with no associated staining, mould growth, blistering decorations, salt deposits, deteriorated skirtings or other symptoms of persistent moisture.

Representative moisture checks were taken throughout the house using a Protimeter Surveymaster in non-invasive relative mode. In this mode, the instrument displays readings on a relative scale from 0 to 999; the figures are comparative indications rather than moisture percentages. For the surfaces tested, readings below approximately 170 fall within the dry range. The recorded readings were generally between about 129 and 169, with no materially raised or concentrated readings identified. The results are therefore consistent with dry internal finishes at the time of inspection.

The original external walls have been internally dry lined with plasterboard, apparently fixed either on adhesive dabs or battens. This arrangement means the meter measures the accessible board finish rather than the concealed masonry behind it. Moisture affecting the original wall could, in principle, remain within the cavity behind the plasterboard before becoming visible internally. However, this is considered unlikely at present because no raised readings, staining, mould, deterioration or other associated warning signs were found.

**Condition rating 1:** No visible damp-related defects were identified, and all representative non-invasive moisture readings remained within the dry range of the instrument's 0–999 relative scale. Concealed dampness behind the dry lining to the original walls cannot be entirely excluded, but there was no evidence to suggest a current problem. Routine monitoring and continued use of the ventilation systems are advised.

The concealed vaulted roof construction and the inaccessible roof void above Bedrooms 2 and 3 should be checked when access is formed. This should confirm that insulation is continuous, the vapour-control layer is properly detailed and any required roof ventilation is unobstructed. These measures are important because interstitial condensation can develop within a roof build-up without initially producing visible internal staining.
