# Building Survey

9 Kings Avenue  
Sandwich Bay,  
Sandwich  
CT13 9PH

**Reference:** DH001 – Dan Hurley

**Date:** 19 August 2026

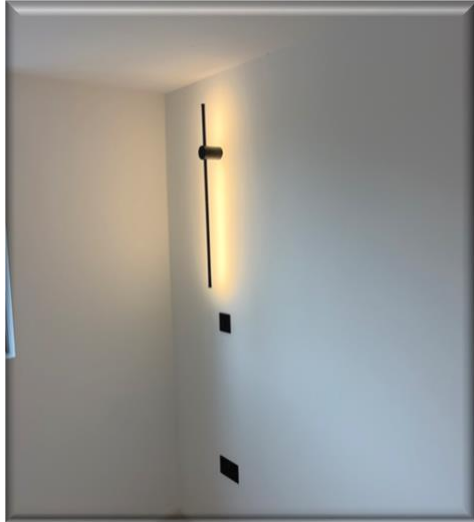
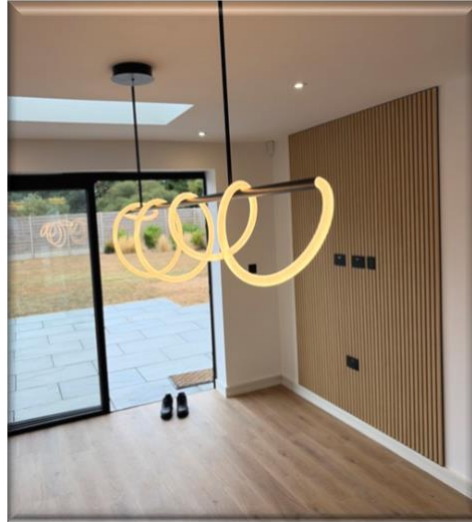
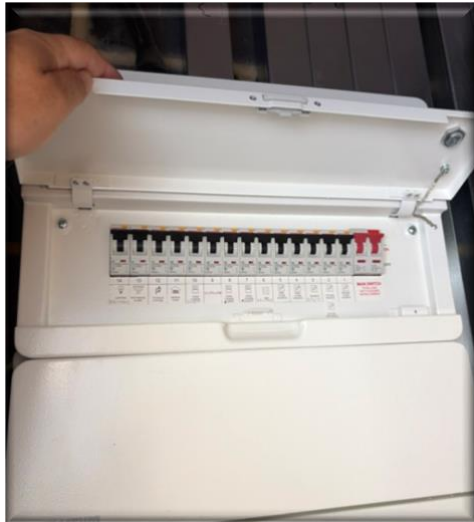
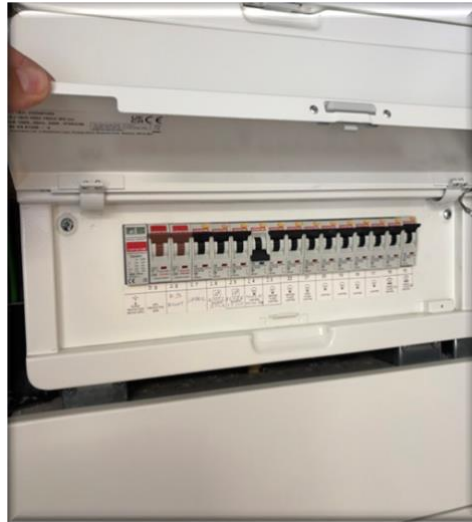
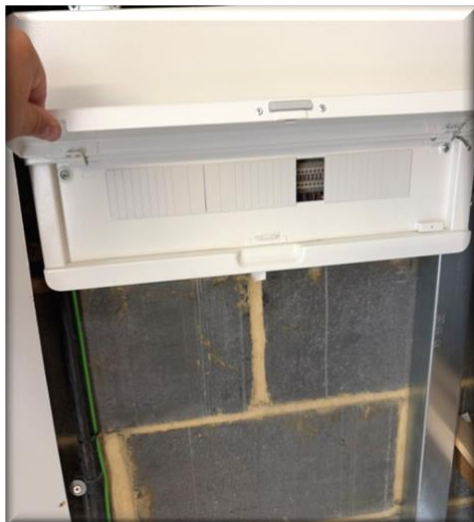
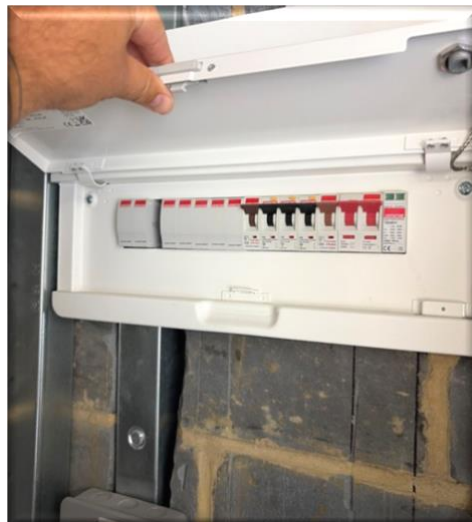
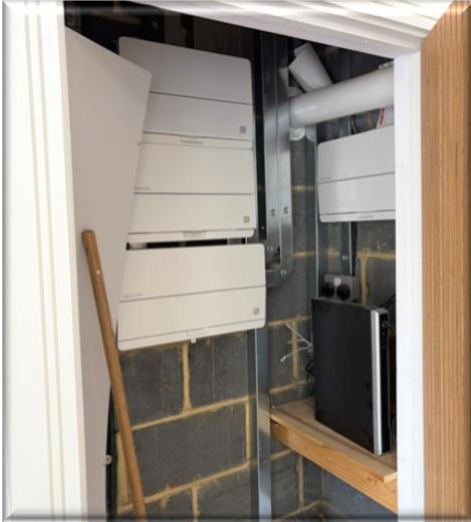
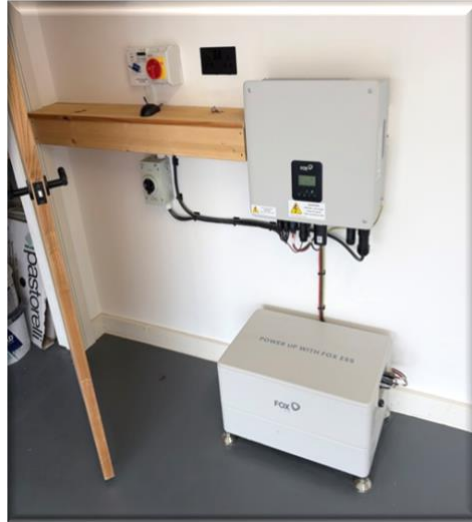
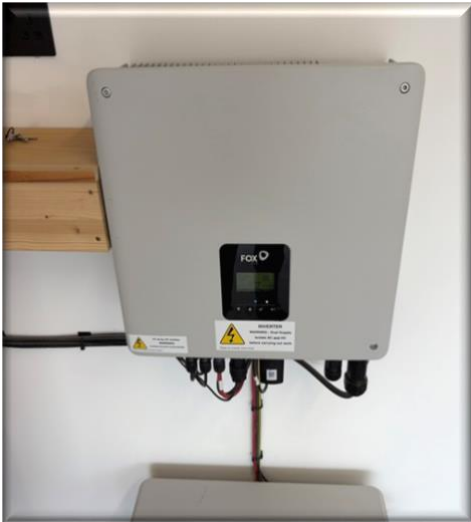
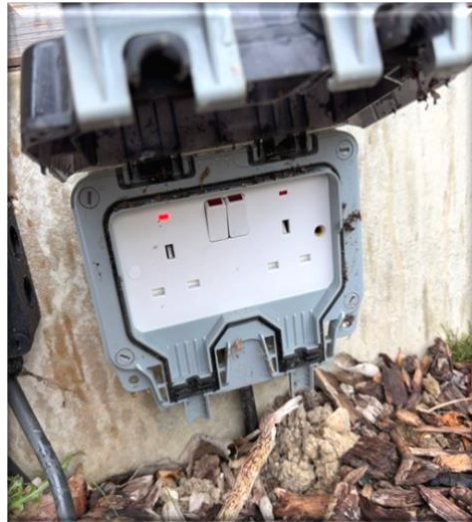
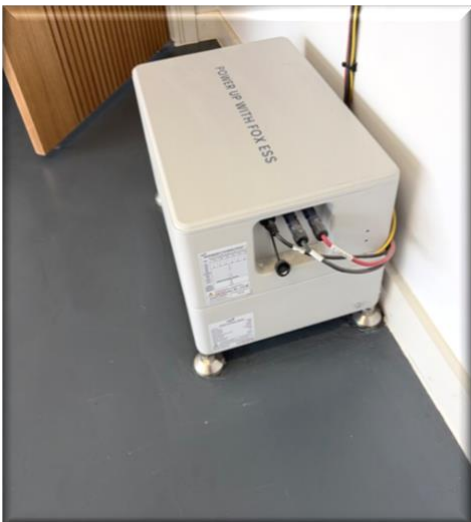
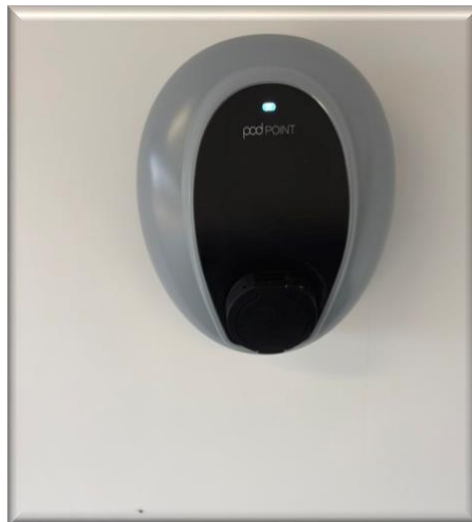
The switches, sockets and light fittings are modern and were generally secure and operational. Minor making good is required around a small number of faceplates where the surrounding plaster or decorative finish is incomplete or damaged. The affected accessories should be safely isolated before being loosened, after which the plaster can be neatly repaired and redecorated. This appears to be a finishing issue rather than a defect with the electrical system.

Numerous external sockets and lighting points are supplied using steel-wire-armoured cable. This is an appropriate robust wiring method for outdoor and underground circuits when correctly selected, supported, buried, glanded and earthed. External accessories should remain suitably weather-resistant, with intact covers and seals, and the circuits should have appropriate RCD or RCBO protection. Damaged covers, loose fittings or corrosion should be addressed promptly, particularly in the salt-laden coastal environment.

**No recent documentation was seen to confirm that an EICR has been carried out within the last 10 years. In the absence of such evidence, the installation must be treated as potentially unsafe: serious defects can exist within concealed wiring even where the system appears to operate normally. You should therefore commission a full electrical inspection and EICR by a competent electrician prior to legal commitment to purchase, unless satisfactory, recent certification is provided.**

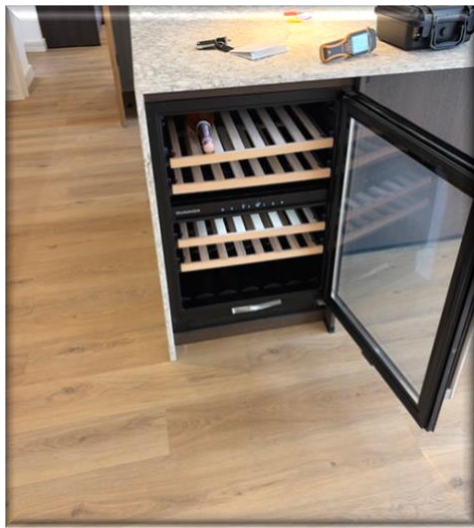
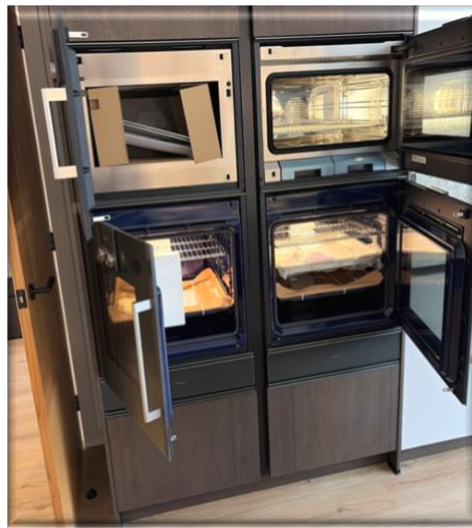
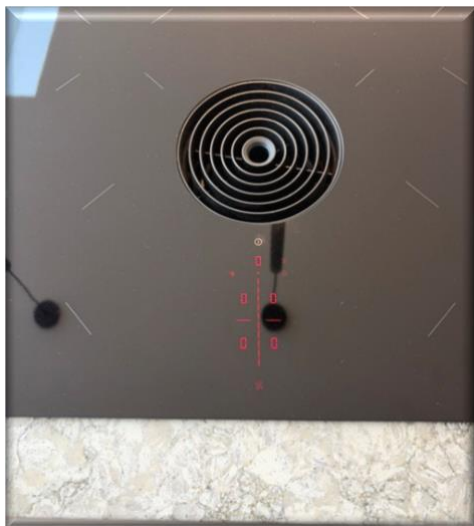
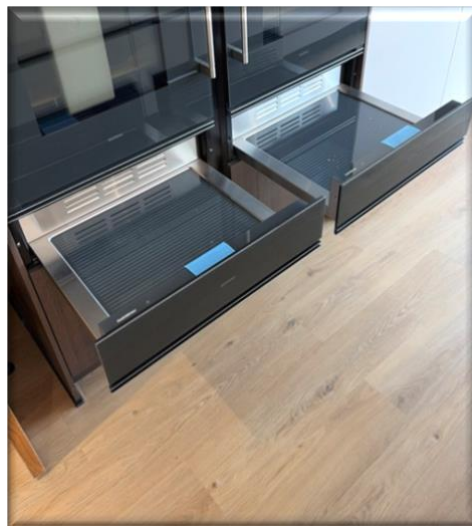
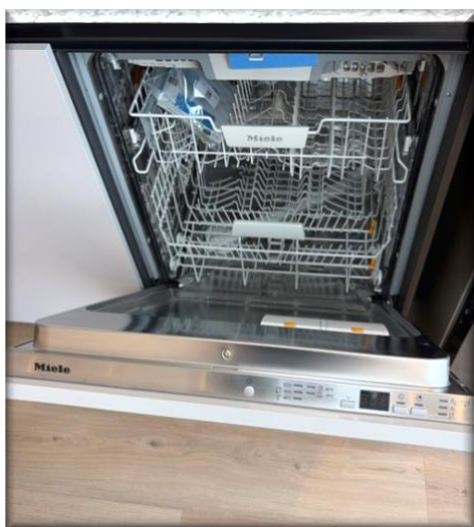
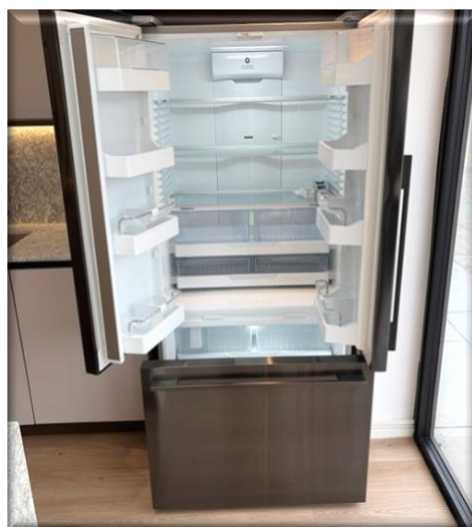
The appliances appear new and no visible damage was noted, but they were not functionally tested. Their presence should not be taken as confirmation that they are included in the sale or covered by the building contract. Your conveyancer should obtain a completed fittings-and-contents form clearly identifying every freestanding and integrated appliance that will remain.

**Condition rating 1:** The appliances appeared new and no visible defects were identified. They were not operated or tested, so their working condition, warranties and inclusion in the sale should be confirmed before legal completion.

The appliances should be demonstrated before completion, including the ovens, hob, extractor, refrigeration, dishwasher and any washing or drying equipment. Any integrated appliance removed by the vendor must be replaced or the resulting cabinetry, plumbing, electrical connection and ventilation arrangements made good as agreed through the sale contract.

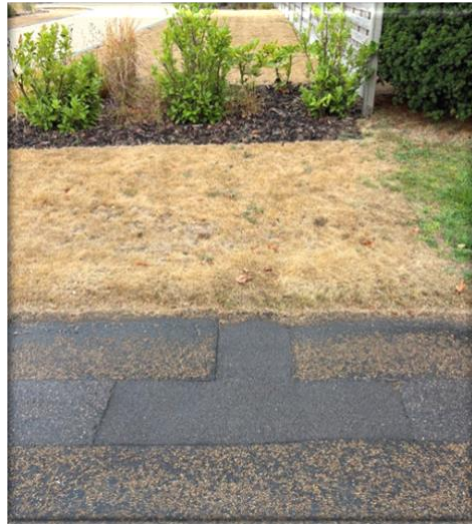
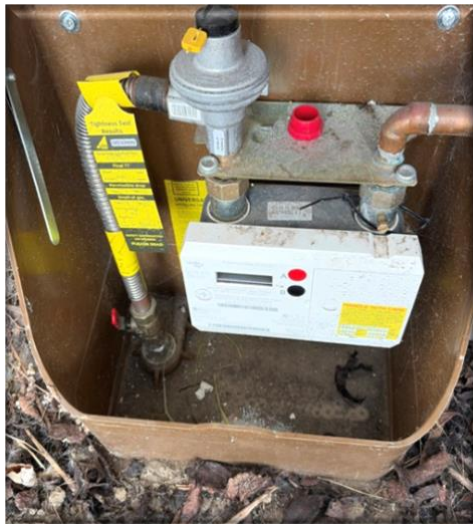
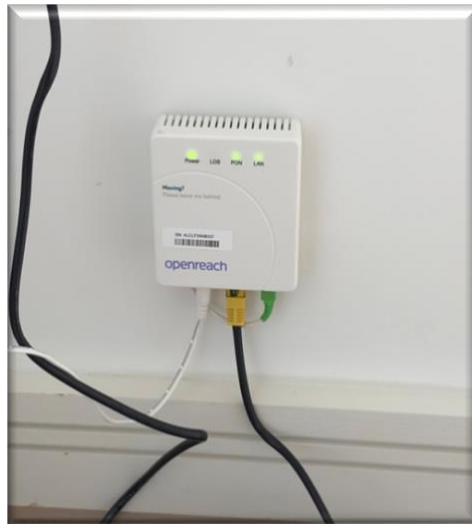
**Condition rating 2:** The electricity, gas and Openreach fibre equipment appeared modern and appropriately located, with no significant visible defects. However, the water meter and main stopcock were not identified and must be located, made accessible and tested before occupation.

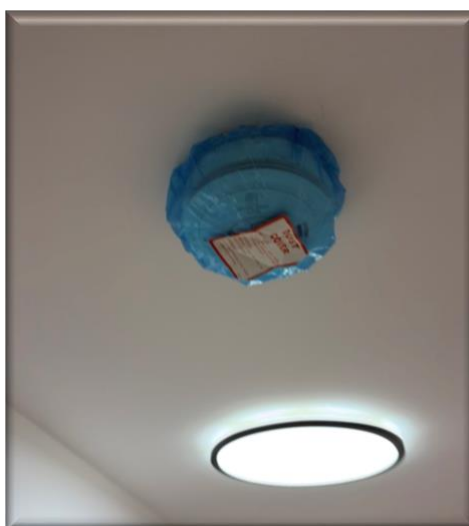
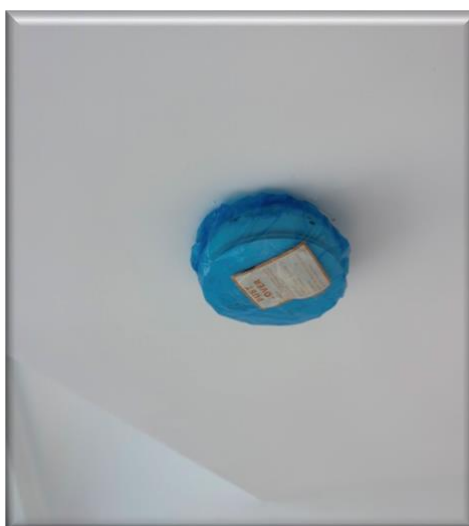
Condition rating 2: The fire-detection, burglar-alarm and CCTV systems are modern and appeared operational. However, the temporary dust covers must be removed from all detector heads and the complete interlinked alarm system retested before occupation. All codes, instructions, account access, commissioning records and warranties should be obtained from the vendor.

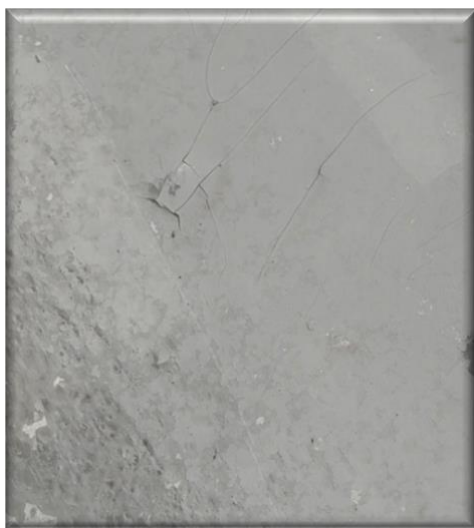
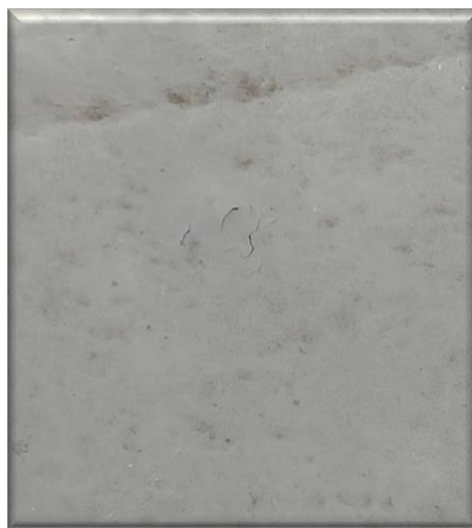
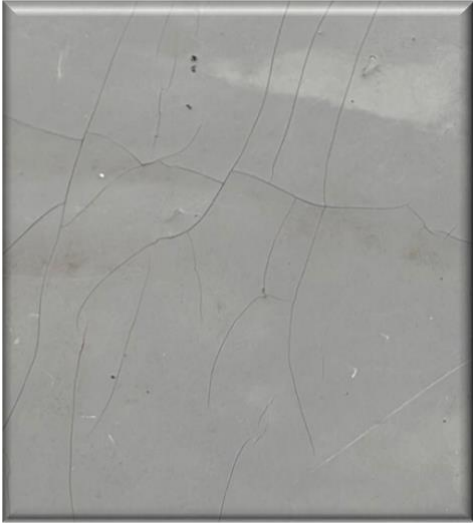
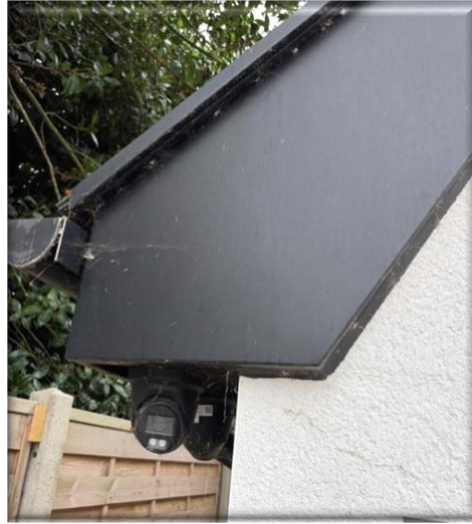
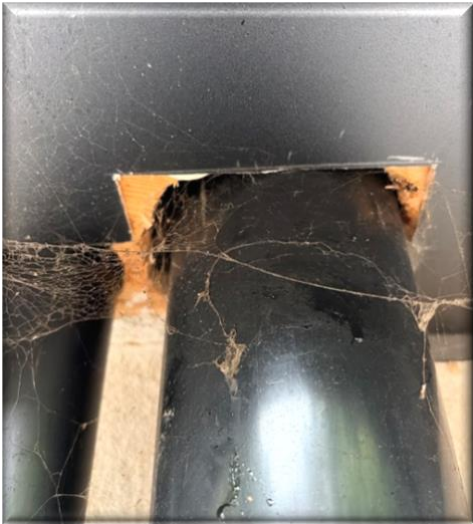
Fine splitting and crazing were noted in the GRP topcoat over the ground-floor rear extension. This may have resulted from excessive catalyst, application in unsuitable conditions, insufficient resin, poor mixing, thermal movement or movement within the supporting deck. An over-catalysed coating can cure too rapidly and become brittle. The photographs suggest that at least some of the cracking may be confined to the protective topcoat, but this must not be assumed because cracks extending through the structural laminate could allow water to reach the timber deck.

The rear extension roof should be inspected by the original installer or a GRP roofing specialist while the work remains new and any warranty remains available. The affected areas should be cleaned and lightly abraded so the depth and extent of the cracking can be established. Where only the topcoat has failed, a compatible repair and renewed protective coating may be sufficient. Where the laminate is

split, loose, poorly bonded or moving, the affected section should be cut back and properly re-laminated before a new topcoat is applied. Simply painting over the cracks is unlikely to provide a durable repair.

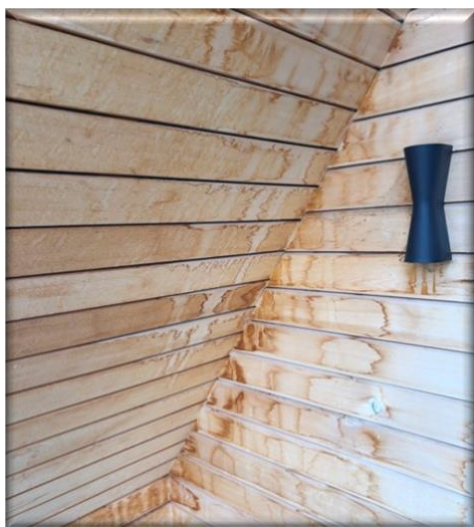
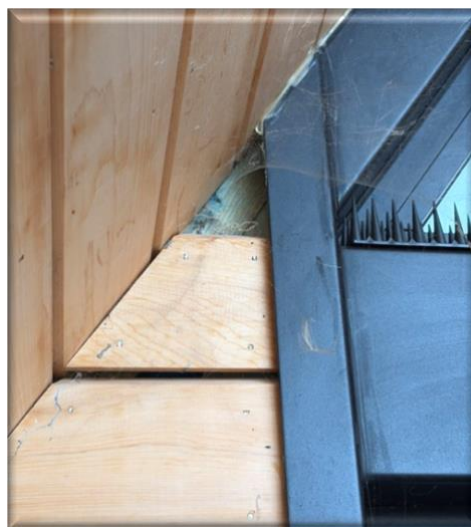
**Condition rating 2:** The external walls were generally modern, visually straight and free from evidence of significant structural instability. However, the prominent render crack to the garage side extension, cracking above the kitchen bi-fold doors, absence of movement joints, blocked cavity-tray weep vents, low render drip beads and missing section of timber cladding require investigation and remedial work. The door opening should be checked by the installer and, if satisfactory adjustment cannot be achieved or cracking recurs, by a structural engineer.

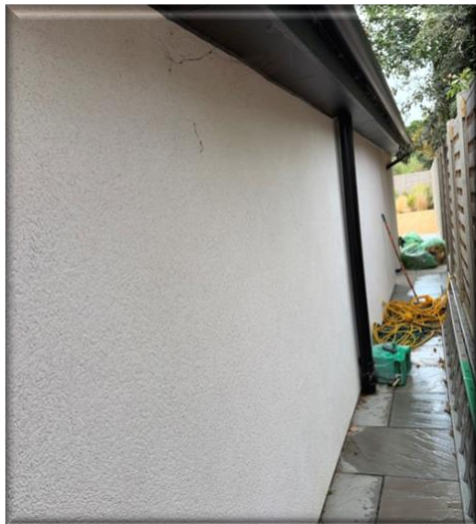
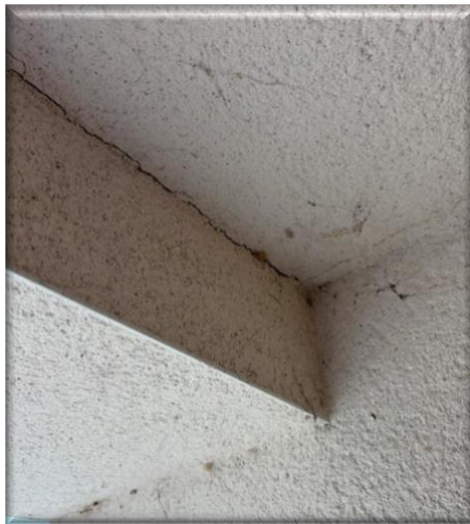
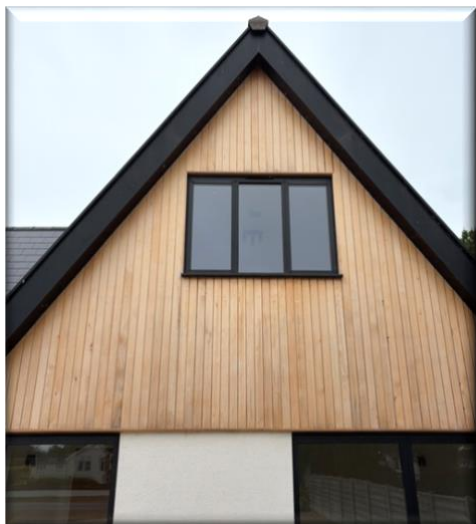
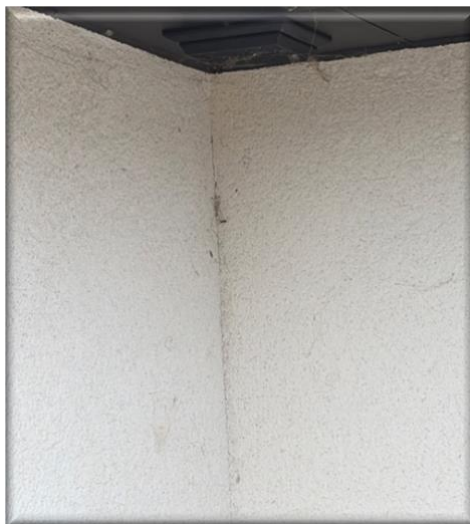
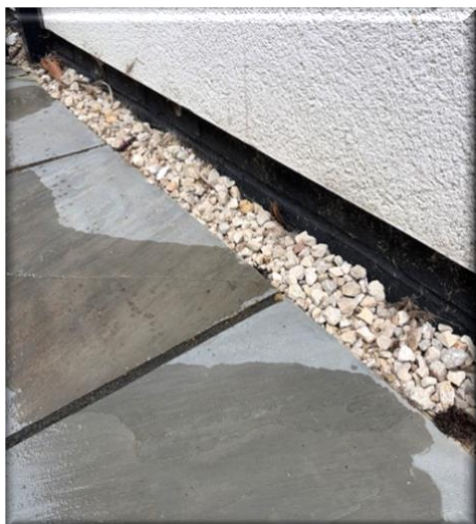
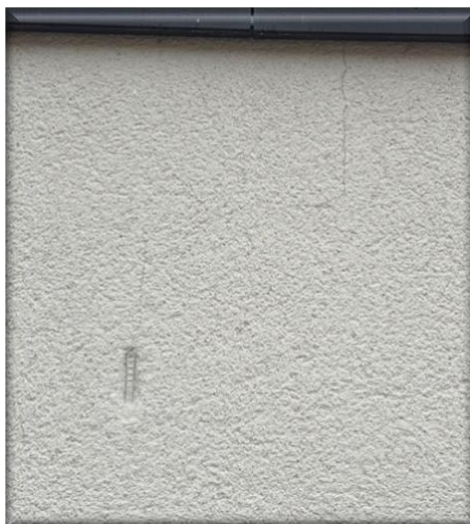
Blocked weep vents and cracked render –  
no expansion joints installed

The vendor should provide the render-system specification, installer's warranty, colour and batch details for future repairs, movement-joint design, cavity-tray information and confirmation that beads and fixings are suitable for coastal exposure.

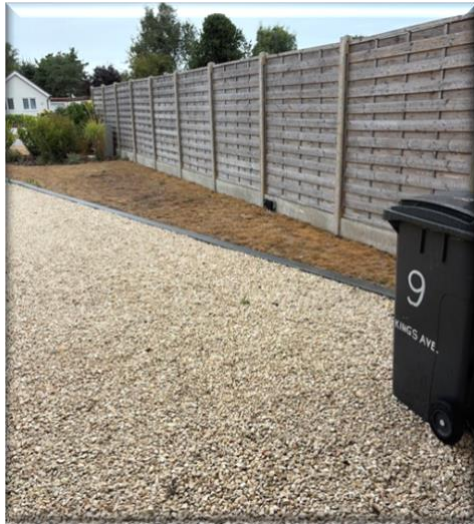
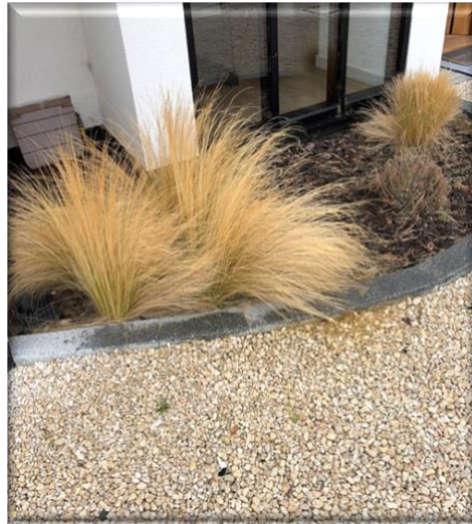
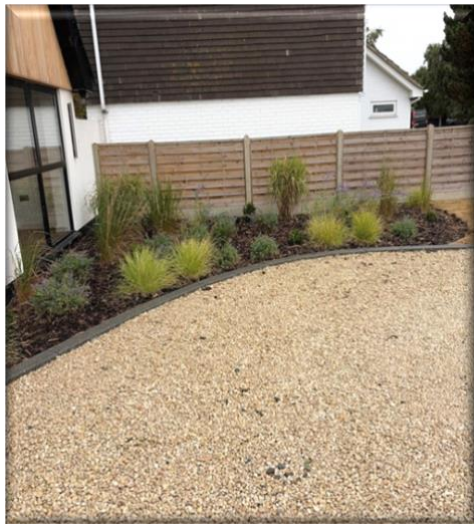
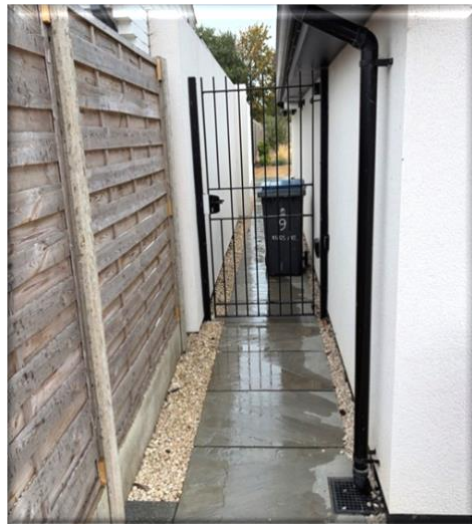
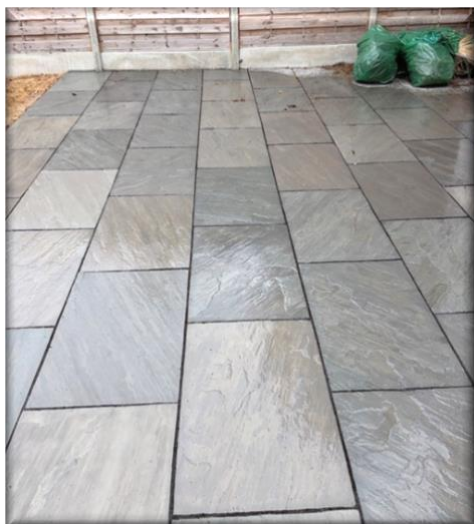
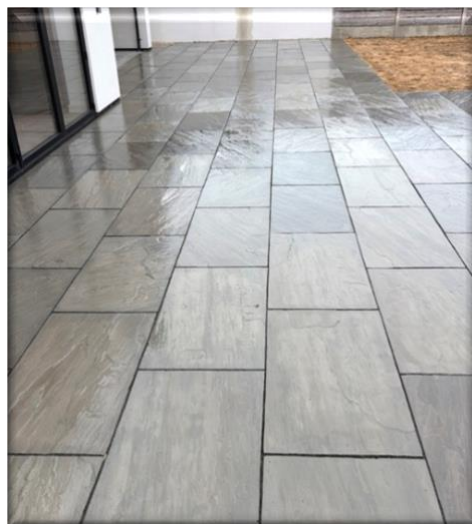
**Condition rating 1:** The gardens, paving and boundary structures were generally in good and serviceable condition. Rabbit activity at the rear boundary and concentrated rainwater staining to a rendered wall require routine monitoring and minor maintenance only.

Boundary positions, ownership and maintenance responsibilities cannot be determined from their physical appearance alone. Your conveyancer should compare the boundaries with the title plan and clarify responsibility for the fences, rendered walls, entrance arrangements and any estate-maintained areas.

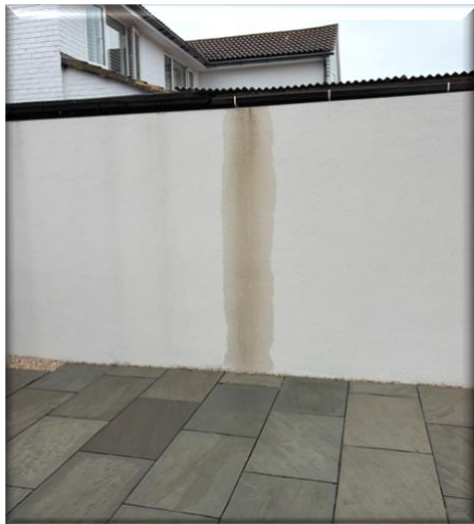
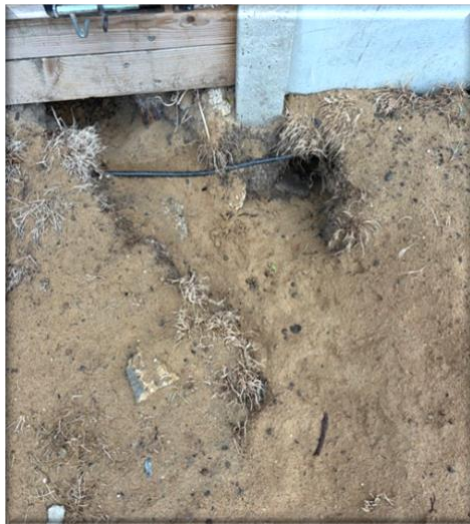
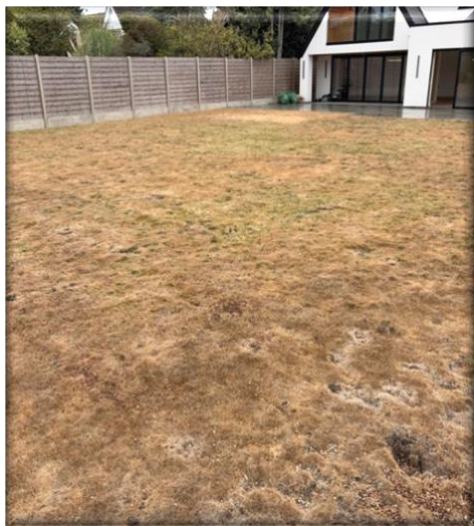
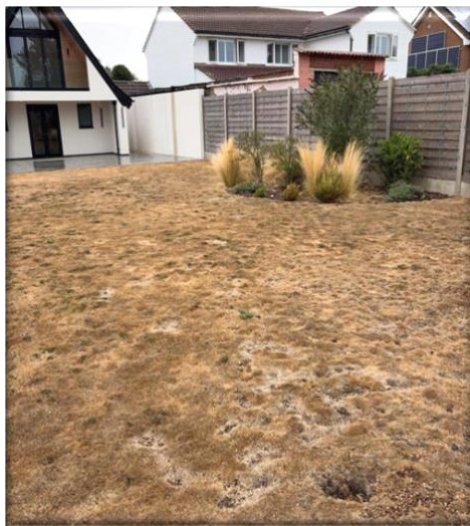
### CR2 Drainage

The hopper receiving water from the rear flat roof is not positioned or detailed effectively. The flat-roof outlet does not project sufficiently into the hopper, allowing some rainwater to miss the opening or track back against the wall. This has produced a pronounced vertical stain beneath the hopper. In wind-driven rain, the amount of water bypassing the hopper is likely to increase.

**Condition rating 2:** The accessible drainage chambers, gutters, downpipes and most rainwater outlets appeared serviceable, with no evidence of blockage or surcharge. However, the rear flat-roof outlet is not discharging effectively into its hopper and is staining the wall. The outlet requires prompt extension or alteration followed by water testing.

The outlet should be extended or reformed promptly so that it projects securely over and into the hopper, with a positive fall and effective drip edge. The repair must remain compatible with the GRP flat-roof covering and should not reduce the outlet capacity or create a raised obstruction that holds water on the roof. The hopper should also be checked for adequate size, secure fixing and alignment with the downpipe.

Following repair, the outlet should be water-tested to confirm that the full discharge enters the hopper without running back onto the render. The wall should be allowed to dry before the staining is cleaned using a method suitable for the silicone render. Any loose, softened or persistently damp render should then be repaired.
