## Building Survey

14 Audley Rd  
Folkestone  
Kent  
CT20 3QA

**Reference:** JB001 - JENNA BANKS

**Date:** 15 July 2026

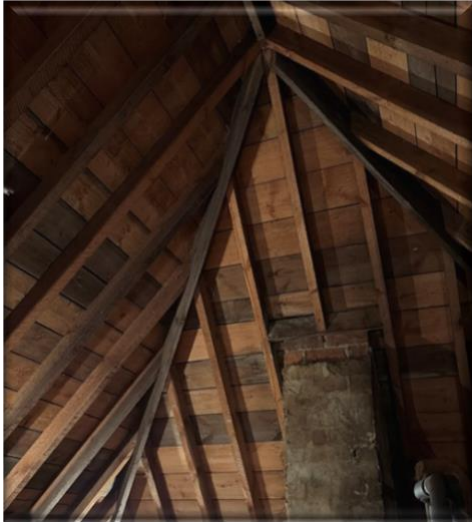
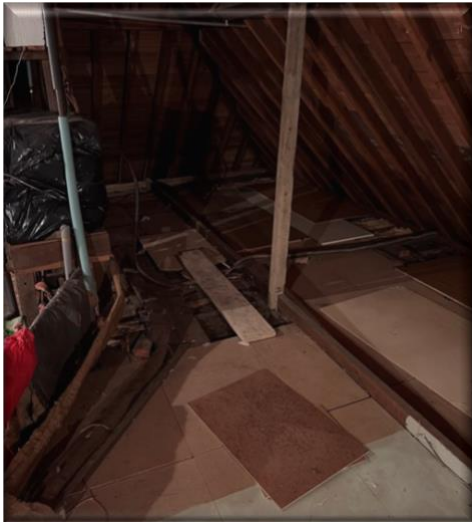
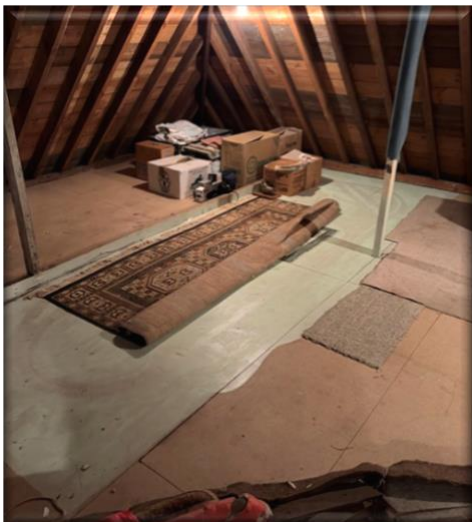
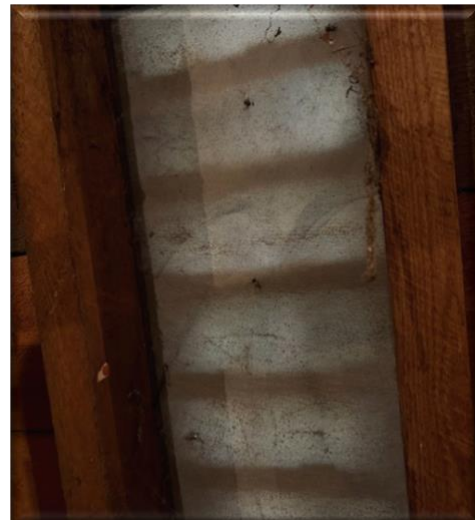
The roof structure is in good condition and no significant repair is presently required. The visible structural timbers appear sound, with no evidence of serious decay, deformation or failure. The recommendation to increase the loft insulation is an energy-efficiency improvement rather than a significant defect, and routine maintenance and periodic inspection should be sufficient.

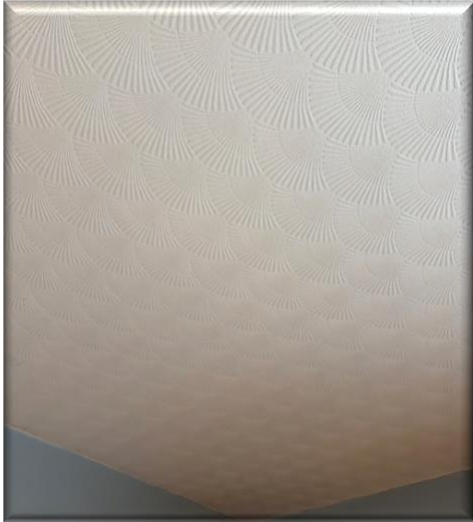
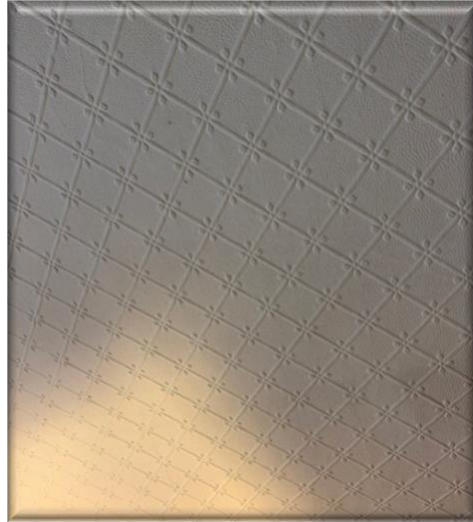
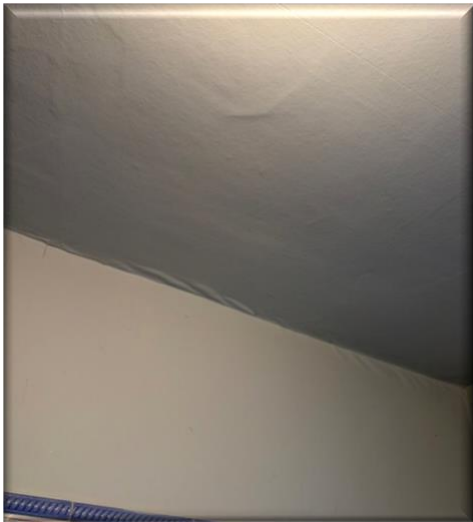
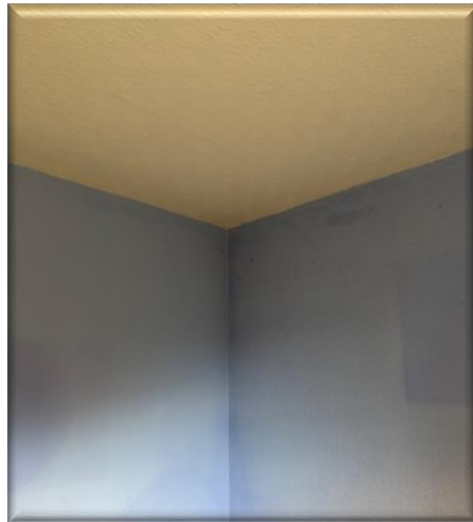
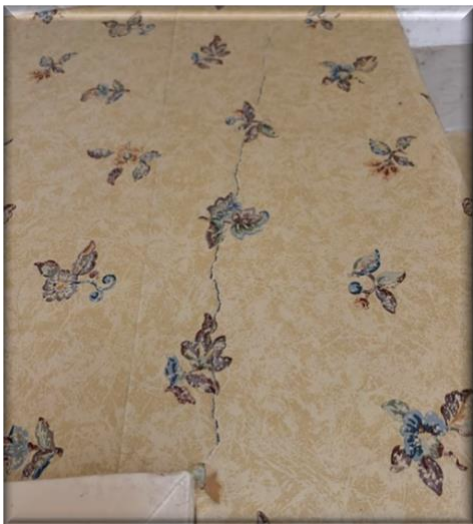
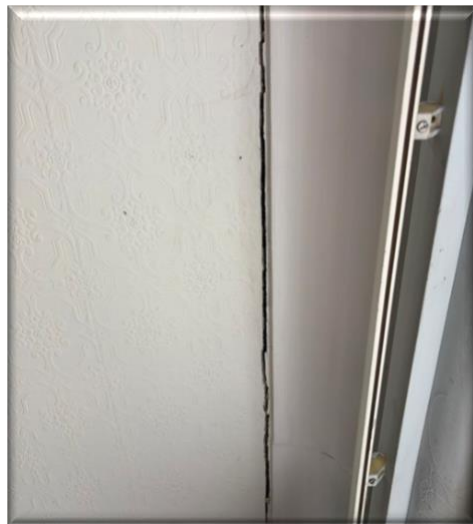
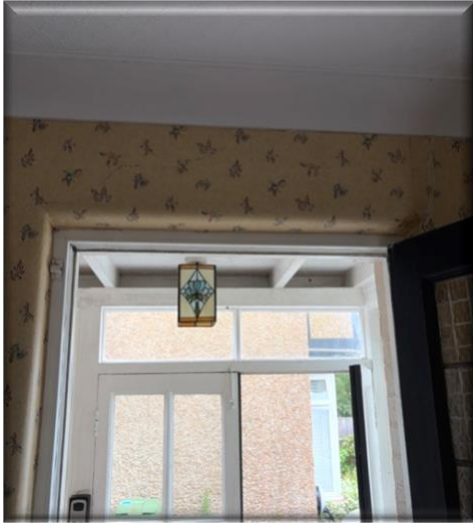
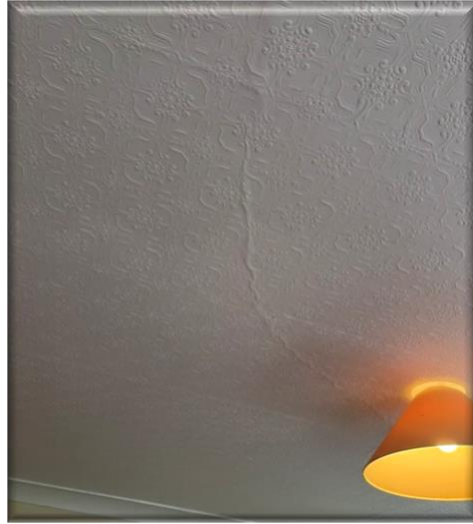
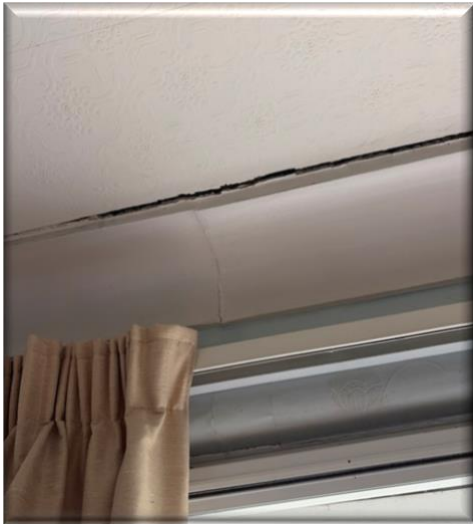
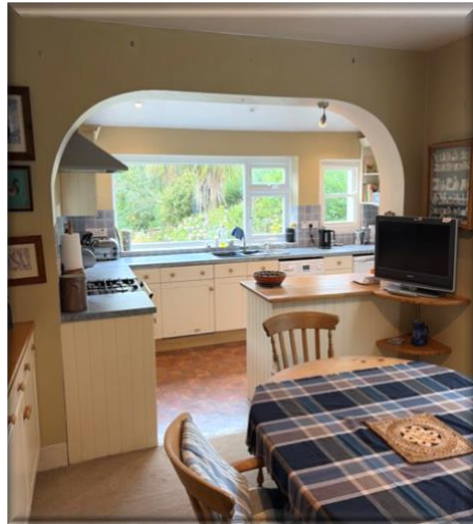
### CR3 Internal Walls & Ceilings

This rating has been applied because the separation and cracking within the front reception room corresponds with localised movement and defective masonry arches above the front windows, which require repair rather than decoration alone. Further investigation is also required in relation to the concealed structural support over the opening into the rear kitchen because no Building Control or structural information was available. The remaining wall and ceiling defects are generally consistent with the age and traditional construction of the property.

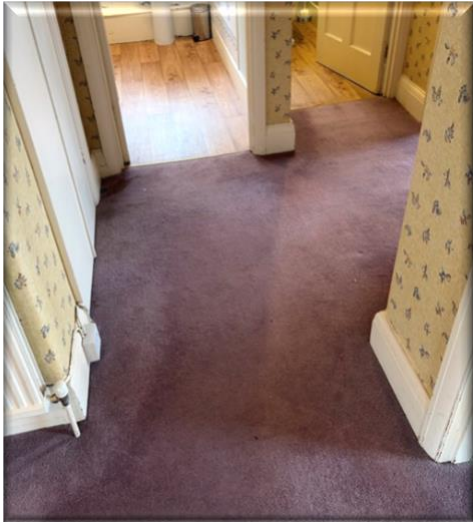
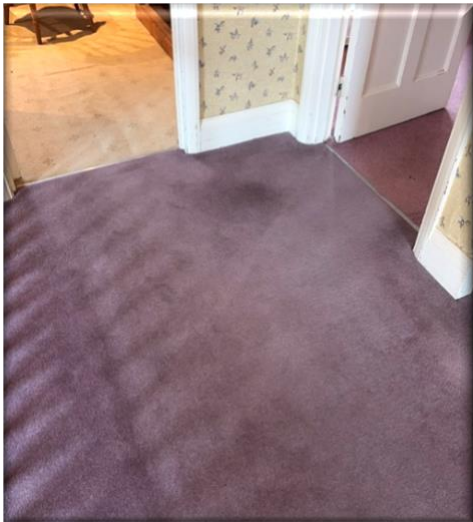
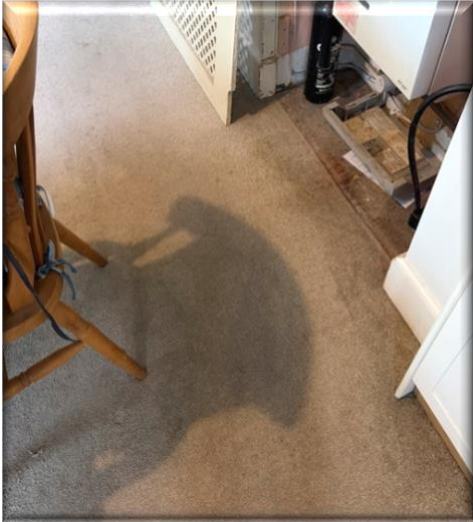
### CR1 Floors

The floors were found to be performing satisfactorily with no evidence of significant structural defects. The loose floorboards adjacent to the boiler are considered a minor maintenance issue resulting from previous access for plumbing works and can be remedied as part of routine maintenance. No further investigation is considered necessary at this stage.

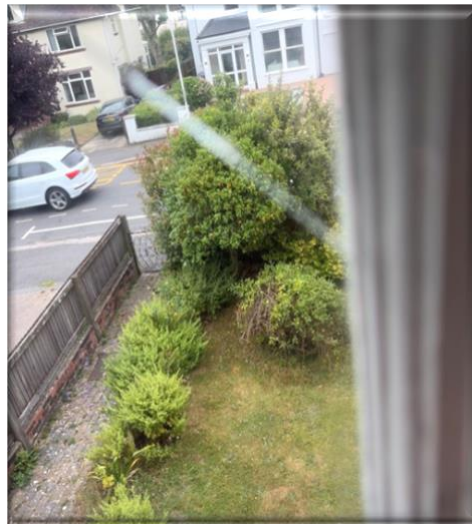
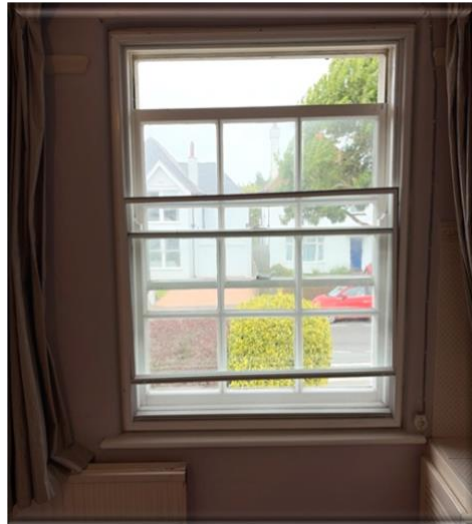
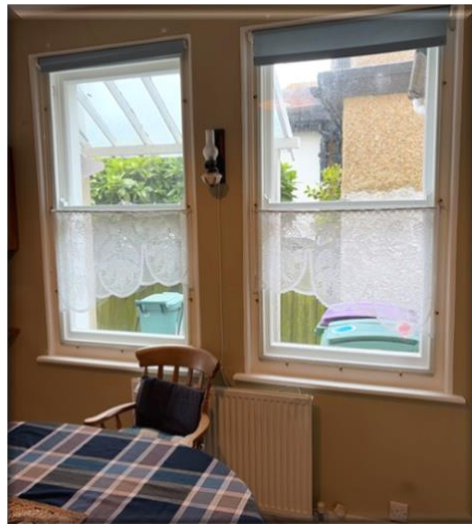
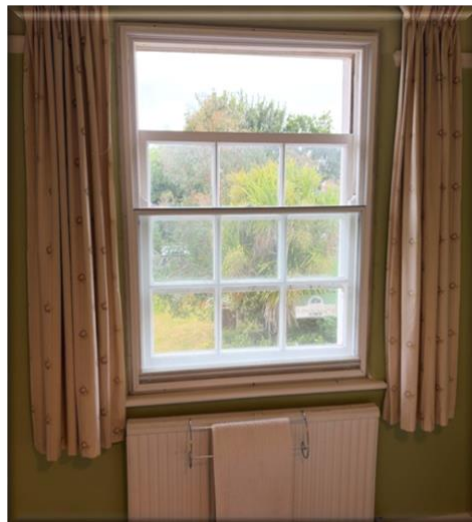
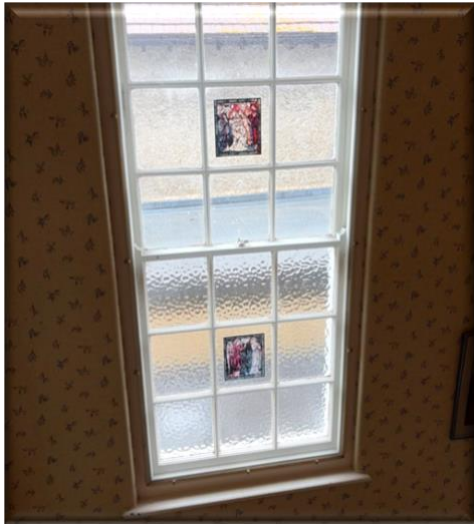
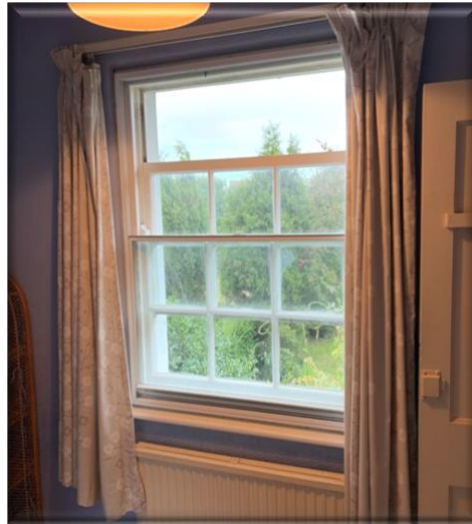
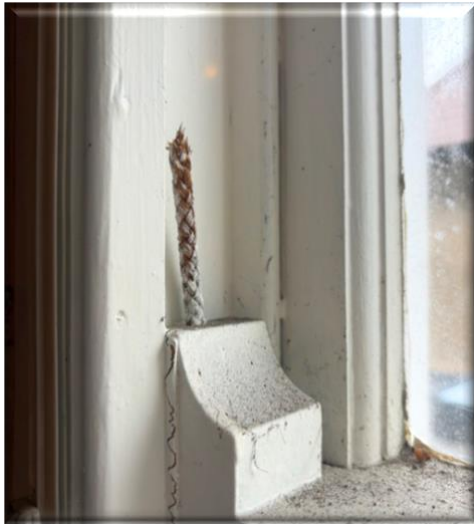
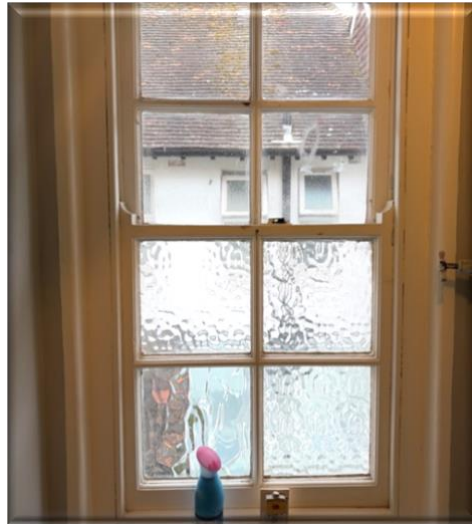
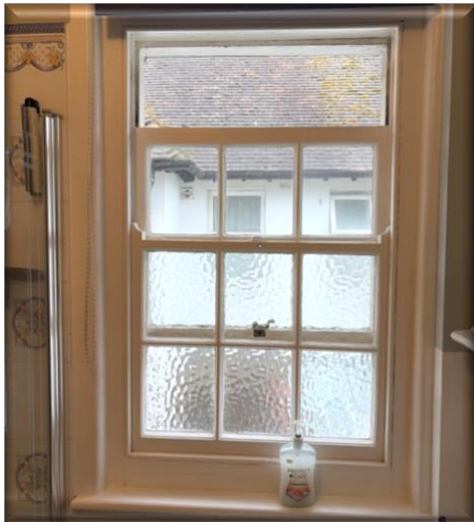
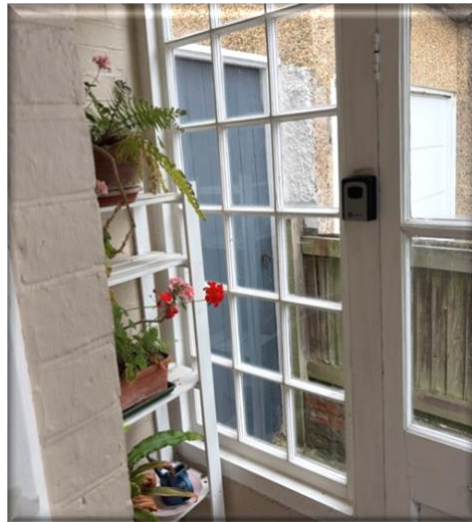
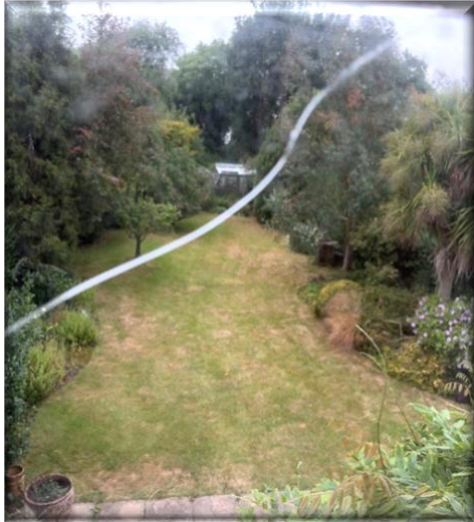
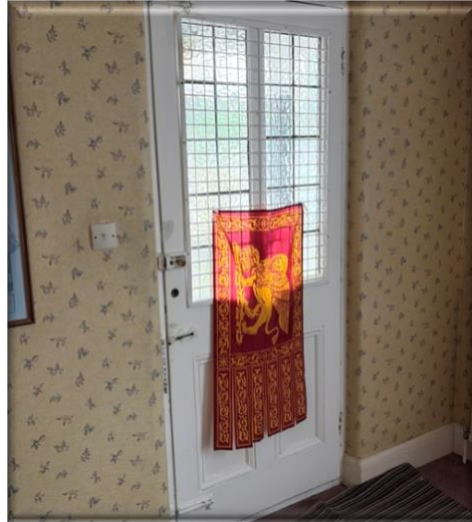
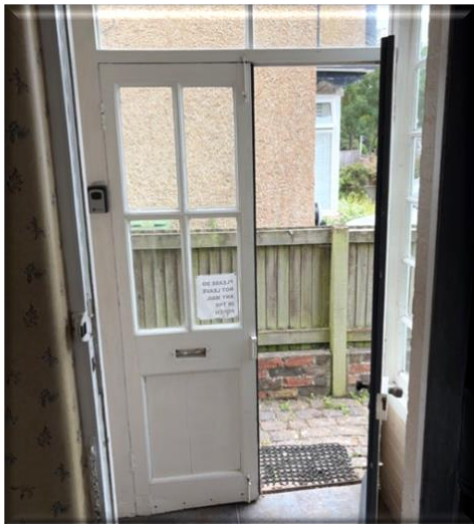
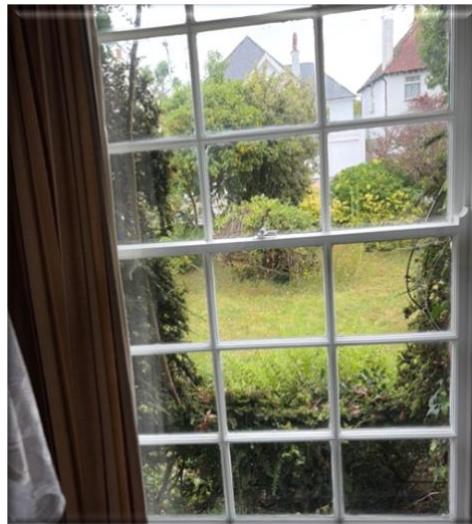
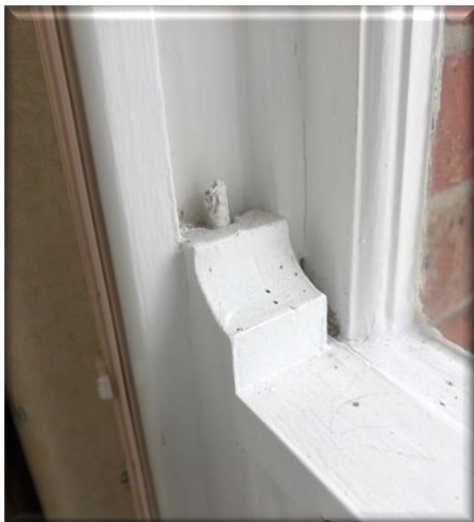
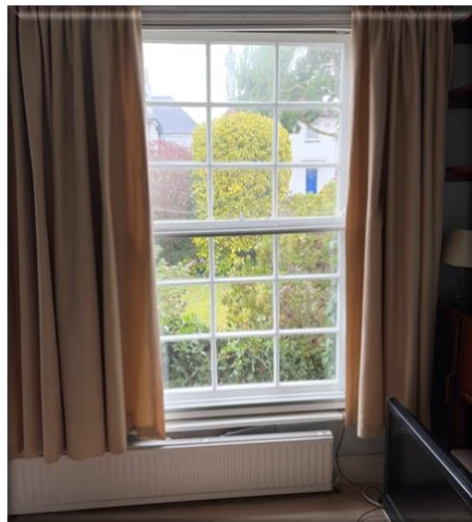
### CR3 Windows & Doors

This rating has been applied because a substantial programme of repair and refurbishment is required to restore the original timber sash windows to full working order. Whilst the timber frames themselves remain largely sound, the widespread failure of sash cords, painted shut windows, missing furniture, cracked glazing and localised distortion to the front living room windows means that significant maintenance work is now necessary. In addition, the front living room windows should not be repaired until the defective brick arches and associated masonry movement have first been remedied. The modern replacement windows and doors require only minor maintenance.

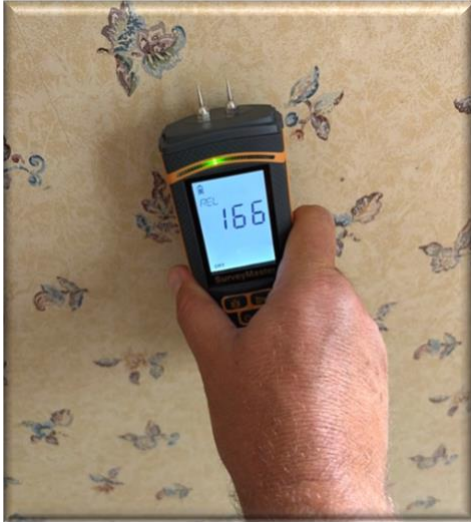
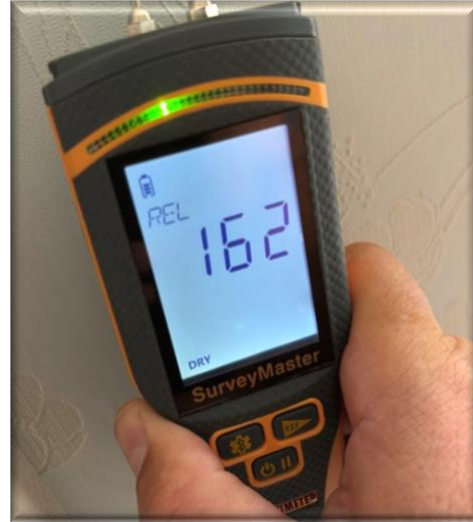
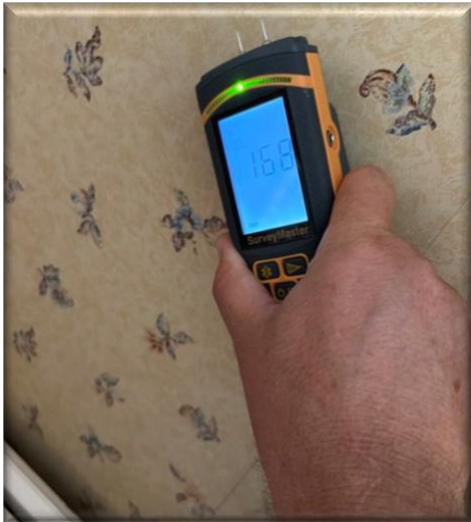
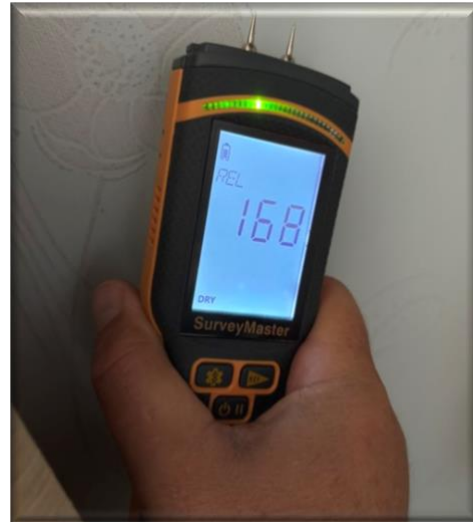
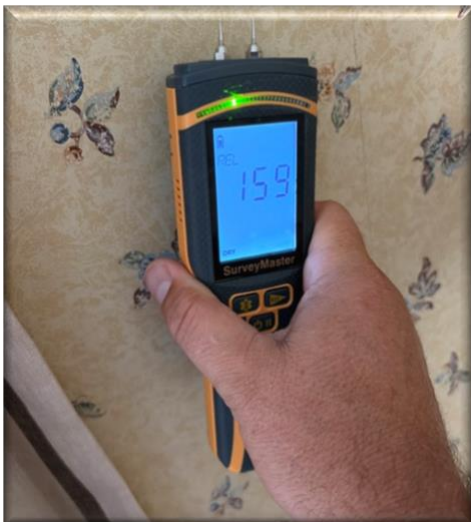
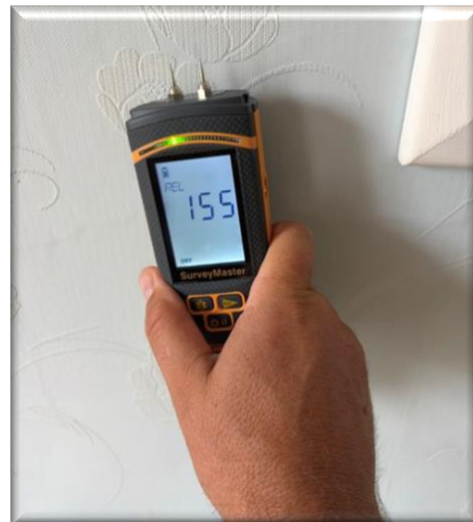
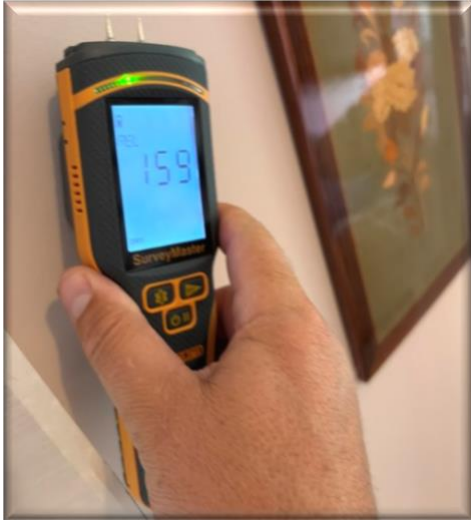
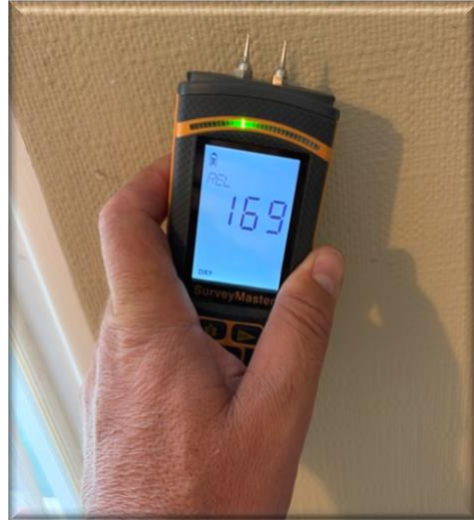
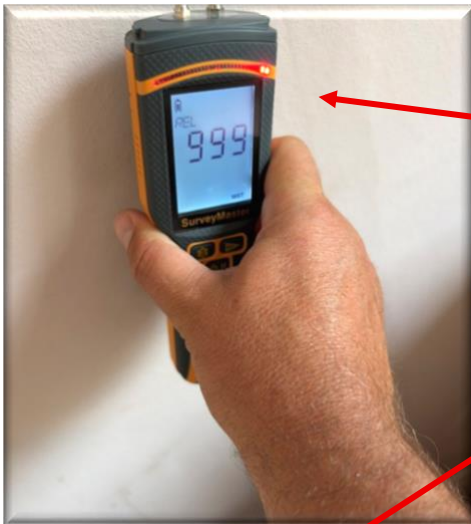
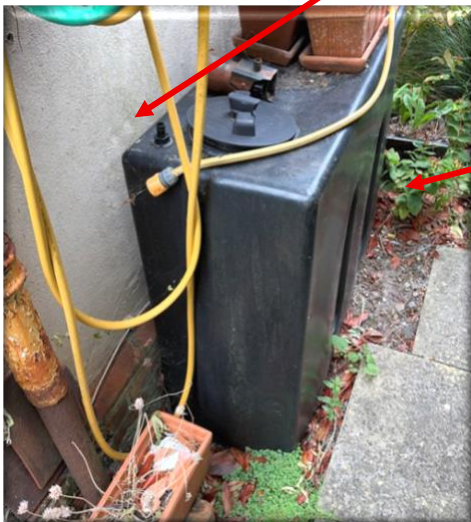
Overflowing water butt outside the living room wall where high moisture readings were found

Moisture testing was carried out to accessible internal wall surfaces using an electronic moisture meter. This provides an indication of relative moisture levels within the surface materials but does not, by itself, confirm the precise source or type of dampness. Readings can also be influenced by salts, metallic fixings, conductive decorative finishes and concealed services, so the results have been considered alongside the visual inspection.

The majority of walls throughout the property produced low and consistent moisture readings. No widespread evidence of rising damp, penetrating damp or significant condensation-related moisture damage was identified within the accessible parts of the accommodation. Decorative finishes were generally dry, and there was no extensive staining, blistering, salt contamination or deterioration associated with prolonged moisture exposure.

One isolated area of elevated moisture readings was identified within the rear reception room. Externally, this position corresponds with an overflowing water butt located close to the wall. The water butt is allowing water to spill against, or immediately adjacent to, the external masonry and is considered the most likely cause of the localised raised readings internally.

No evidence was identified to suggest a widespread damp-proof course failure or a generalised damp problem affecting the property.

### Condition Rating 2

This rating has been applied because localised raised moisture readings were identified within the rear reception room and remedial action is required to remove the overflowing water butt and prevent further wetting of the wall. The issue appears isolated and no evidence of widespread dampness was found elsewhere.

Continued saturation of the wall in this location could eventually lead to deterioration of internal plaster and decorative finishes. The water butt should therefore be removed, repaired or repositioned so that all rainwater is discharged safely away from the building. The surrounding wall and ground level should also be checked to ensure water cannot collect against the external masonry.

Once the source of moisture has been addressed, the wall should be allowed to dry naturally before internal redecoration is carried out. Drying may take several months depending on the thickness and construction of the wall, weather conditions and internal heating and ventilation. The area should then be monitored, with further investigation undertaken only if elevated readings or visible dampness persist.

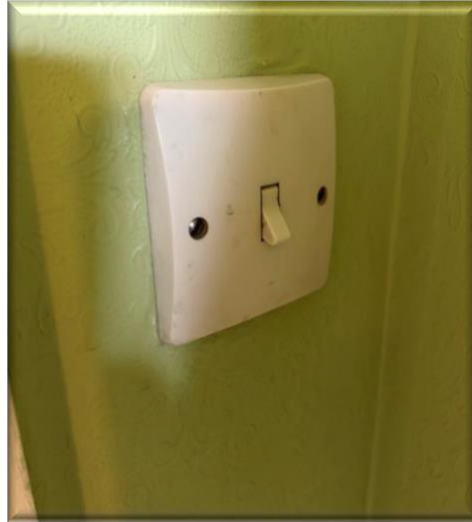
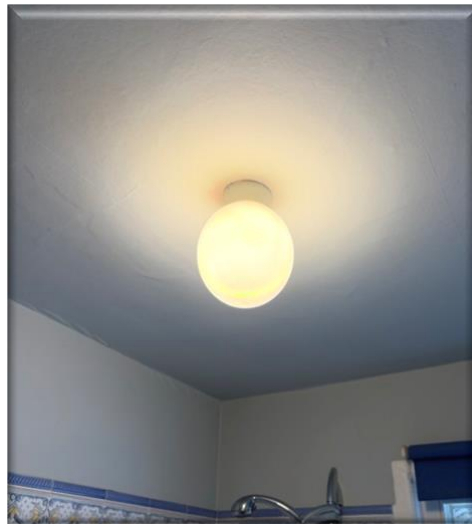
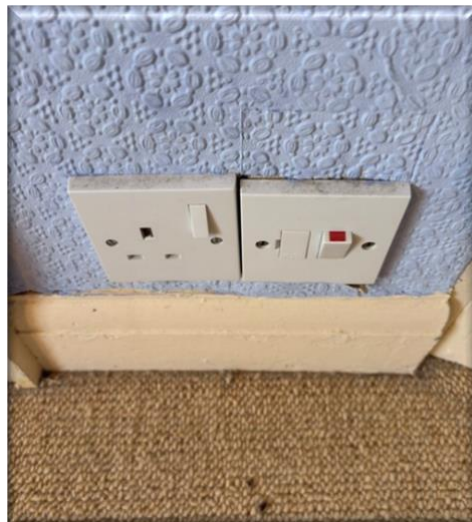
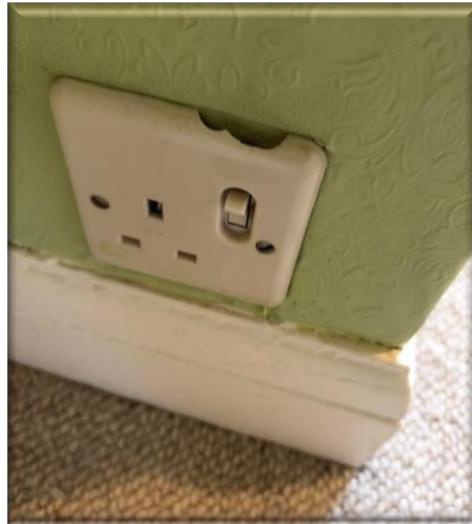
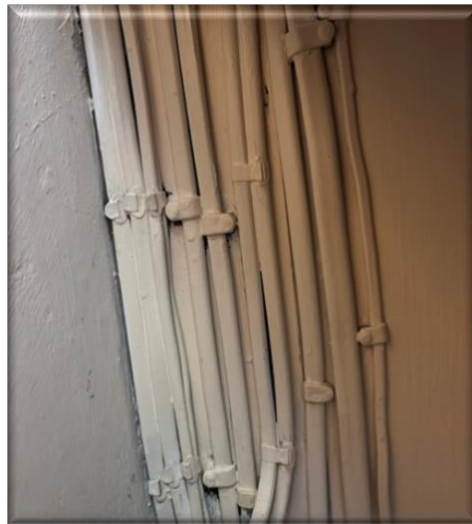
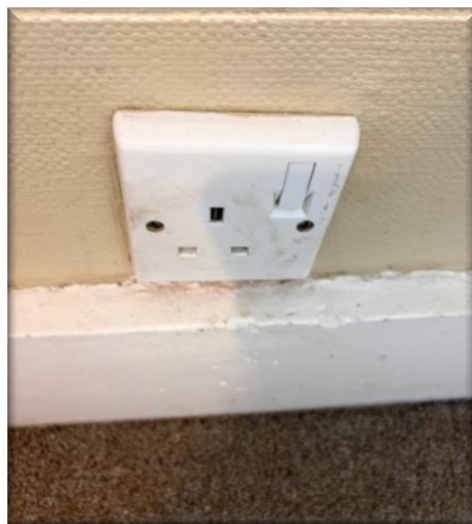
The consumer unit comprises an older style fuse board incorporating rewirable fuse carriers rather than modern miniature circuit breakers (MCBs) and residual current device (RCD) protection. Consumer units of this age generally provide a significantly lower level of electrical safety than modern installations and do not incorporate many of the protective devices now required by current editions of BS 7671 (IET Wiring Regulations). Although older fuse boards are not automatically unsafe, they do not provide the level of protection expected within a modern domestic installation.

Visible wiring is predominantly PVC insulated cable, consistent with a rewiring programme undertaken during the 1970s or 1980s. No obvious examples of older rubber-insulated or lead-sheathed wiring were observed within the accessible areas inspected. However, only a limited amount of wiring is visible during a non-invasive survey, and the concealed sections of the installation could not be inspected.

The switches and socket outlets are older style accessories which remain generally serviceable but show signs of age and wear. Surface-mounted wiring and conduit were also noted in several locations, reflecting alterations carried out over many years. Whilst these installations appear functional, they are dated by modern standards.

The fixed lighting installation similarly appears to comprise older wiring and accessories. No significant defects were apparent to the visible light fittings during the inspection; however, the age of the installation means concealed components cannot be assumed to comply with current electrical standards.

### Condition Rating 3

This rating has been applied because the electrical installation is of considerable age, incorporates an obsolete rewirable fuse board and is unlikely to meet modern safety standards or the demands of contemporary living. Whilst no immediate dangerous defects were visually identified, the installation requires formal testing by a qualified electrician, and significant upgrading or replacement should be anticipated depending upon the outcome of the Electrical Installation Condition Report.

Given the age of the installation, the obsolete consumer unit and the relatively limited provision of electrical outlets, the installation is likely to benefit from substantial upgrading in the foreseeable future. Depending upon the findings of electrical testing, this may range from replacement of the consumer unit through to a complete rewire if the installation is found to be in poor condition or unsuitable for continued service.

Prior to exchange of contracts, the purchaser should commission an Electrical Installation Condition Report (EICR) from a NICEIC, NAPIT or similarly approved electrical contractor. The report will identify any safety defects, assess compliance with current regulations and establish whether repairs, upgrading or complete rewiring are required. The findings should be used to inform negotiations with the seller where appropriate.

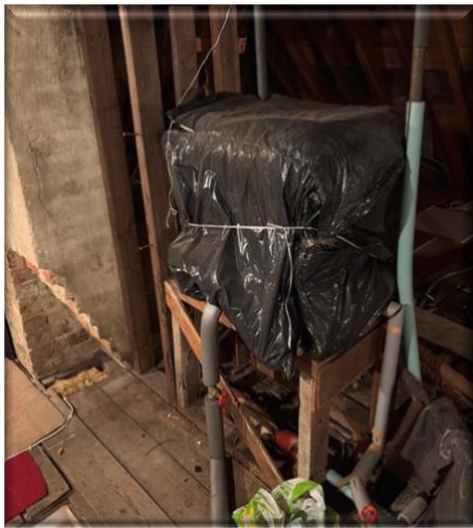
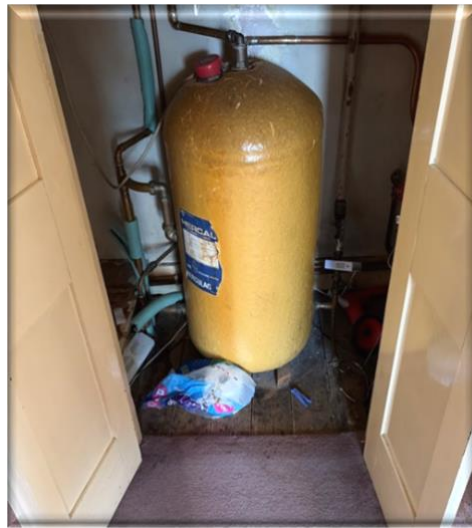
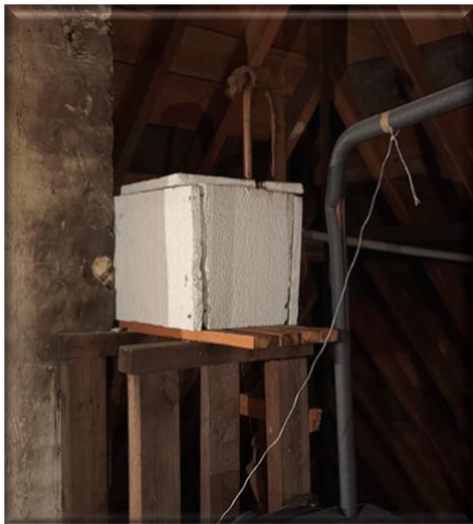
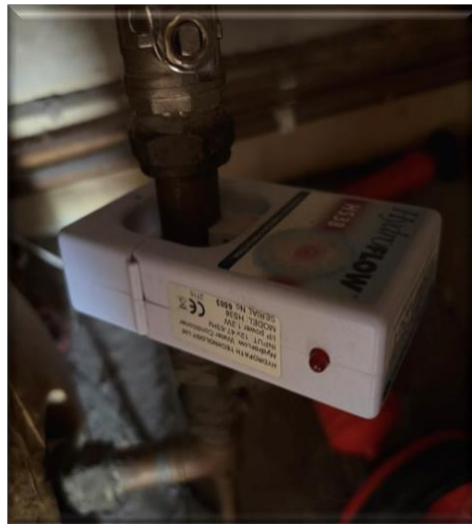
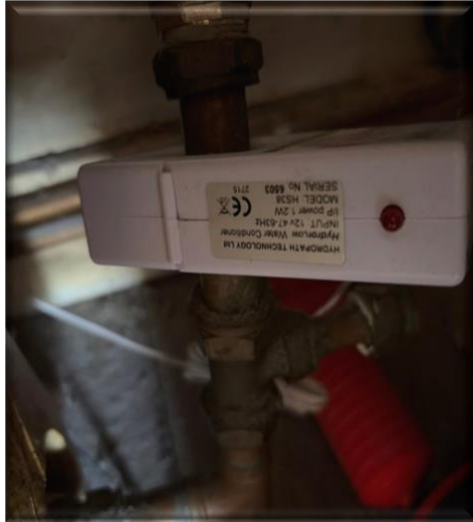
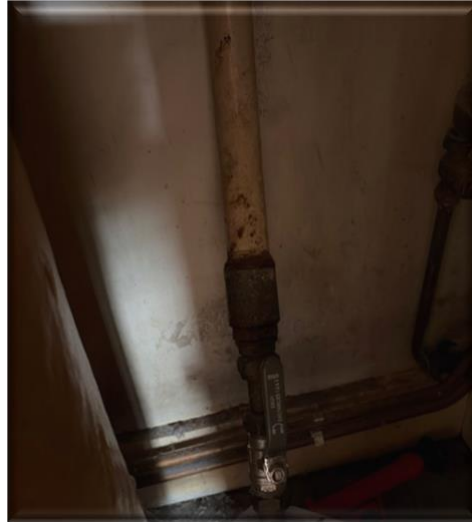
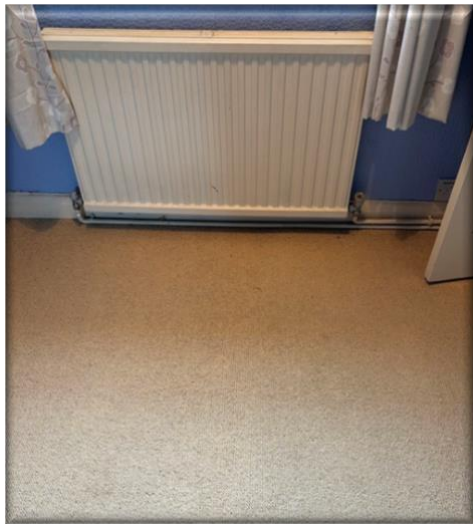
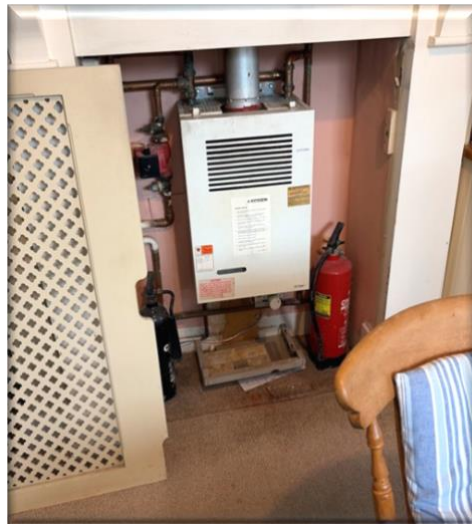
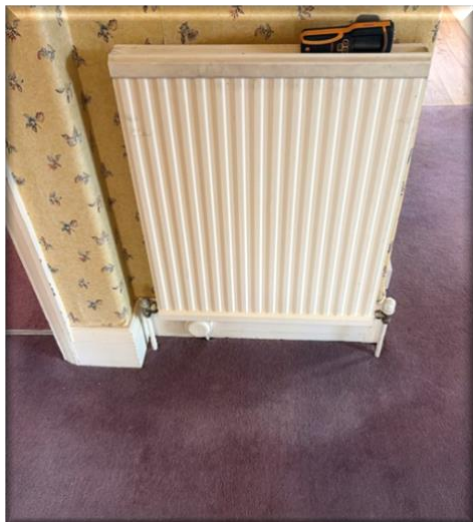
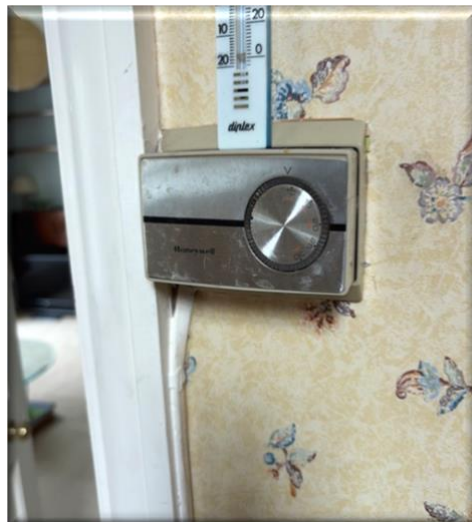
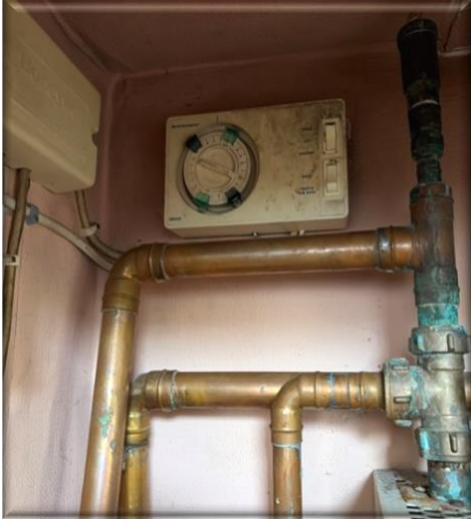
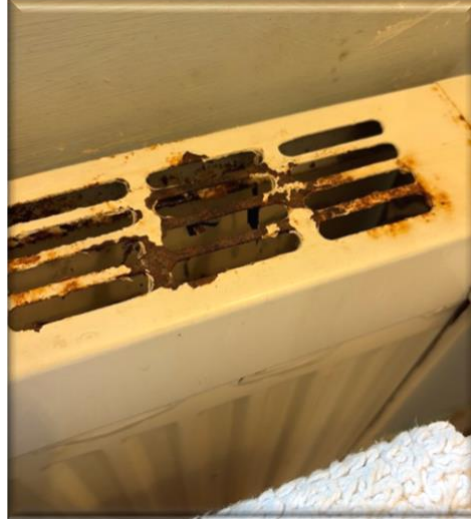
### Condition Rating 2

safety inspection by a Gas Safe registered engineer is recommended before commitment to purchase or immediately after completion.

**Gas Safe guidance recommends that all gas appliances and boilers are inspected and serviced at least annually, in accordance with the manufacturer's instructions. Gas installations can appear satisfactory while serious, potentially fatal defects remain concealed. You should therefore commission a Gas Safe registered engineer to inspect and test the gas and heating installation prior to legal commitment, unless recent, verifiable certification is provided.**

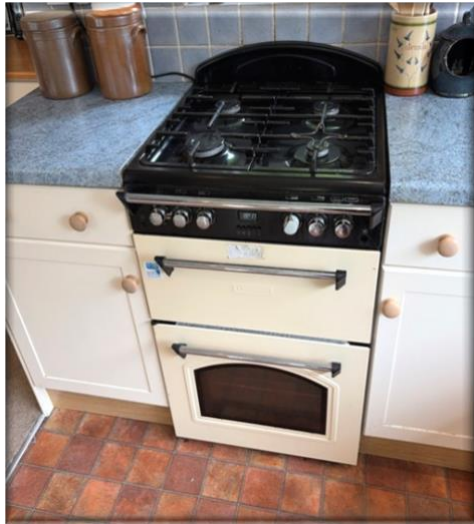
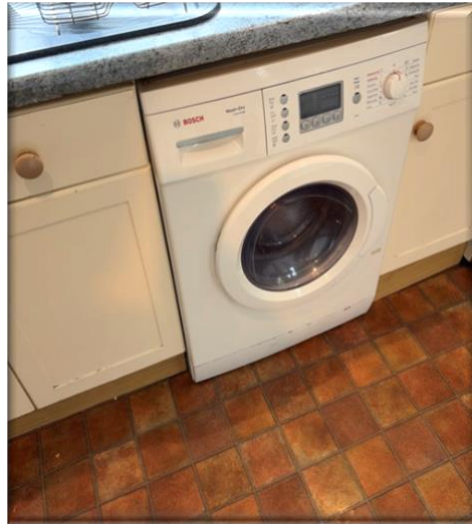
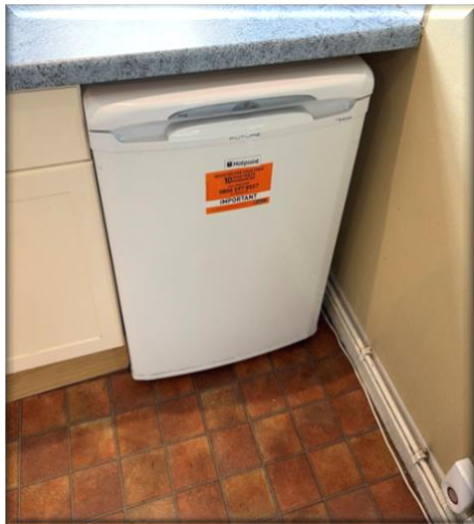
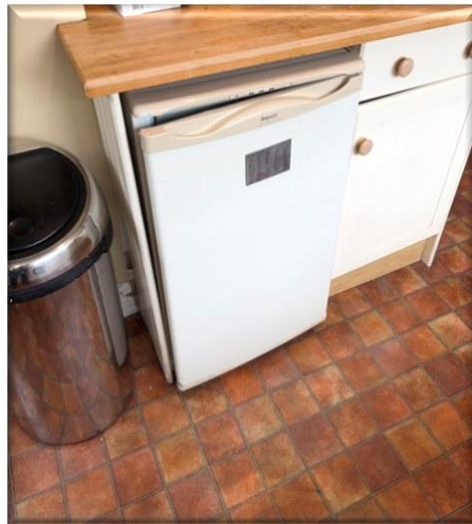
#### Condition Rating 1

The built-in fittings are generally serviceable and no significant defects were identified. The kitchen remains functional, with provision for freestanding appliances, although it is showing signs of age and cosmetic wear. Replacement should be considered as part of future modernisation rather than as an immediate repair requirement.

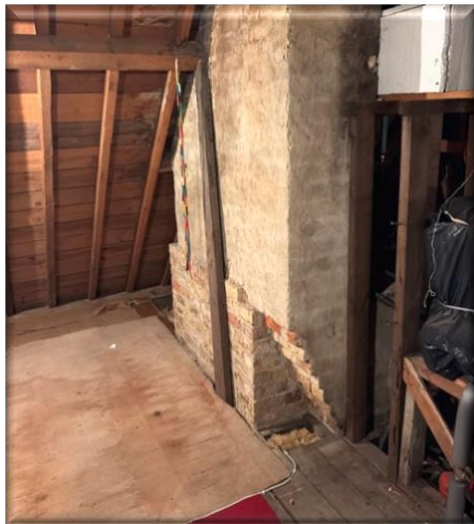
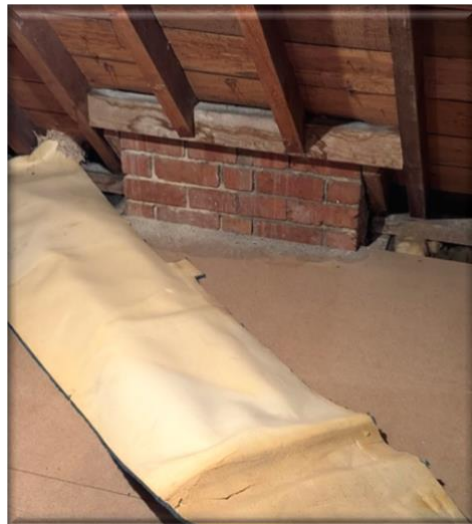
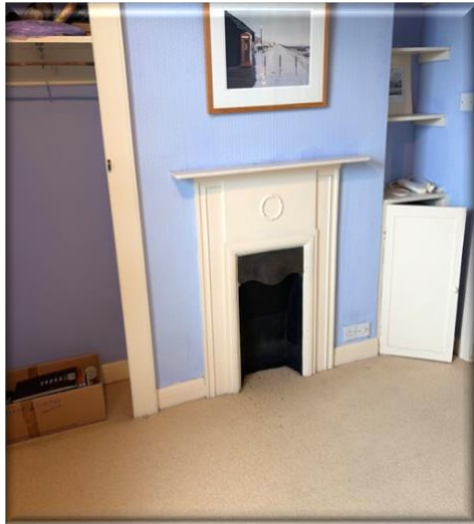
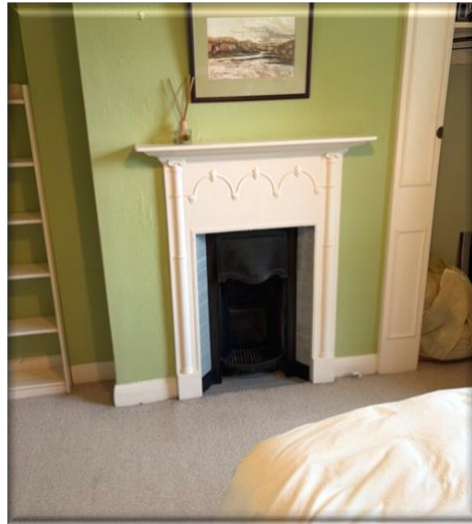
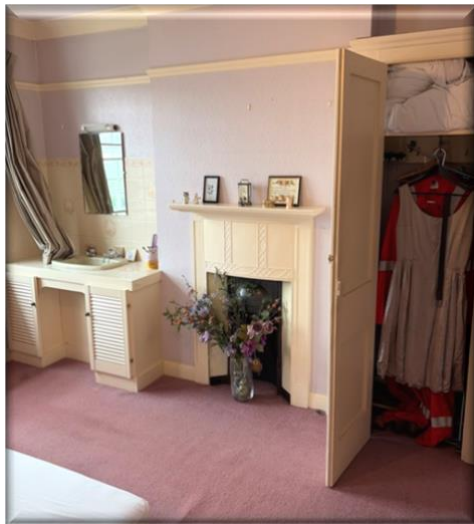
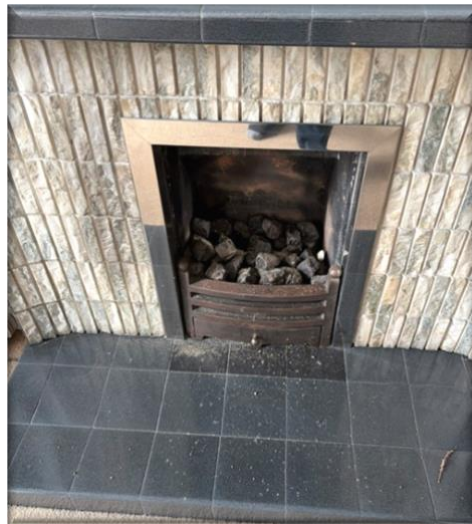
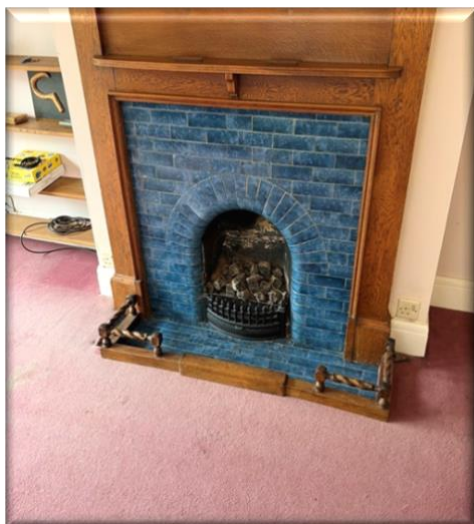
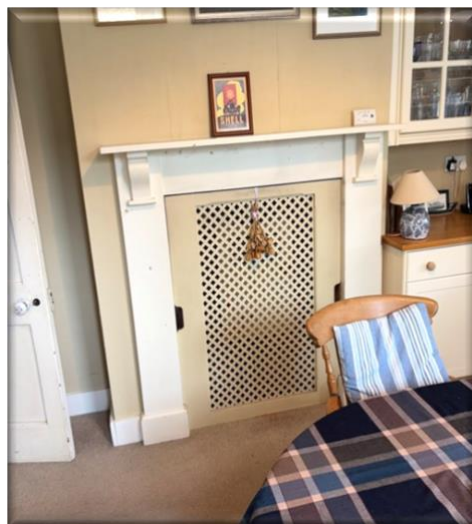
### Condition Rating 1

The chimney stacks, chimney breasts and fireplaces were found to be in good overall condition with no evidence of significant structural defects. Routine maintenance, periodic sweeping of active flues and regular servicing of the gas appliances by a Gas Safe registered engineer are recommended to maintain safe operation.

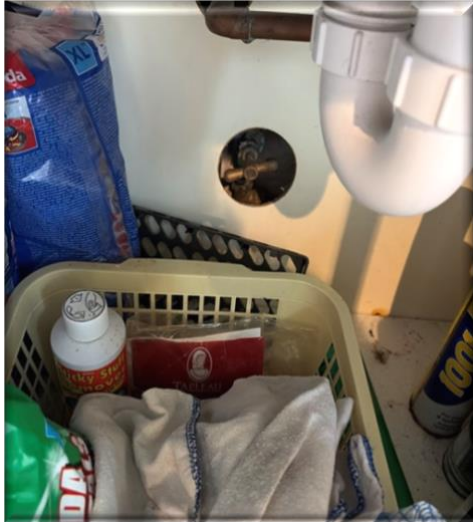
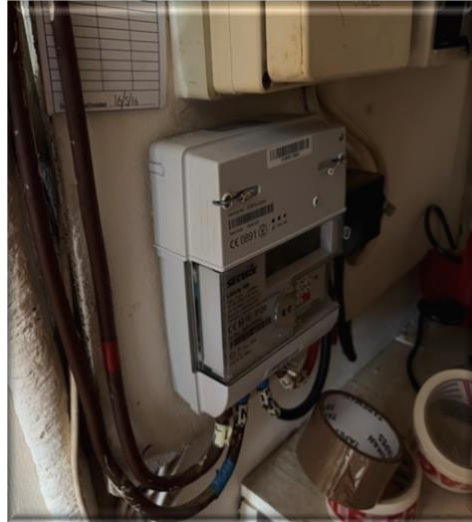
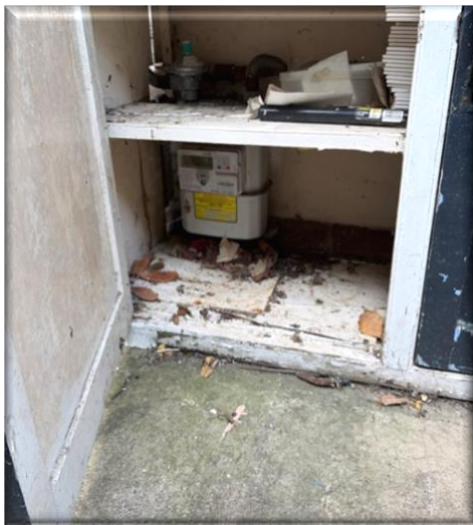
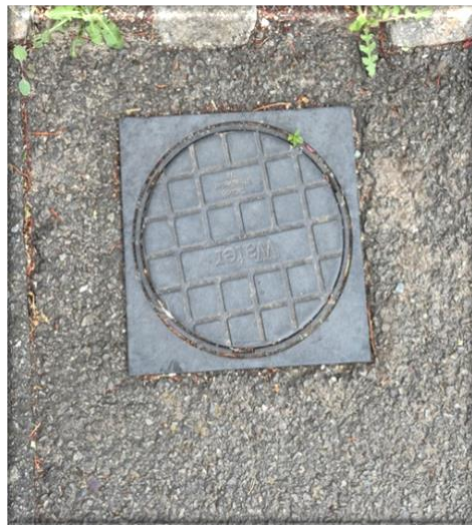
The visible service connections appeared generally satisfactory, with no significant defects identified during the inspection. The accessible drainage inspection chamber was clear and free-flowing. Continued routine maintenance and periodic

servicing of the associated installations is recommended, together with the specialist inspections recommended elsewhere within this report.

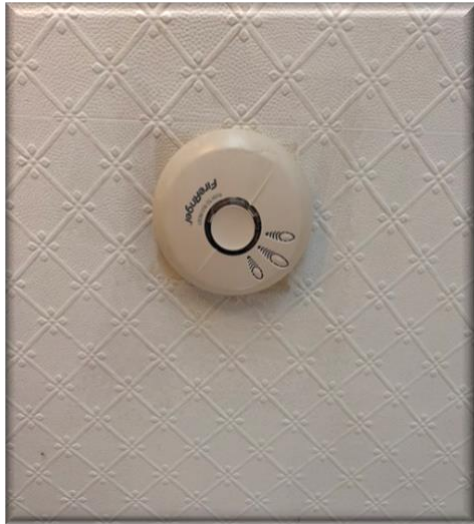
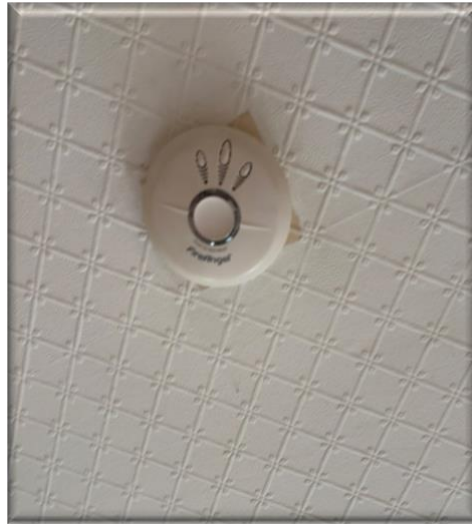
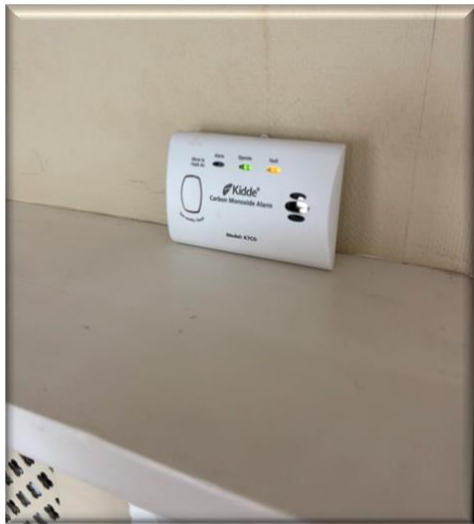
The alarms were operational when tested during the inspection. No significant defects were identified, although the alarms should be fully tested again upon occupation, batteries replaced as necessary and the units renewed at the end of their service life.

Immediately upon taking occupation, the purchaser should test all smoke alarms and the carbon monoxide alarm, replace the batteries where necessary and confirm that suitable protection is provided throughout the property before occupation.
