## Building Survey

14 Audley Rd  
Folkestone  
Kent  
CT20 3QA

**Reference:** JB001 - JENNA BANKS

**Date:** 15 July 2026

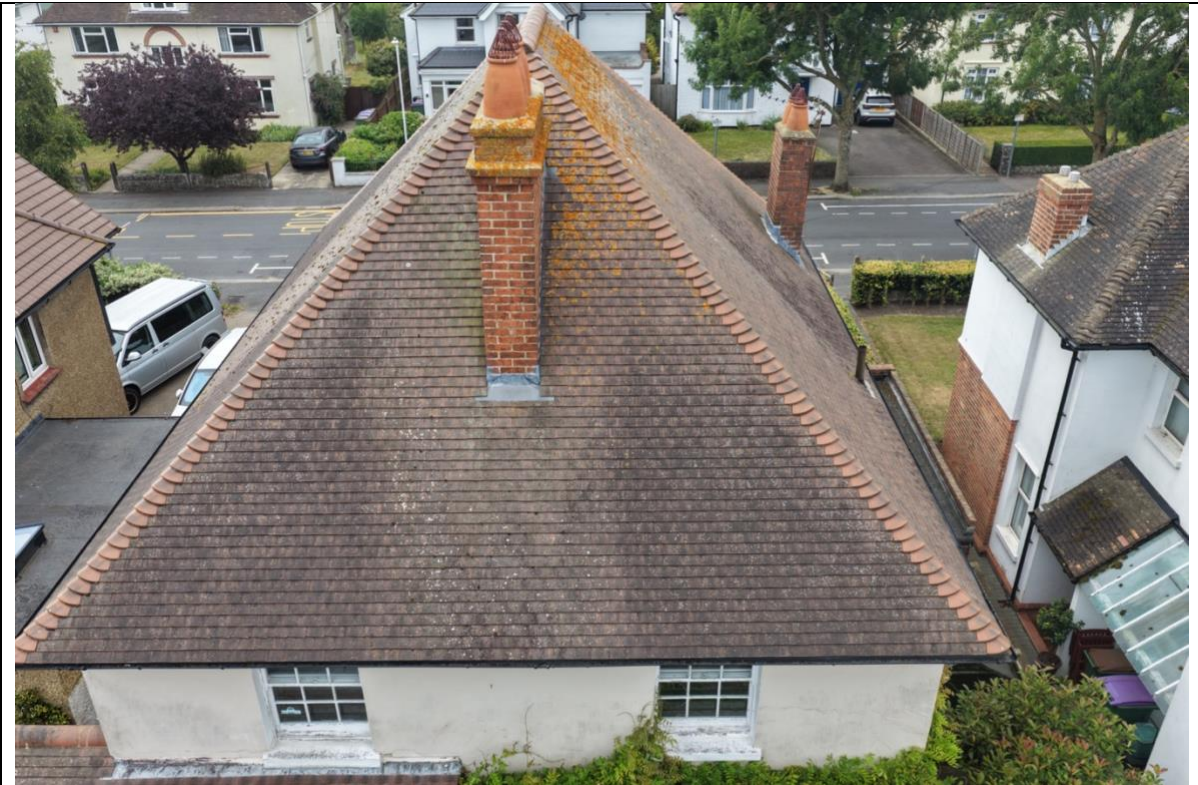
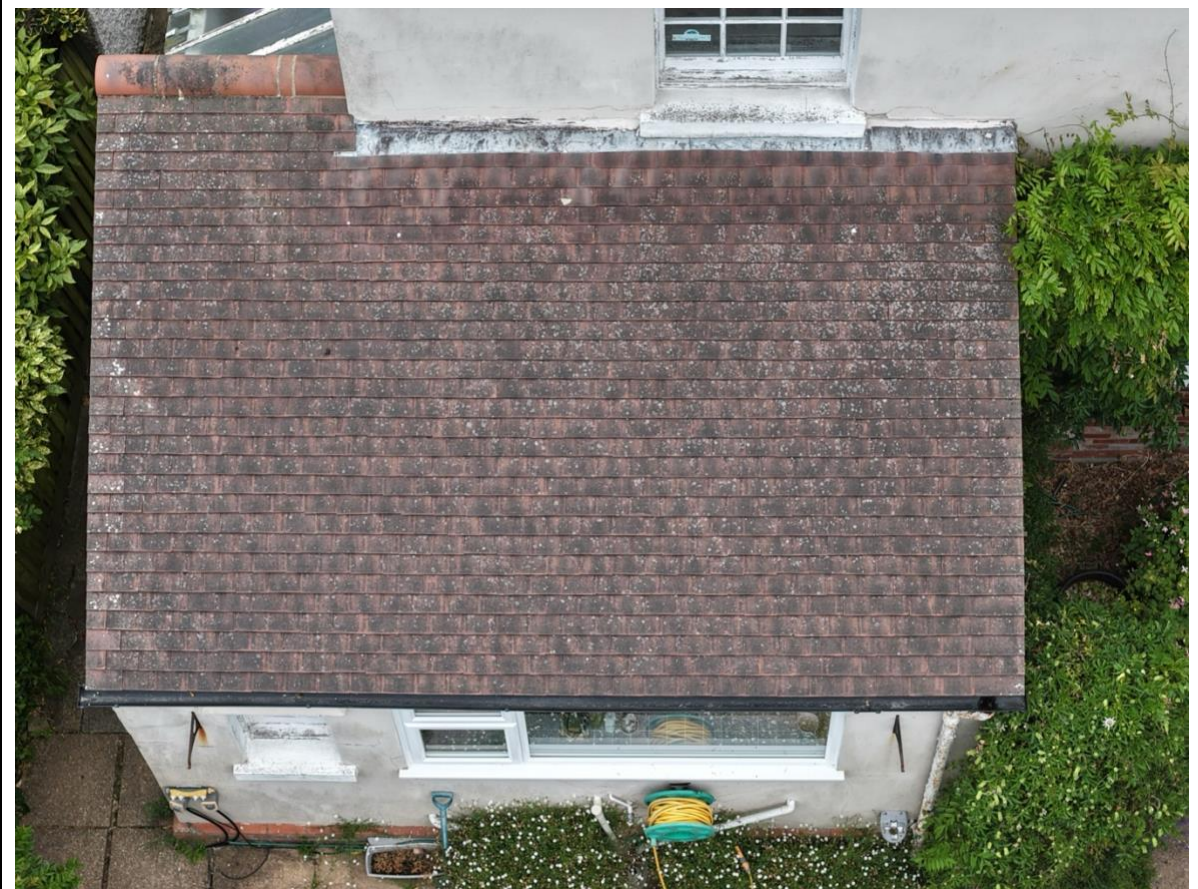
There is widespread biological growth across parts of the roof, including moss, lichen and algae, particularly to the more shaded slopes and around the chimney stacks. This is common and is not presently causing an obvious defect. Heavy accumulations should nevertheless be monitored because retained moisture can gradually encourage surface deterioration and obstruct rainwater goods. Any cleaning should be undertaken carefully by a competent contractor without pressure washing or damaging the clay tiles.

A small area of replacement tiles was noted where the tiles differ slightly in colour and appearance from the surrounding roof covering. This indicates that localised repairs have been carried out. The repairs appeared serviceable and no immediate concern was identified.

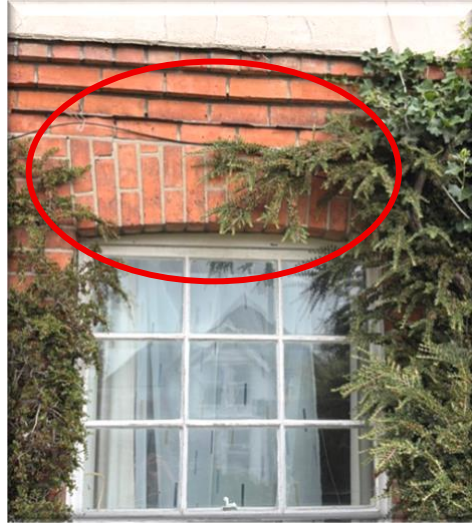
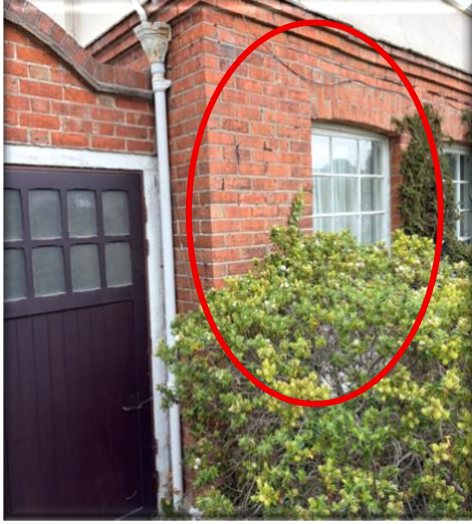
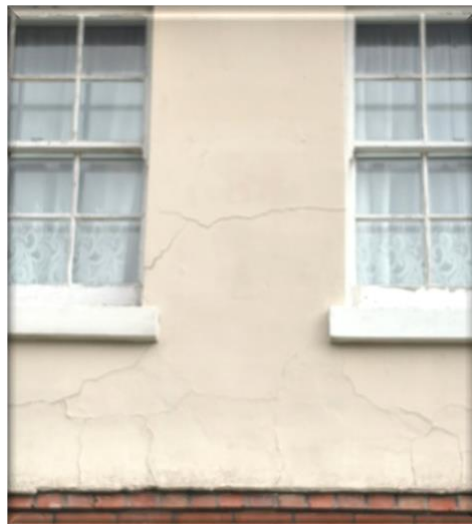
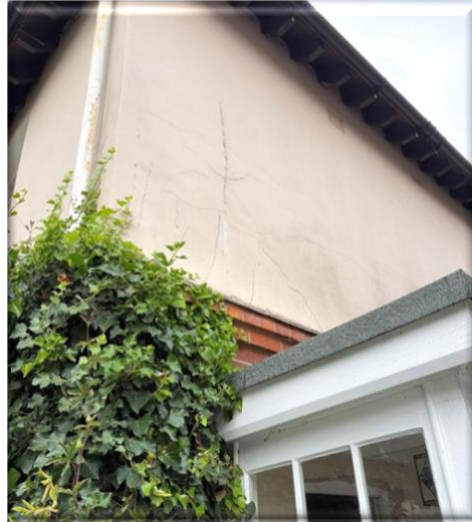
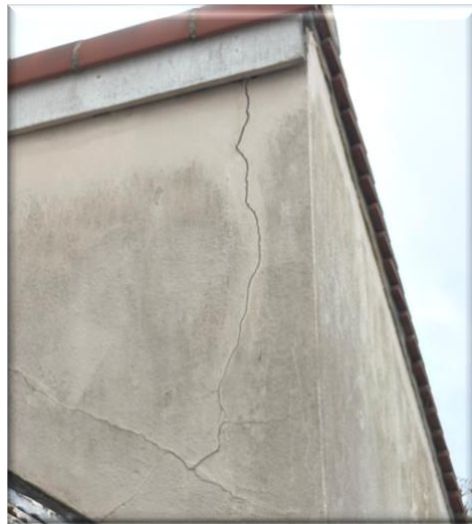
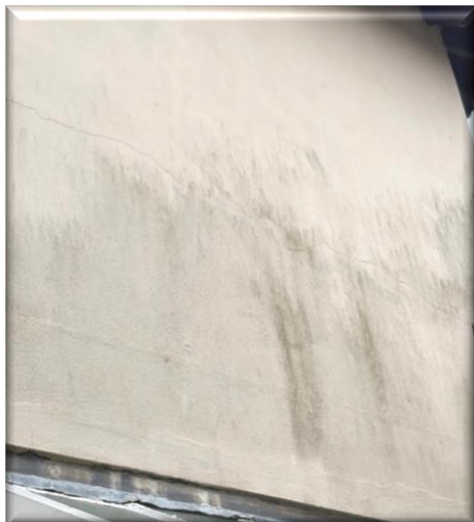
This rating has been applied because the external walls require significant repair and further investigation. Two front brick arches have failed and require rebuilding, a third arch requires closer inspection once vegetation has been removed, and crack stitching is likely to be required within the front brickwork and possibly elsewhere. The widespread horizontal cracking also warrants a specialist cavity wall tie survey before exchange of contracts. Substantial re-rendering should be anticipated after the underlying masonry defects have been stabilised.

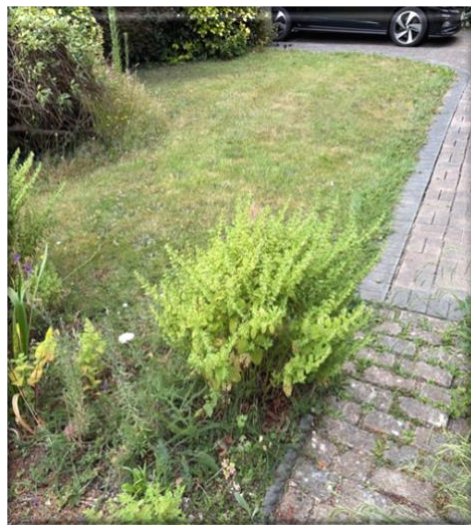
The principal grounds, driveway and front boundary wall are in generally satisfactory condition. However, the eucalyptus tree requires professional management advice, the rear fencing will need periodic repair, and the greenhouse and timber shed are in poor condition with limited remaining serviceable life. Minor paving maintenance and regular vegetation control are also required.

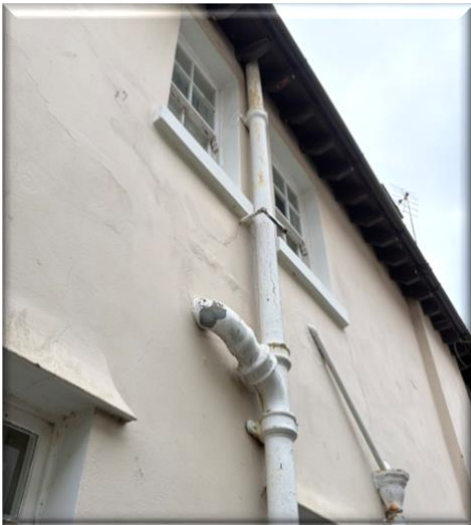
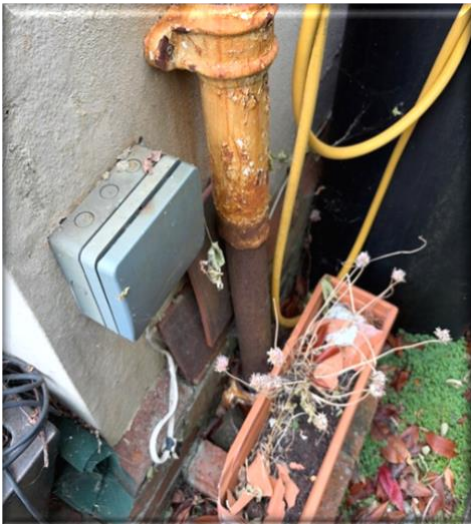
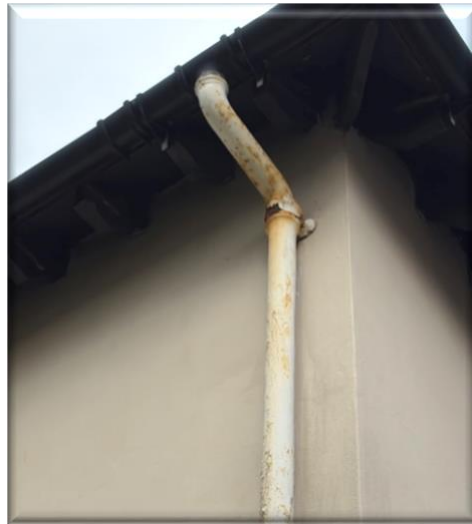
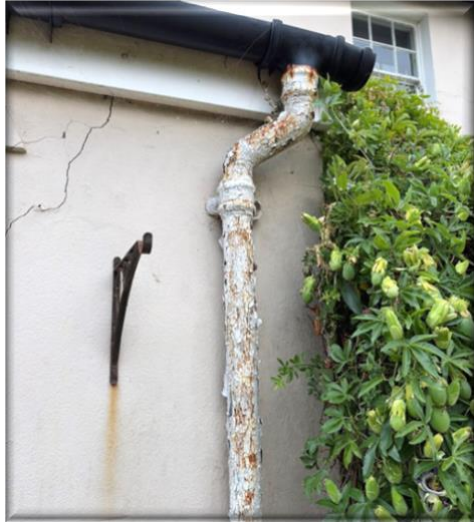
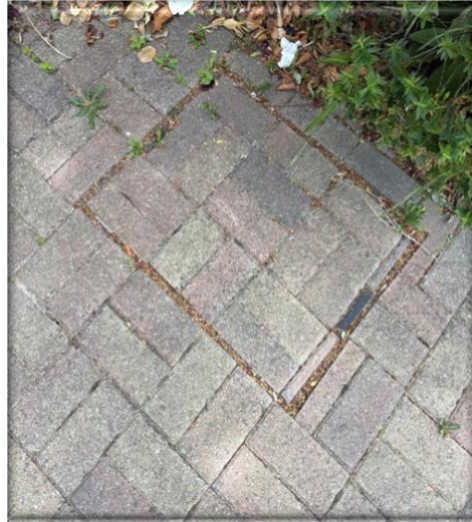
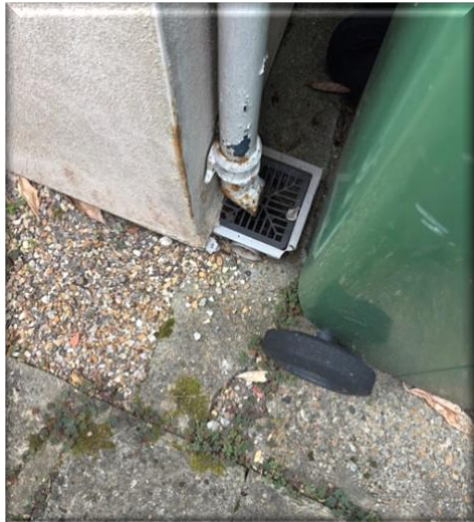
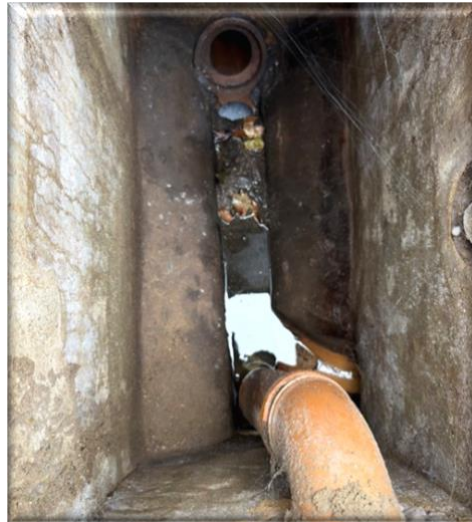
### CR2 Drainage

Several original cast iron rainwater downpipes and soil stacks remain around the property. These components display significant age-related corrosion, with widespread surface rust, flaking paint and localised deterioration visible. Whilst they appeared to remain functional at the time of inspection, they have reached an age where continued deterioration should be expected. Loose rust should be removed, the pipework treated with an appropriate rust inhibitor and redecorated using a suitable metal paint system. Sections that have become excessively corroded or begin to leak should be replaced.

The modern plastic rainwater goods are generally in satisfactory condition. However, the retained cast iron downpipes and stacks exhibit significant corrosion and require maintenance and eventual replacement as necessary. A partial blockage was identified within one inspection chamber and should be cleared by rodding. A CCTV drainage survey is recommended before undertaking the structural masonry repairs to the front elevation to confirm that defective underground drainage is not contributing to the observed cracking.

Given the significant repairs recommended to the front elevation masonry, particularly the rebuilding of the failed brick arches and crack stitching works, I also recommend that a CCTV drainage survey is commissioned before the structural repairs are undertaken. Defective underground drainage can contribute to localised ground movement and should be ruled out before investing in masonry repairs. The CCTV survey will confirm whether the drains are structurally sound, correctly aligned and free from fractures, displaced joints or root ingress that could be influencing ground conditions adjacent to the front elevation.

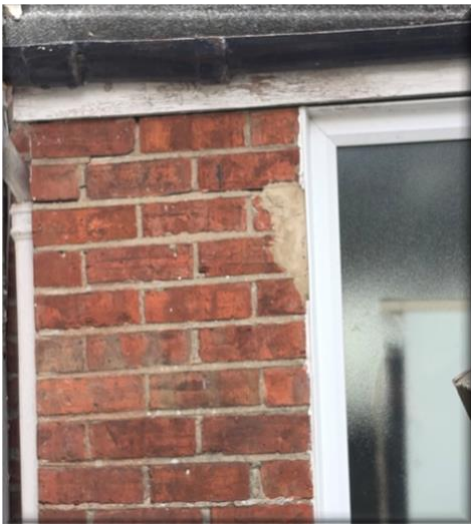
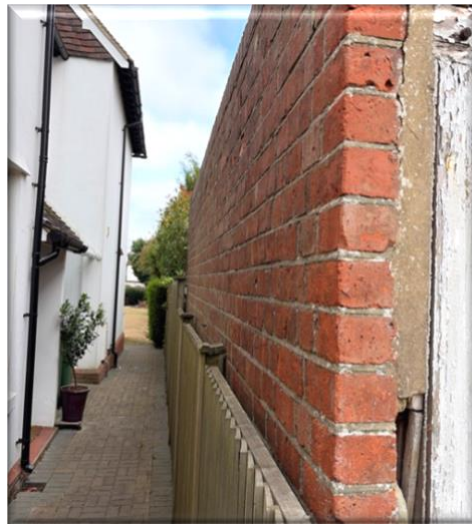
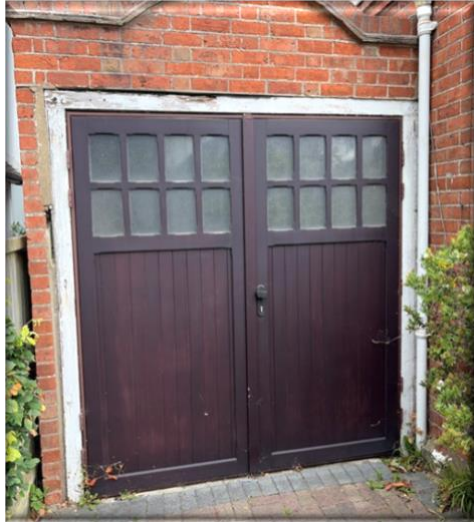
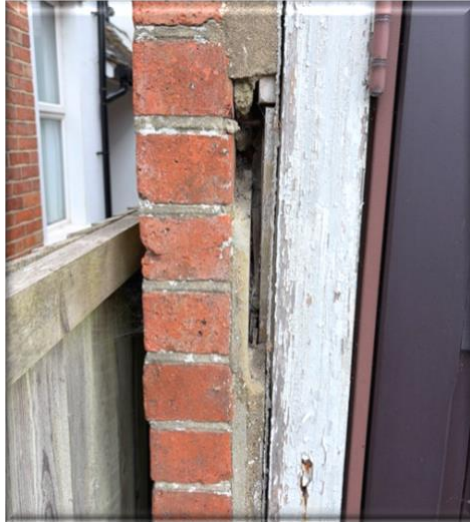
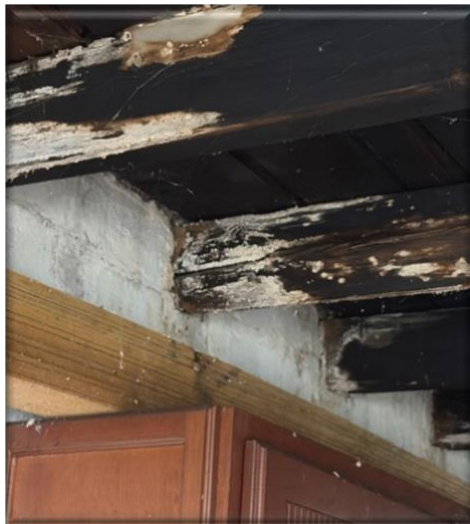
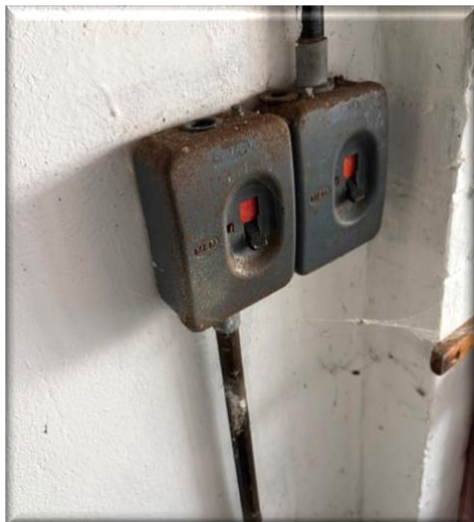
### CR3 Garage

The garage is accessed via a pair of metal garage doors which remain operational but are set within a substantial timber door frame. The frame has deteriorated significantly through prolonged exposure to moisture. Extensive timber decay was noted, particularly to the head and side members, where the timber has become soft and rotten. Localised repairs are unlikely to provide a durable solution and complete replacement of the timber door frame is recommended.

The mortar fillets and pointing between the timber frame and the surrounding brickwork have also eroded over time. These joints no longer provide an effective weather seal and are allowing moisture to penetrate the junction between the frame and the masonry. The deteriorated mortar should be raked out and repointed following replacement of the timber frame.

Inspection of the garage roof structure identified dampness affecting several of the ceiling joists together with extensive white mould growth. This confirms that water penetration has occurred through the flat roof covering, as discussed in the Roof Coverings section of this report. The exact source of the leak should be identified and repaired before any internal remedial works are undertaken.

The garage walls generally appeared satisfactory; however, isolated areas of weathered pointing were noted, particularly to the rear elevation. These areas should be repointed using a compatible mortar to prevent further moisture penetration and frost damage.

This rating has been applied because the garage is affected by active water ingress resulting in damp roof timbers and mould growth. The rotten timber garage door frame requires replacement, associated mortar joints require renewal, and some roof timbers may require replacement following repair of the leaking flat roof. Localised repointing and upgrading of the older electrical installation should also be anticipated.

Once the roof has been made weatherproof, the affected timbers should be reassessed. The mould should be cleaned using an appropriate fungicidal treatment, and the timber allowed to dry naturally. Any joists that have suffered significant deterioration or loss of structural integrity should be repaired or replaced by a competent contractor. At the time of inspection the deterioration appeared to be localised, although concealed decay cannot be ruled out until the roof covering has been repaired and the structure fully exposed.

Overall, the garage remains structurally serviceable, but repairs to the roof, timber door frame and associated masonry should be undertaken without undue delay to prevent further deterioration.
